Idaho 2024 Interagency Forest Practices Water Quality Audit

State of Idaho
Department of Environmental Quality

January 2025

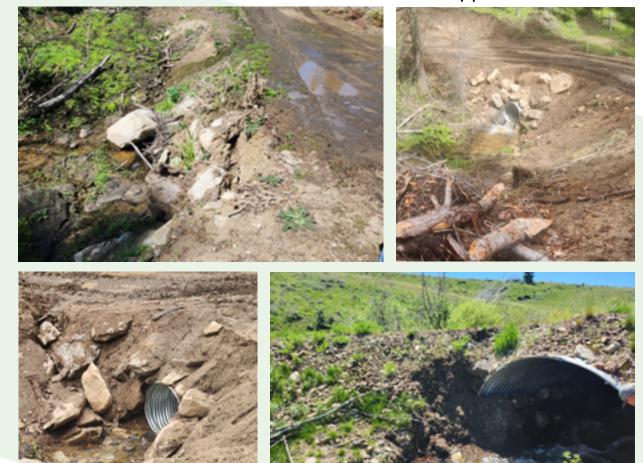
On three occasions, the auditors found that stream crossing culvert pipes were too short. This meant the fill had to be steeper than otherwise required, and often bare dirt reached to the very end of the pipe. This then encouraged erosion directly into the water.

Figure C5. Short culvert pipe, vertical headwalls.

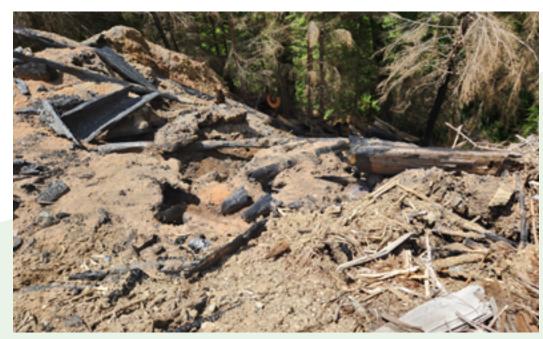
Figure C7. Slash pile burned and eroded next to creek.

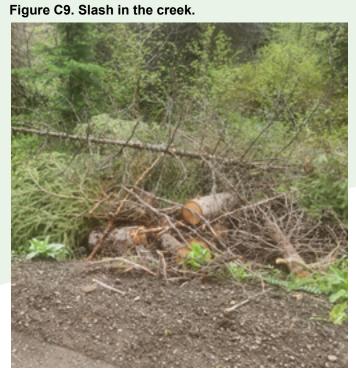
In one case, large amounts of slash in a stream contributed to the failure of a culvert. In another case, several Class II streams were ignored. While they may not have been flowing at the time and were not on the (outdated) area map, the streams were clearly identifiable by their bed and banks. They should have been protected. The audit team visited when the creeks were flowing, and the skid trails and slash piles in the SPZs had caused significant sedimentation of the creeks.

Figure C8. Blown out culvert (blocked by slash).

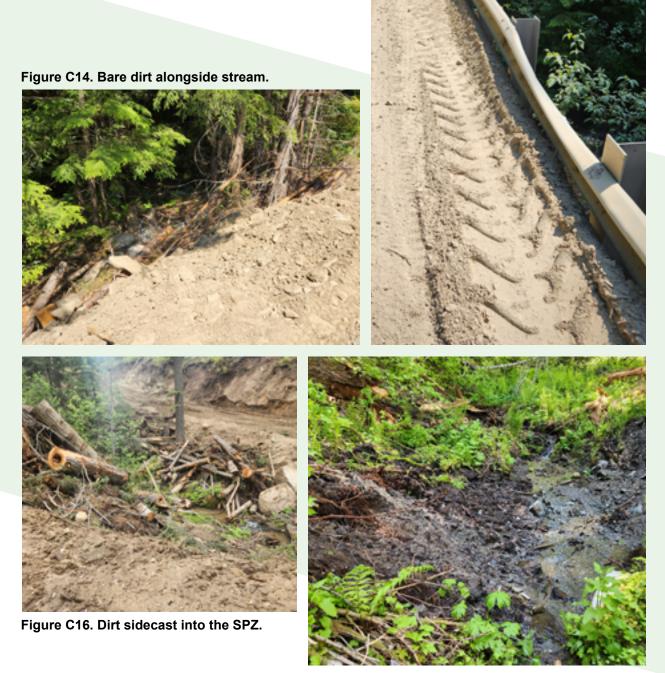
The audit team found rule 040.04a (governing maintenance debris) violated five times. On most of these occasions, debris from cleaning culvert entrances was left immediately next to the stream, where it was vulnerable to being washed back into the stream. Twice, auditors found

Figure C17. Culvert cleaning debris in stream.
