# Triumph Mine Tailings Piles Site

## Fifth Five-Year Review

Blaine County, Idaho

January 2025

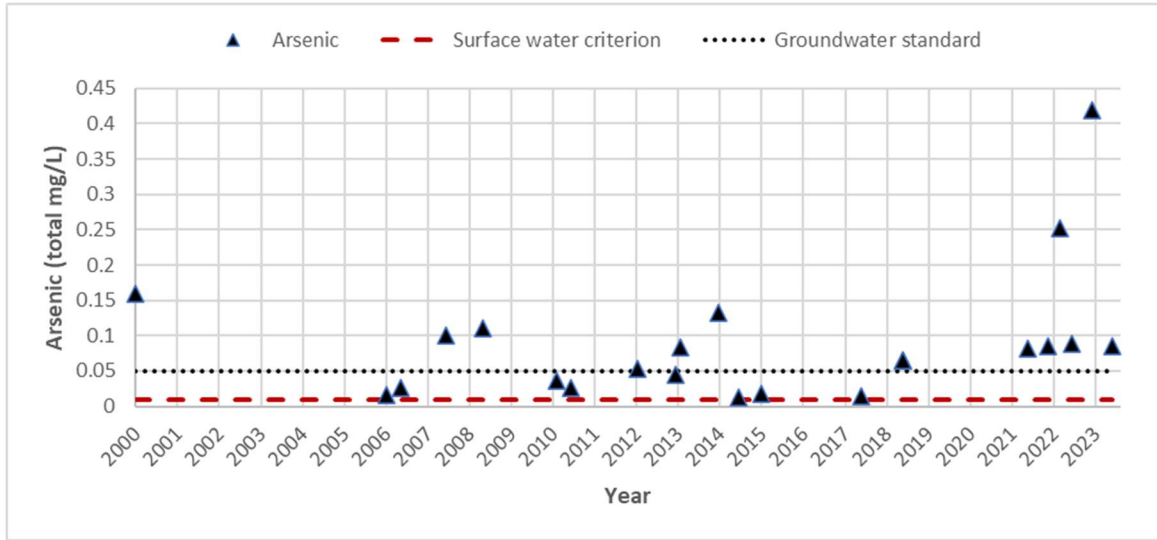
**Figure 3. Arsenic concentrations measured in permanent pond samples.**

manganese, zinc, cadmium, and lead concentrations. Arsenic and manganese concentrations have remediation goals. Figure 3 shows current and historic arsenic concentrations. One high concentration was detected in April 2023 during large snowpack melt and runoff conditions. The Idaho groundwater standard for arsenic is 0.05 mg/L (IDAPA 58.01.11) and the Idaho surface water standard is 0.01 mg/L (IDAPA 58.01.02). The six samples taken in the last five years have exceeded both the groundwater and surface water standards.

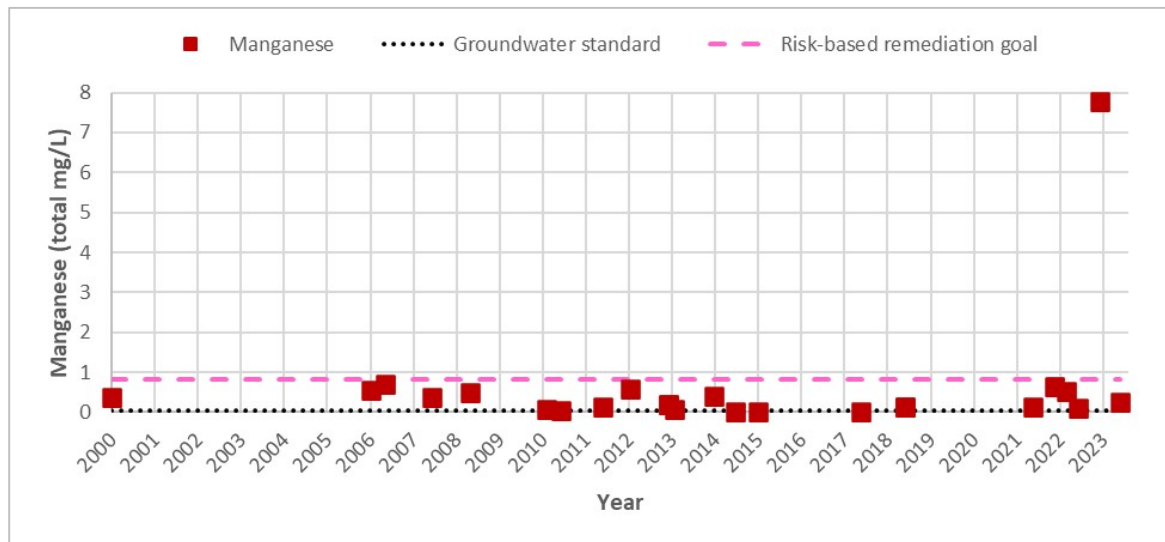
**Figure 4. Manganese concentrations measured in permanent pond samples.**

For manganese, no sample results exceeded the Triumph risk-based remediation goal of 0.84 mg/L except for the results of one sample collected during the April 2023 snowmelt sampling event, which had an uncharacteristically high concentration detected (Figure 4).

The secondary groundwater standard for manganese (0.05 mg/L) is exceeded frequently in the permanent pond sample results.

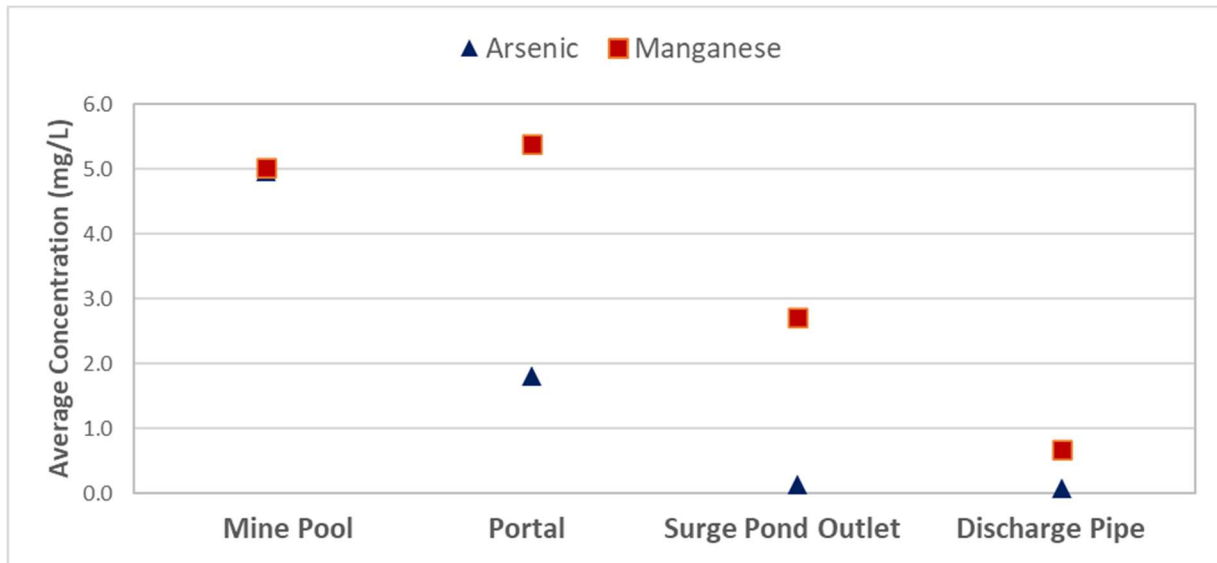
Figure 5. Arsenic and manganese concentrations throughout the mine water management system.

The mine water management system treats metals concentrations. Figure 5 demonstrates steadily decreasing arsenic and manganese concentrations from the mine pool, after treatment in the surge pond, and at the discharge pipe for combined discharge.

These data represent the average metals concentrations for the number of samples and date ranges shown in Table 6.

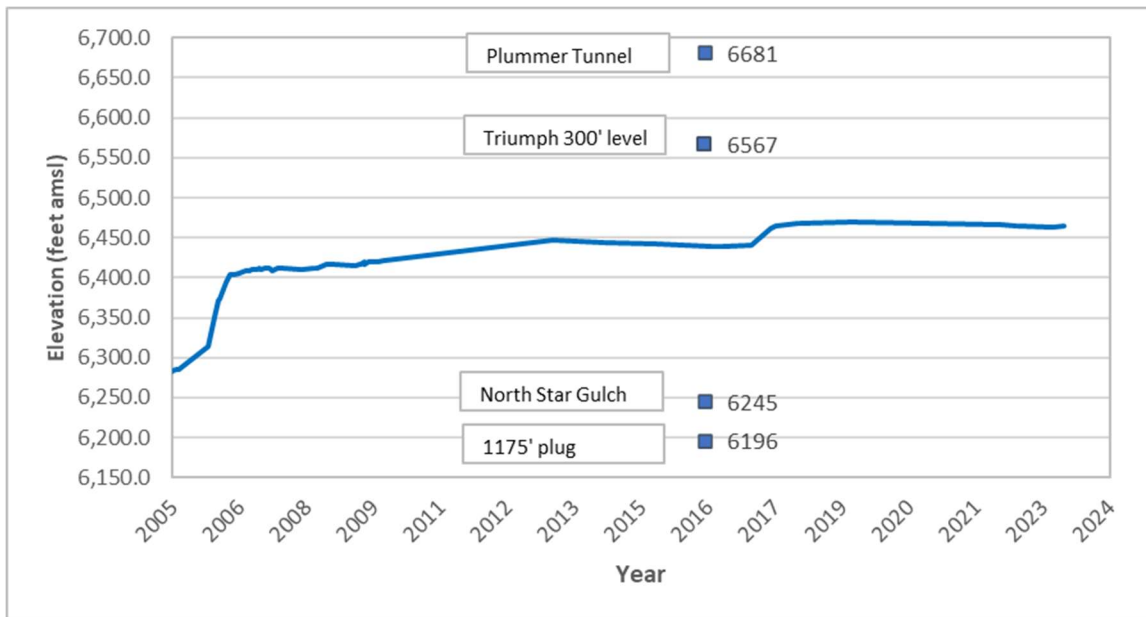
**Figure 6. Mine pool elevation record.**

DEQ monitors the elevation of the mine pool by plug pressure readings at the 235-foot plug. After the 1,175-foot plug installation in 2003, the elevation of the mine pool began to rise as the mine workings behind it filled with water. By 2013, the elevation stabilized and slightly decreased. After the second plug was installed at 235 feet, another small increase in elevation occurred.

Currently, the approximate mine pool elevation is 6,465 feet above mean sea level. Elevations would need to rise to 6,567 feet for water to enter the nearby North Star Mine workings and flow into the Plummer tunnel. The Plummer tunnel is the lowest known elevation opening with a connection to the Triumph tunnel. Figure 6 provides the record of mine pool elevations to date with comparisons to the Plummer tunnel elevation; Triumph tunnel 300-foot level; elevation of seeps at the North Star Gulch; and elevation of the 1,175-foot plug. These elevations were measured from a monitoring well which correlates with groundwater elevations near the level of the 1,175-foot plug.

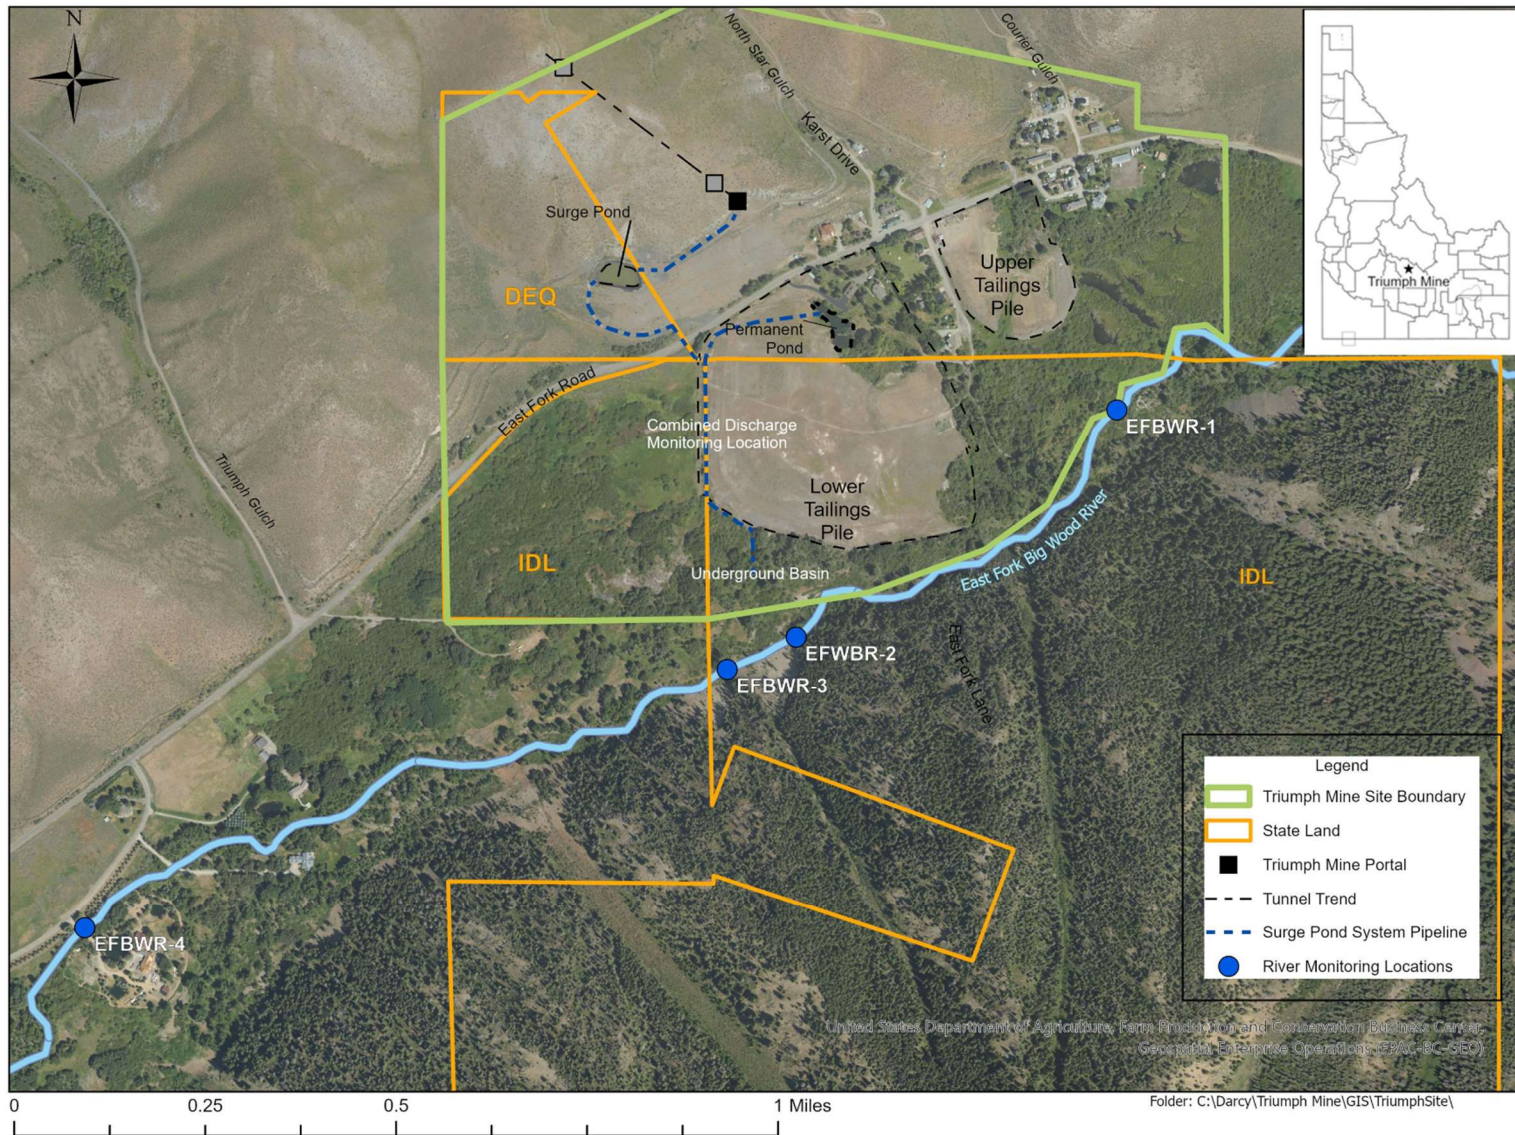
Figure 7. Monitoring locations to evaluate impacts of combined discharge on surface water.

The combined discharge of mine water piped from the surge pond and groundwater discharge piped from the permanent pond terminates in an underground basin about 500 feet from the river. DEQ established four river monitoring locations to determine if the underground basin discharged to the river, either via a surface connection or functional equivalent of direct discharge to surface water through groundwater (Figure 7). Table 9 provides a summary of arsenic and manganese concentrations for 2023.
