# **Magdalena Mine Preliminary Assessment Report**

Blaine County  
State of Idaho

**Department of Environmental Quality**

December 2006

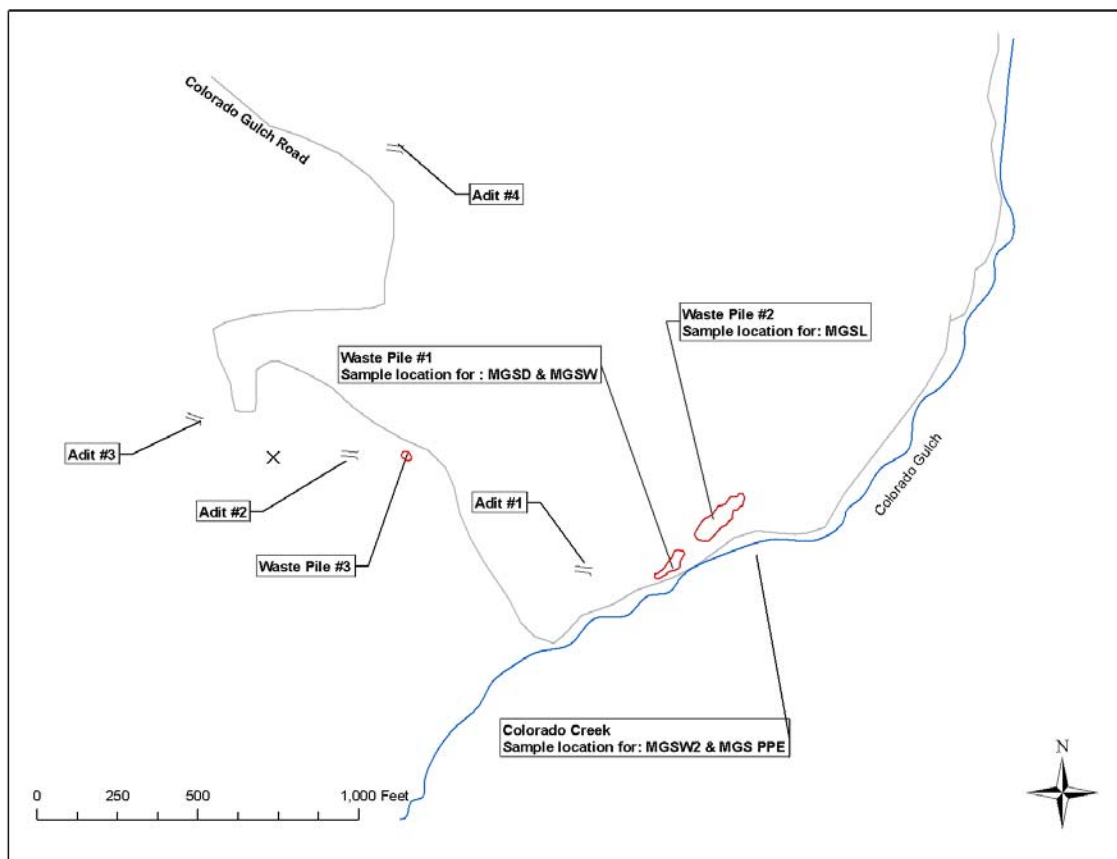
Figure 6. Small-scale sketch of the Magdalena Mine and environmental sampling locations.

As a result of observing clear indications of acid mine drainage from the lower Magdalena mine workings (Adit #1, see Figure 6), DEQ conducted a site investigation on July 11, 2006, which included a visual inspection of the Magdalena Mine and collection of two (2) water samples and three (3) soil and sediment samples.

Waste Pile #3 is located mid-slope of the mine on the western side of the Colorado Gulch road, due east of adit #2 (Figure 6). Adit #2 was partially collapsed approximately 150 feet up the hill from the waste pile. This pile is relatively small, measuring approximately 30 feet long, 30 feet wide, and 15 feet deep (approximately 500 cubic yards). No samples were collected from this pile, and no water was observed that was associated with this pile.

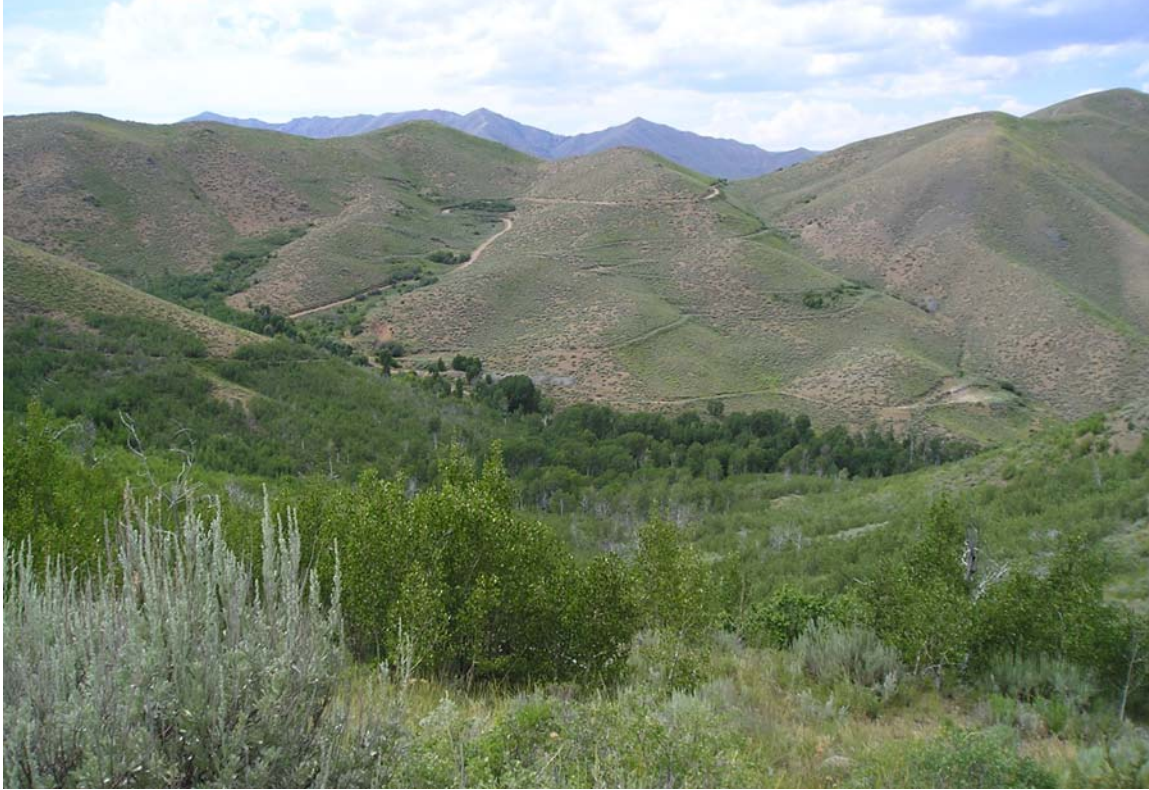
During DEQ's July 2006 visit, the volume of the mine waste piles associated with the Magdalena Mine were mapped at approximately 98,500 cubic feet. The Magdalena Mine waste piles are located on the north side of Colorado Creek, where the mine operated, on mostly open south-facing slopes, which allowed DEQ personnel the ability to make good observations and assessments (Photo 1).

**Photo 1. View looking north at the Magdalena Mine Site.**

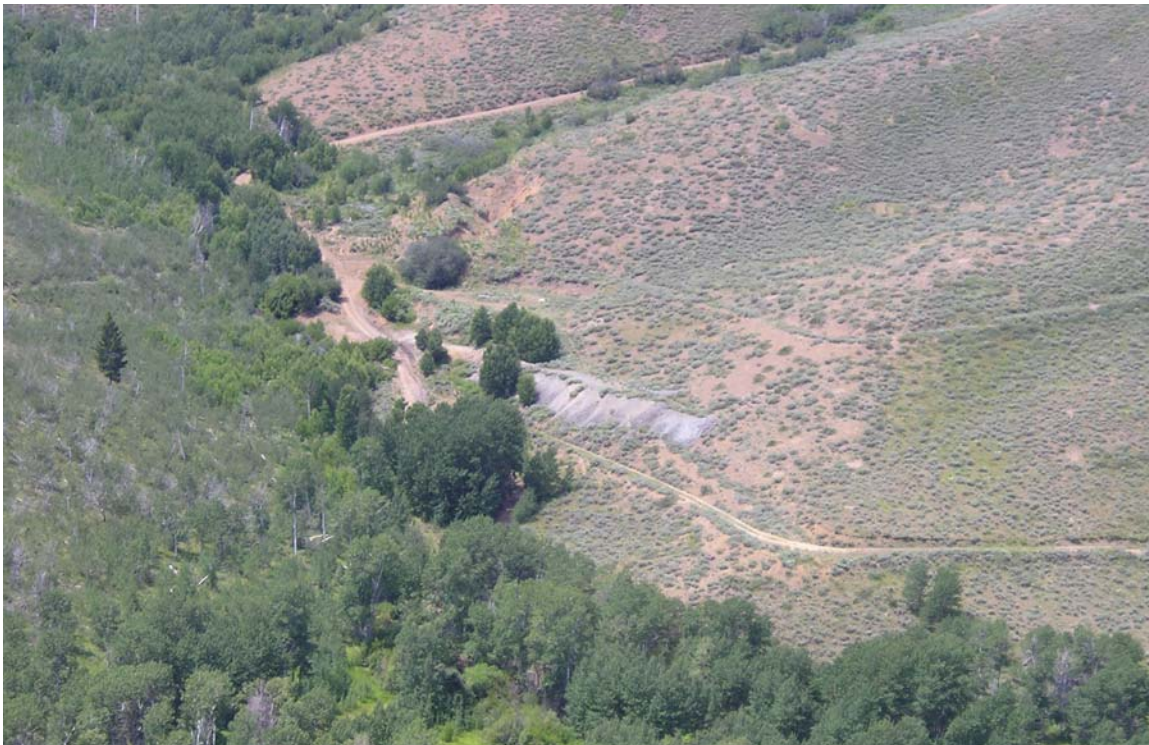
The Magdalena Mine has three significant waste piles that were inspected during the DEQ site visit. The waste piles were arbitrarily named Waste Pile #1 through Waste Pile #3 (Figure 6). The three waste piles exist on gradual slopes of approximately 10 percent (Photo 2).

**Photo 2. View looking northwest at the lower waste dumps and the collapsed Adit #1.**

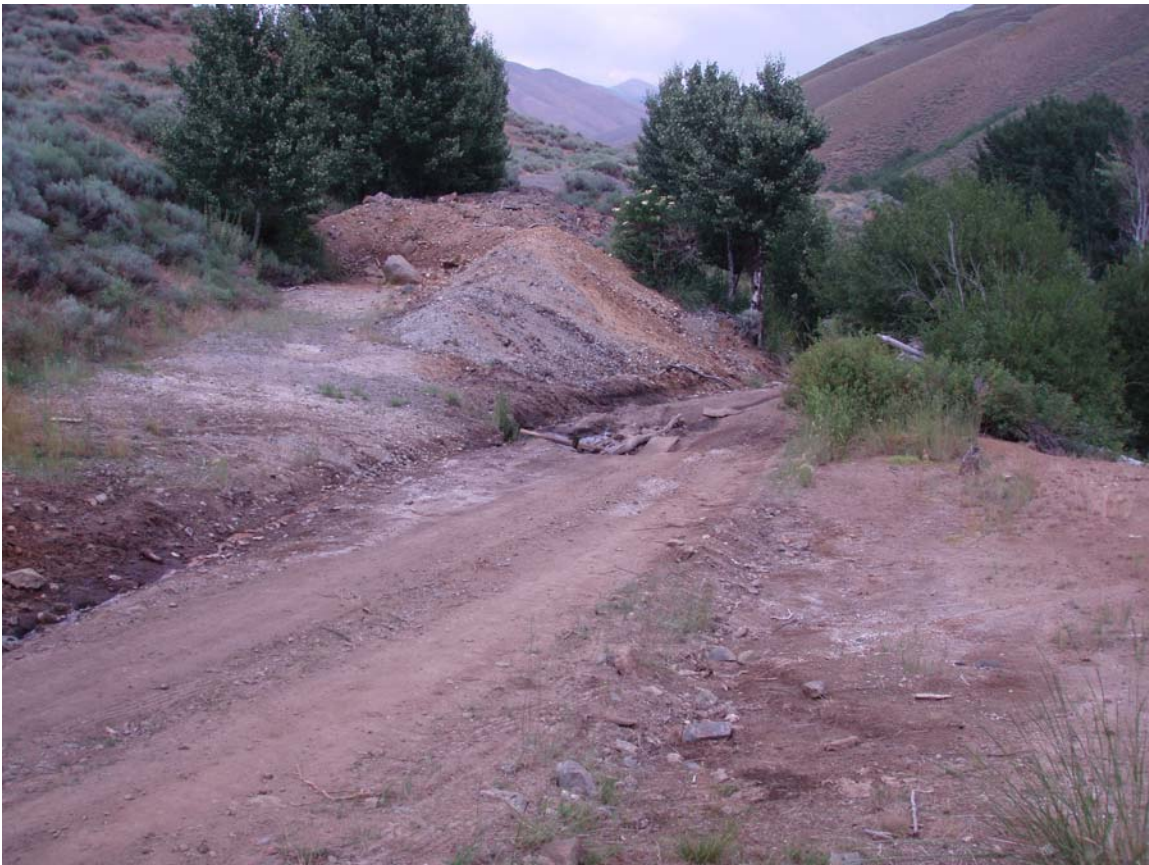
Acid mine drainage was observed surfacing from the toe of this waste pile along the edge of the Colorado Gulch road. This drainage exhibited classic discoloration and has staining of the underlying soils (Photo 3). Based on the location of the expression of this water with respect to the collapsed adit and trench, it is assumed that this water is adit drainage that happens to surface at the toe of this dump. Flows observed during the site visit were low (approximately 0.5 gallons per minute [gpm]) and traversed the Colorado Gulch road into Colorado Creek.

**Photo 3. View looking east down the Colorado Gulch road. Waste Pile #2 is located in the center of the photo. The acid mine drainage can be seen flowing along the road on the left side of the photo.**

The pile was composed of crushed rock of various size and composition (Photo 3). The color of the material in this pile varied from a light grey to a reddish brown. No water was observed that was associated with this pile.

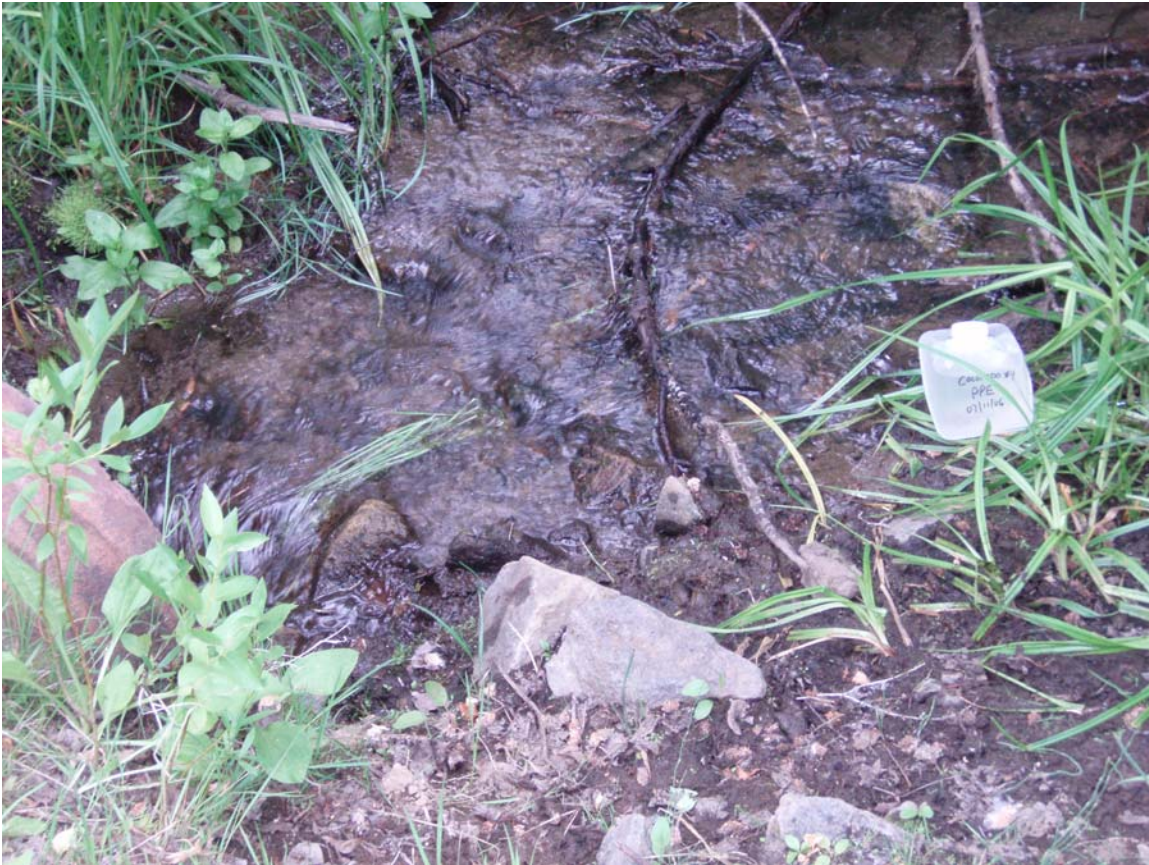
Samples (water and sediment) were collected from the toe of the waste dump and analyzed for metals (samples MGSD and MGSW). Additional water and sediment samples (MGSD-PPE and MGSW-PPE) were collected from Colorado Creek, directly downgradient from the point in which the adit water entered the stream (Photo 4). This was considered the PPE sample for this media.

Photo 4. PPE water sample from Colorado Creek, directly downgradient from the lower mine activity.

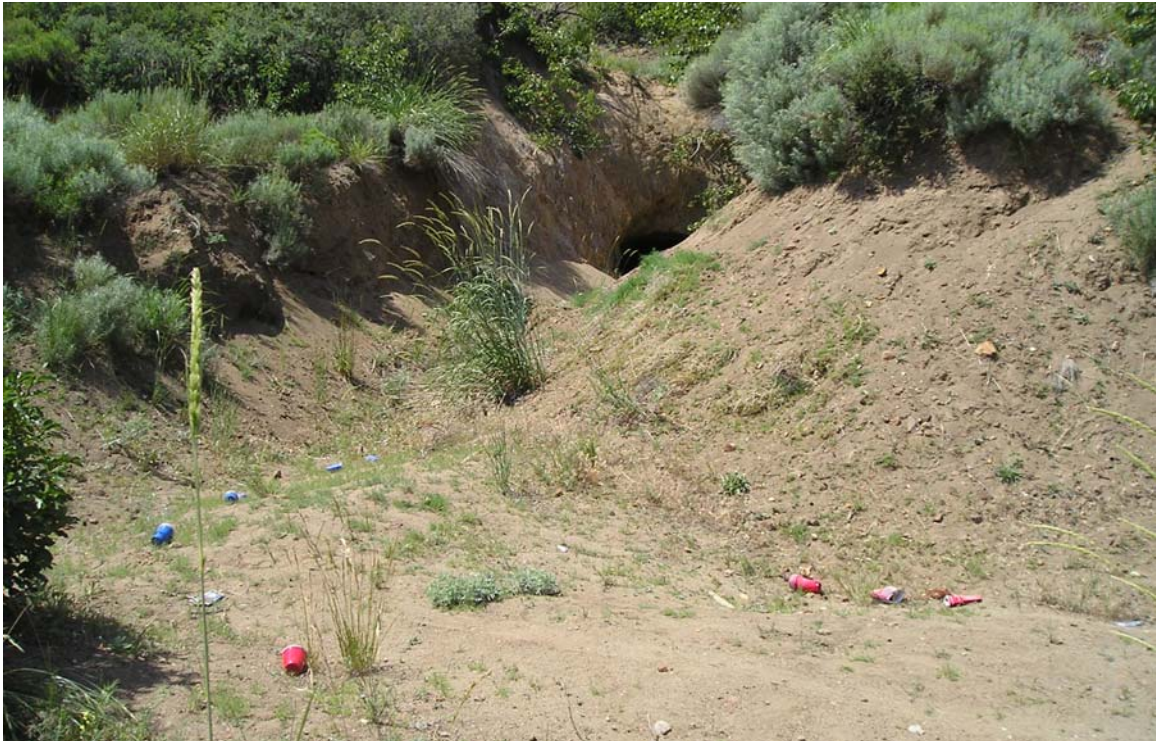
Adit #3 was mapped at the top of the hillslope on the western side of the Colorado Gulch road (Figure 6). This adit has remained open and human activity appears to occur near the

entrance to this adit by the evidence of litter scattered around the area (Photo 5). A waste pile associated with this adit was not observed, and no water was present. No samples were collected from this location.

**Photo 5. View of Magdalena Adit #3. This adit was open and access to the public is not restricted.**

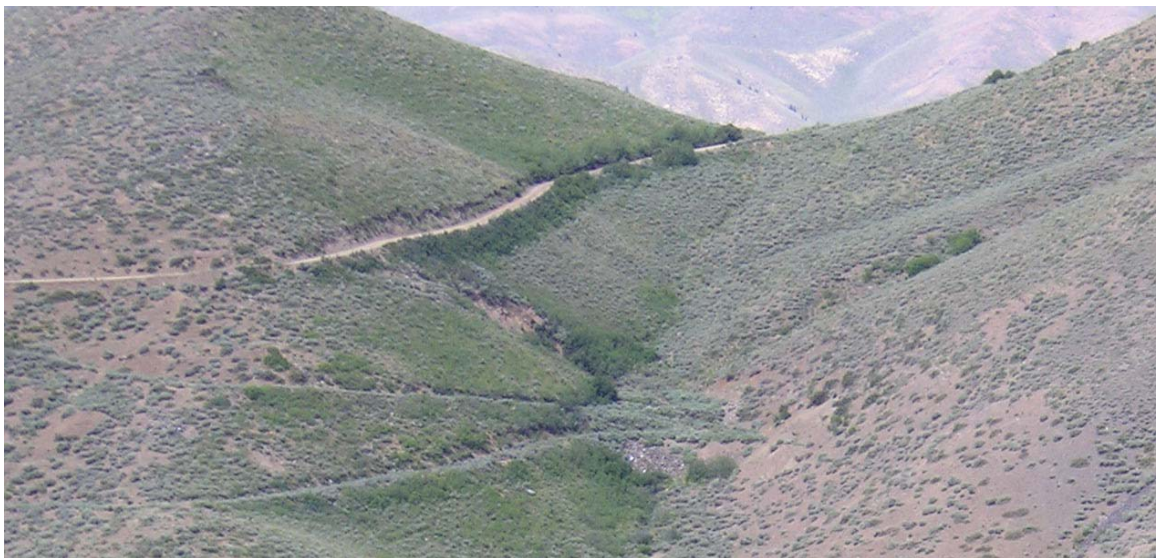
Adit #4 is located on the top of the ridgeline of the basin on the east side of the Colorado Gulch road (Figure 6). This adit was not mapped during the site visit and information regarding this adit is based on previous investigations and aerial photographs (Photo 6).

**Photo 6. Looking north at Adit #4, located directly below the road in the center of the photo.**
