January 5, 2012

Subject: Site Assessment of the Sultan Shaft (Mine), Elk City Mining District,
Idaho County, Idaho

ABBREVIATED PRELIMINARY ASSESSMENT

Site Name: Sultan Shaft

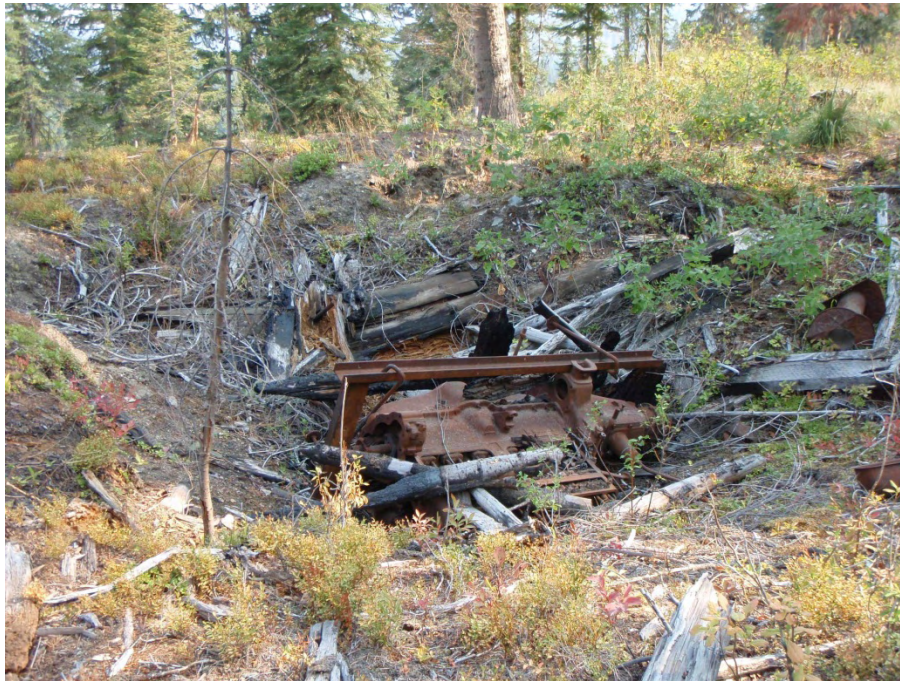
Photo 1, Site #1. Sultan Shaft (collapsed).

No structures were observed on site. Boards and metal used in the mining operation are scattered around on Waste Dump #1 and in the collapsed/reclaimed shaft.

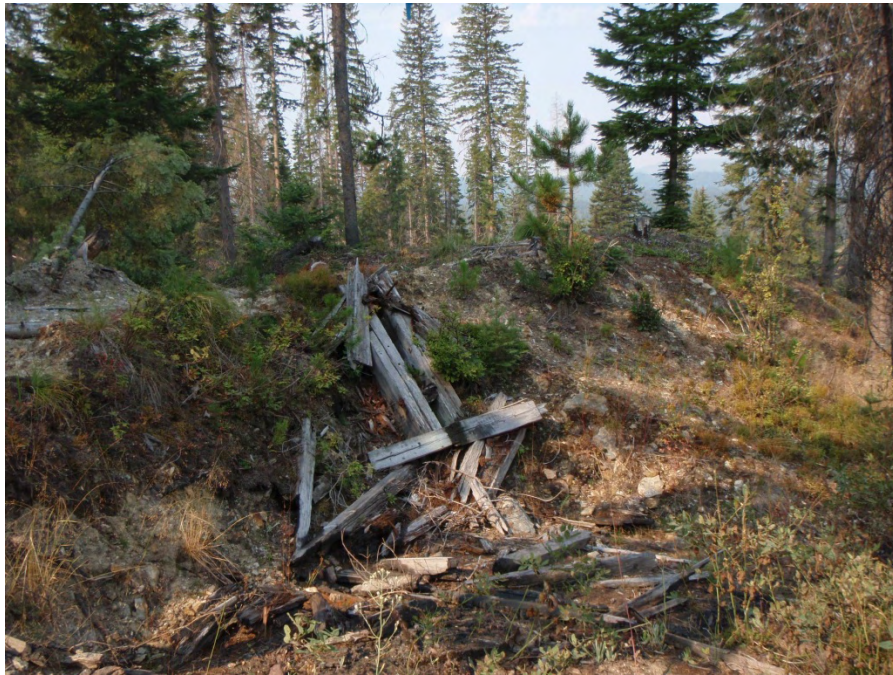
Photo 2, Site #1. Waste Dump #1 and collapsed/reclaimed shaft.

Vegetation appears to be well-established and there are mature trees. Waste Dump #1 is composed of country rock with no mineralized material left, no sulfide smell was observed at time of field visit. The mined area has been logged including trees cut off of the waste dump and by the shaft.

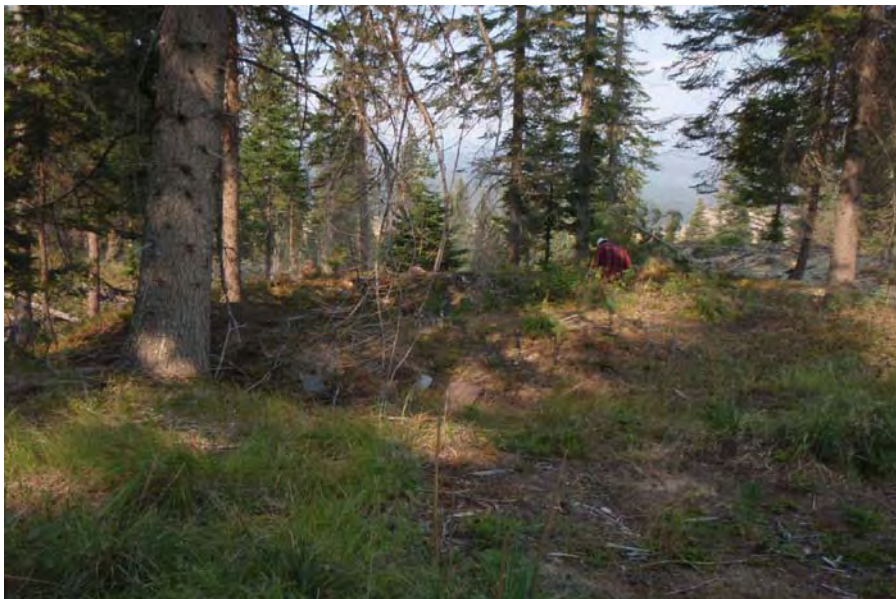
Photo 3, Site #1. Top of Waste Dump #1.

In the IGS 2003 report the estimated total volume for the Sultan Shaft waste dump was 555 cubic yards. DEQ estimated the waste dump to be approximately 500 cubic yards.

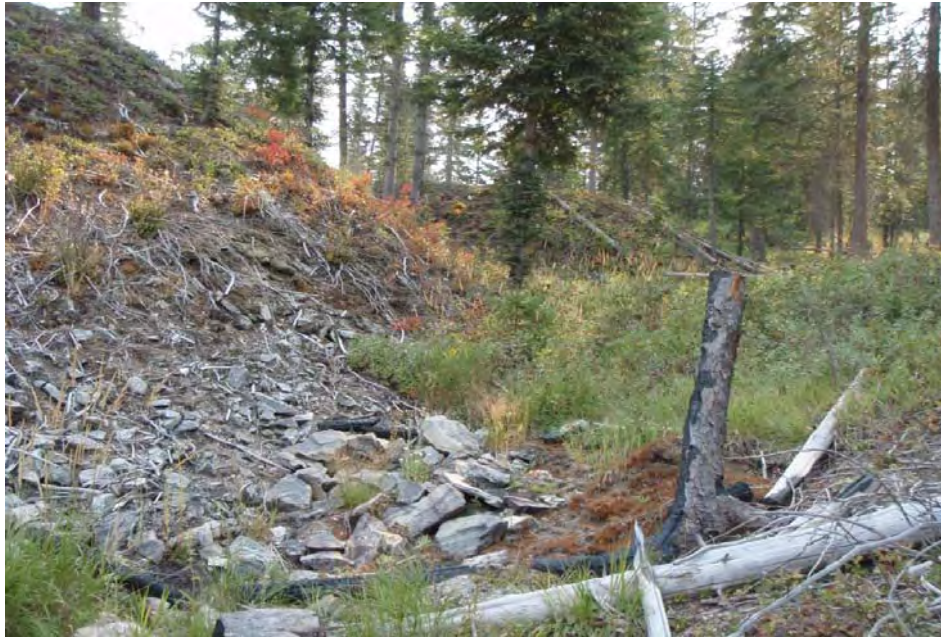
Photo 4, Site #1. Sultan Shaft Waste Dump #1.

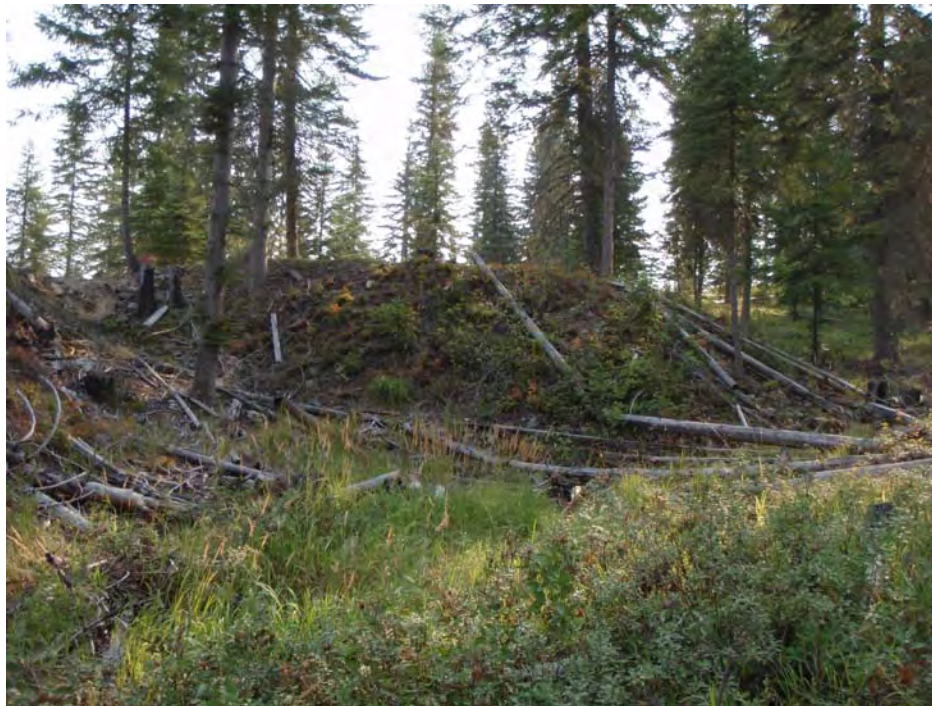
Photo 5, Site #1. West side of Waste Dump #1.
Note vegetation on the top and at the toe.

Located at the toe of Waste Dump #1 there is a shallow drainage without a defined bed, bank or channel. During spring runoff, snow melt water may run in it. The channel drains to the road, where there is no culvert, and goes subsurface beneath the road. Surface water pathways are incomplete for this site.

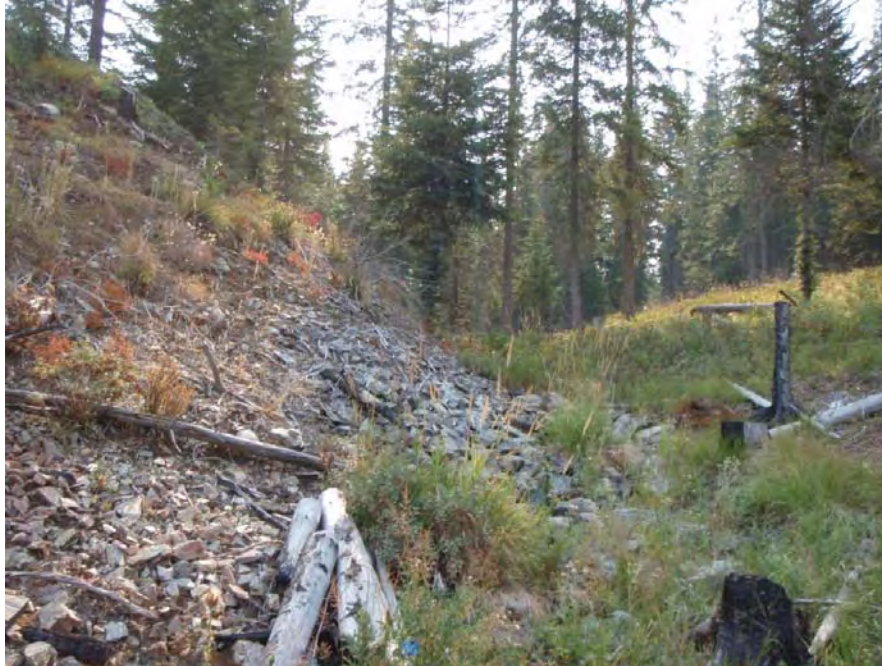
Photo 6, Site #1. Toe of Waste Dump #1.

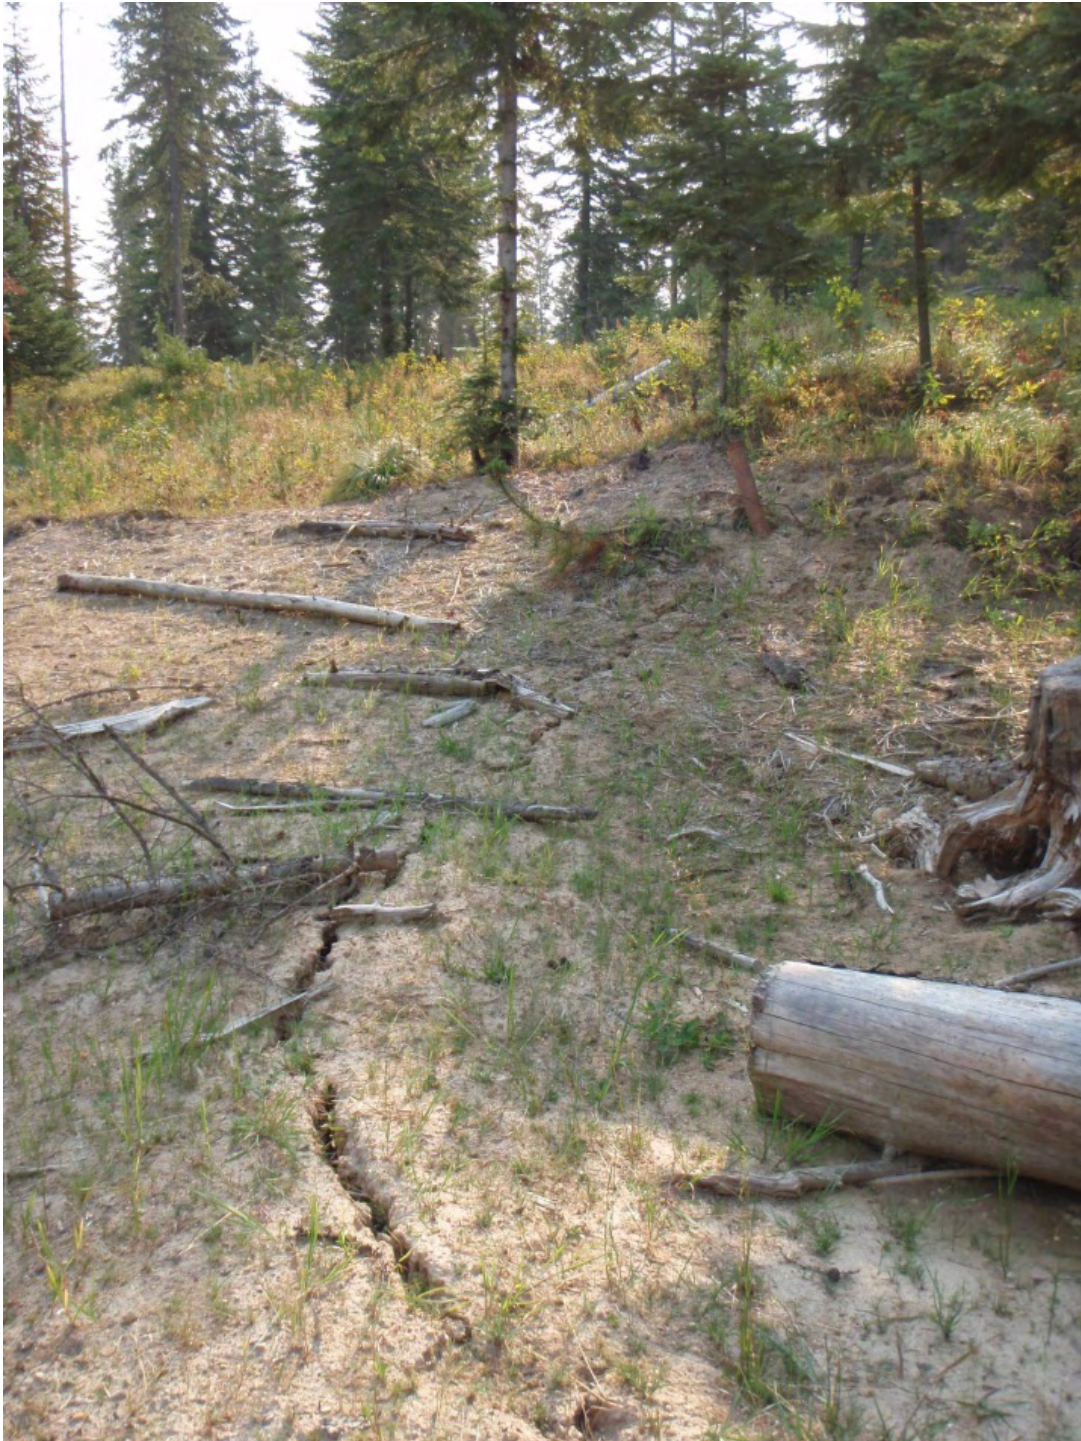
The old road to the Sultan Shaft and the waste dumps appears to have been worked by equipment, smoothed, and pushed around. DEQ assumes the BLM has seeded the disturbed area with a rye and grass mix. All areas are well vegetated, except for the disturbed/fixed area in Photo 7.

Photo 7, Site #1. Seeded area adjacent to the shaft.
The area has settled and the pipe sticking out could be an air vent pipe.

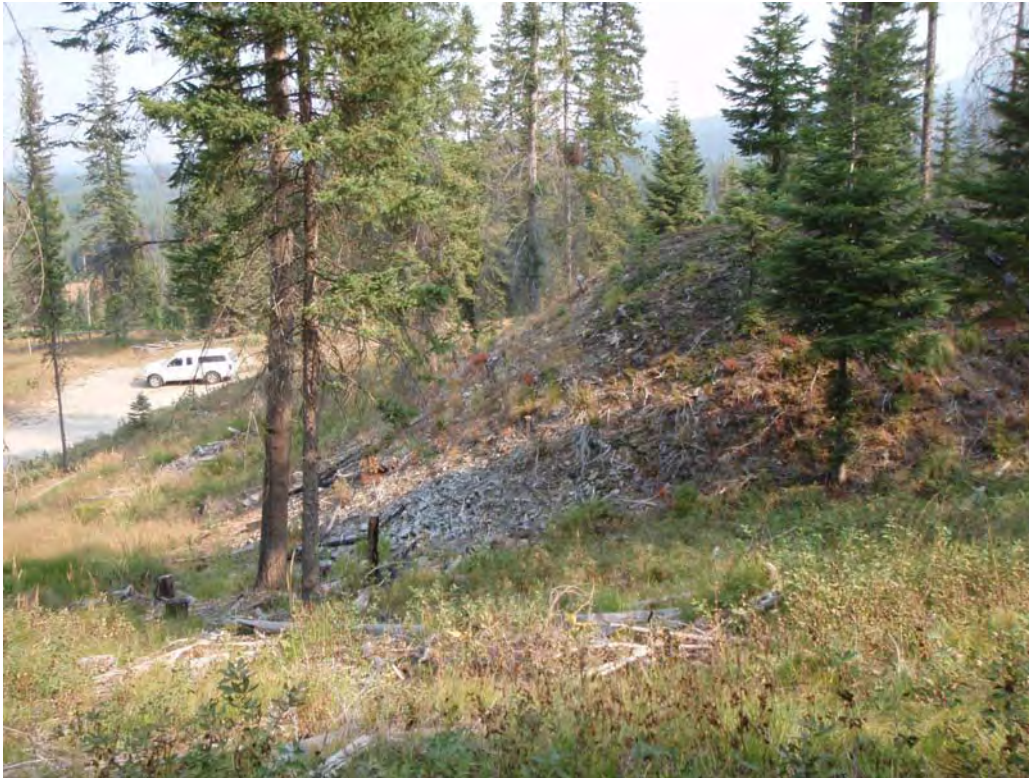
Located approximately 30 yards east of the primary area there is a collapsed adit/tunnel and a waste dump. Both are very well vegetated. Waste Dump #2 is approximately 47 cubic yards. No evidence of surface water erosional pathways from this waste dump was observed.

Photo 8, Site #2. Sultan Shaft Waste Dump #2.
