# Upper and Lower Henry's Fork Total Maximum Daily Loads:

Addendum to the Upper Henry's Fork Subbasin Assessment and TMDLs

**Upper and Lower Henry's Fork Total Maximum Daily Loads:  
Addendum to the Upper Henry's Fork Subbasin Assessment and  
TMDLs**

**Prepared by:  
Idaho Falls Regional Office  
Department of Environmental Quality  
900 North Skyline Dr., Suite B  
Idaho Falls, ID 83402**

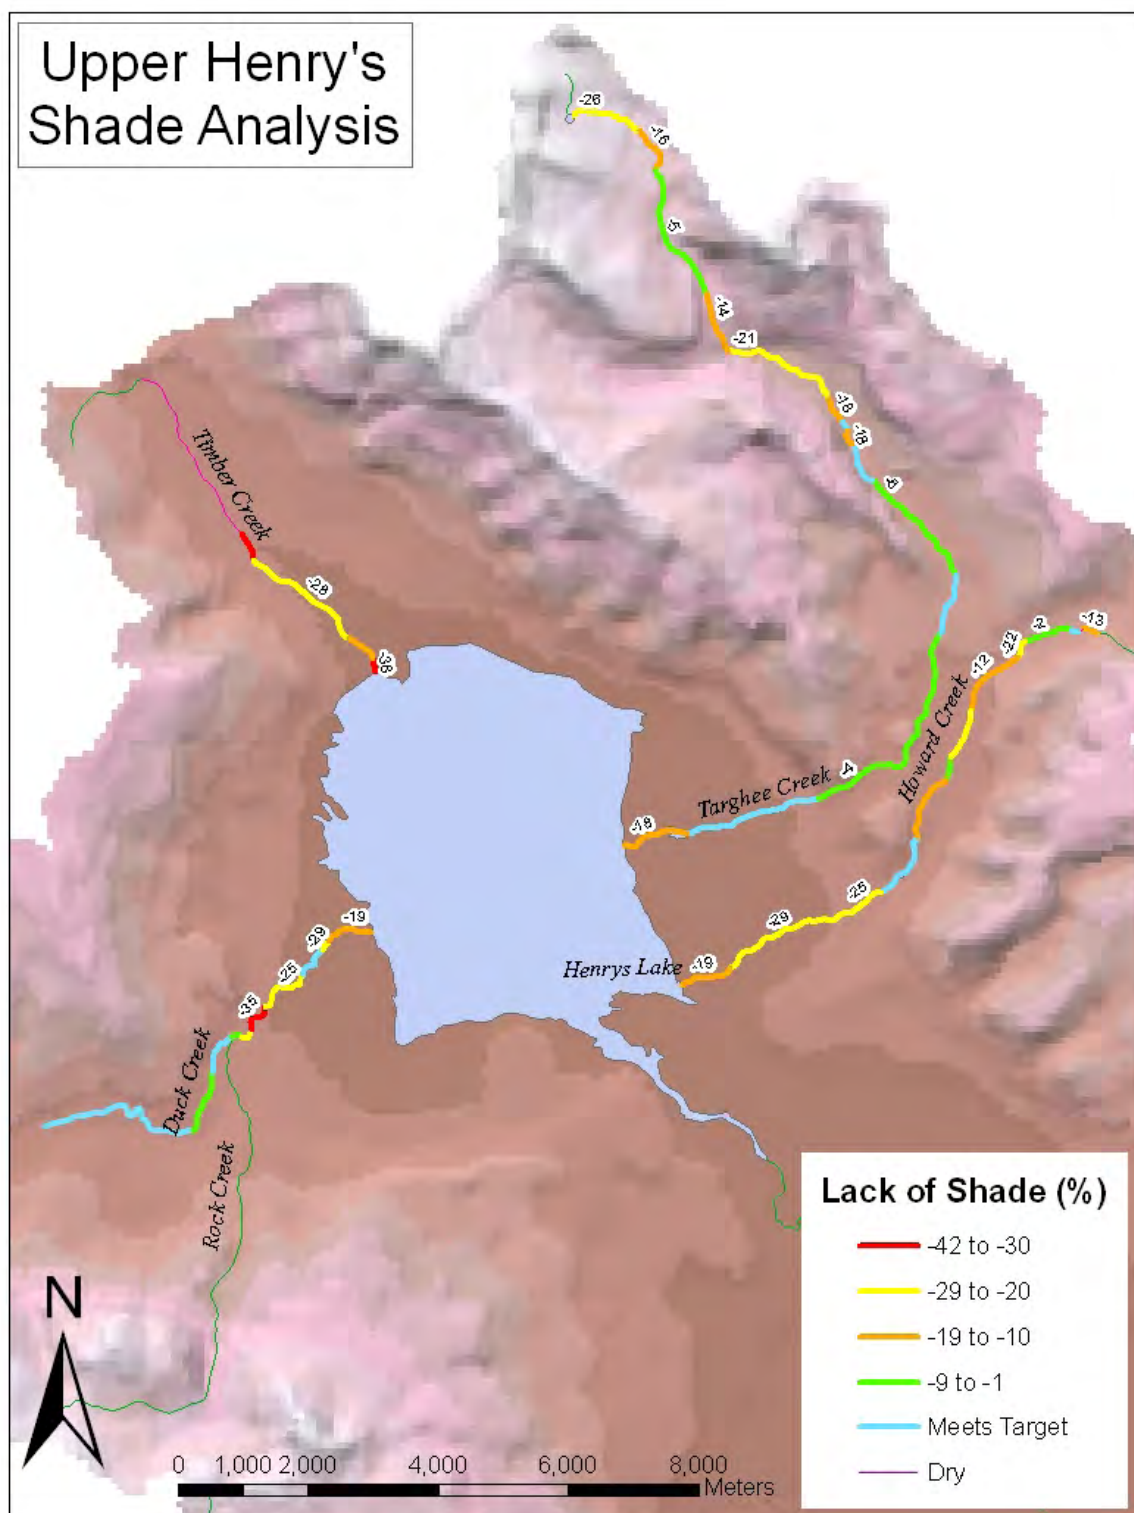
Figure 11. Lack of shade (difference between existing and target) for tributaries to Henry's Lake.

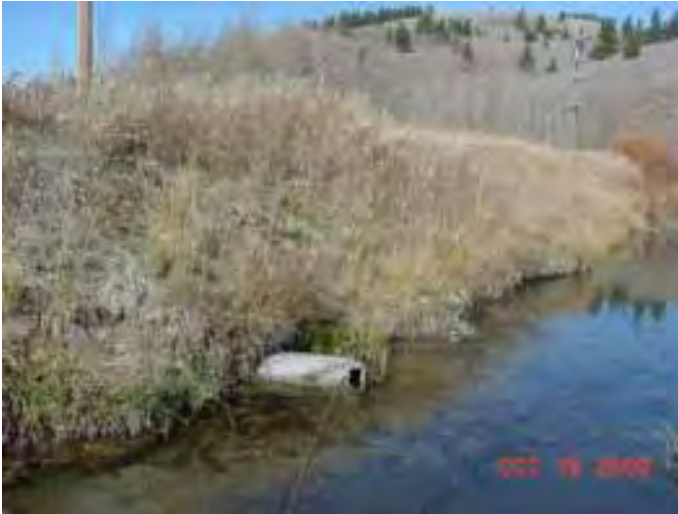
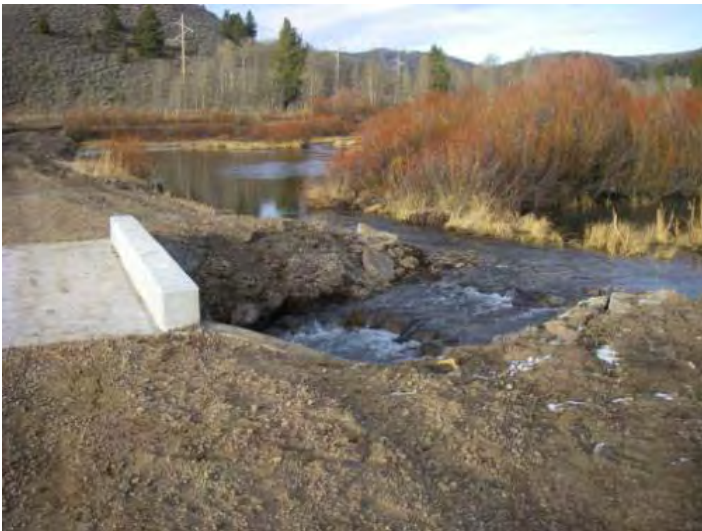
The impassable culvert was replaced with a bridge to restore Yellowstone cutthroat trout passage.

**Howard Creek Passage Project:** More of Howard Creek was connected to Henry's Lake with the replacement of a barrier culvert with a bridge, 200 yards upstream from Highway

87. This allows for passage of Yellowstone cutthroat trout from Henrys Lake further up the stream. The Nature Conservancy led the project, and other partners included the private landowner and Eastern Idaho Resource Advisory Committee. Two smaller culverts that are partial barriers remain upstream and are scheduled for replacement in 2010.

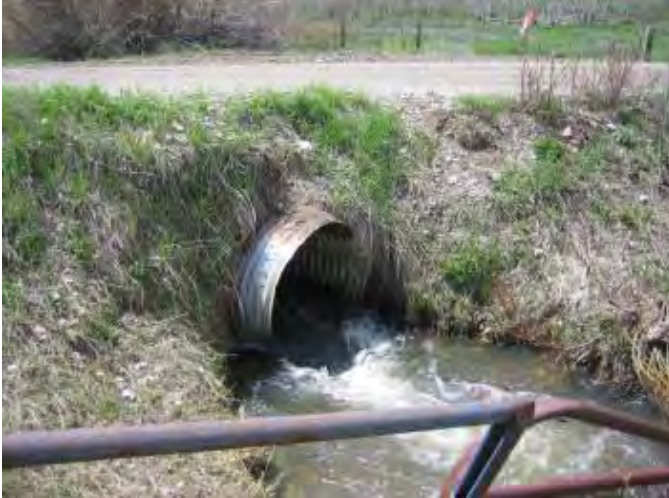
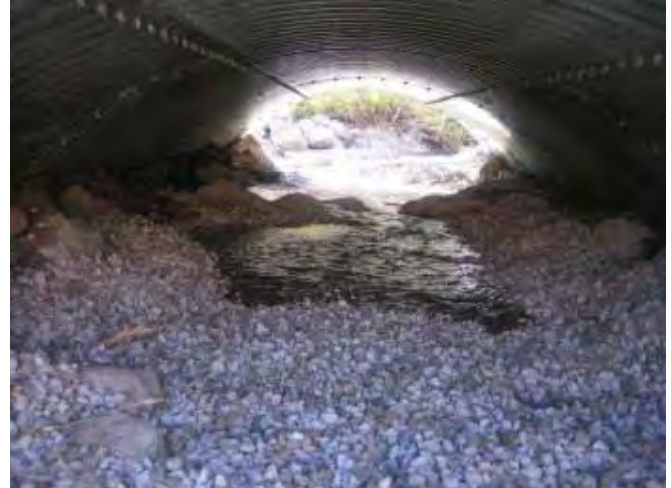
Pre- (left) and post- (right) construction at Duck Creek crossing site. The impassable, under-capacity culvert was replaced by a bottomless arch with a natural stream bottom.

**Passage Progress at Duck Creek:** In 2009 the Forest Fisheries Program, in partnership with Eastern Idaho Resource Advisory Committee, U.S. Fish and Wildlife Service, and Henrys Lake Foundation, initiated the Duck Creek fish passage project, restoring upstream passage at one out of the four fish passage barriers on Duck Creek, a tributary to Henrys Lake. This project benefits Henrys Lake Yellowstone cutthroat trout. Work on the other 3 crossings is expected to occur in 2010.

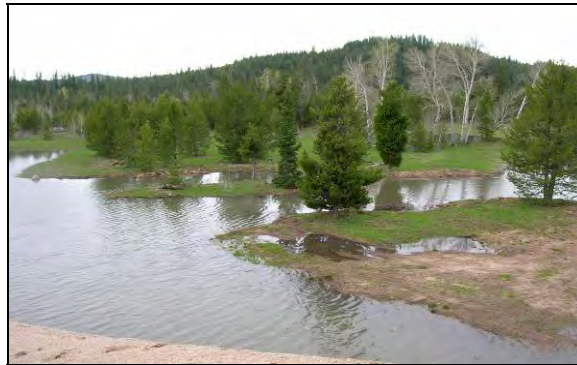
Lyle Spring Area: center is where ponds were connected.

**Lyle Springs Improvement (5 acres improve):** The purpose of this project was to improve Lyle Springs ability to capture spring runoff and keep water off road and running into adjacent dispersed camping area. Additional pond area was excavated to increase holding capacity. Excavated material was used to raise road system approximately 1 foot in elevation. Wildlife habitat was improved as water holding capacity was increased. Public safety in the dispersed camping areas was also improved. The work was completed by the Caribou-Targhee Road Crew.

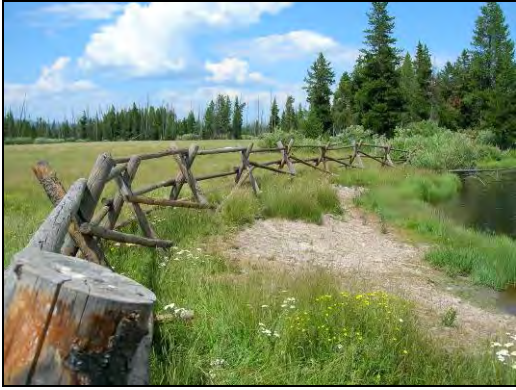
**Elk Creek and fenced off area where willows were planted along bank.**

**Elk Creek Willow Planting and Fence Construction (2 acres):** Willows were planted in the fall of 2007 along a 200 foot section of Elk Creek where cattle have historically used as a watering point. Buck and rail fence was installed for additional bank protection. The project was completed by Forest Service staff. Thanks to Brad Higginson (forest hydrologist) and Kyle Moore (district range management specialist) for their help on this project.

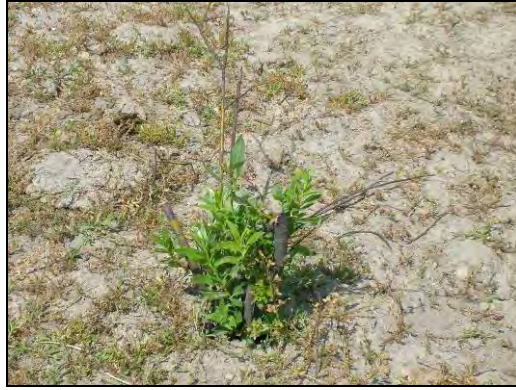
**Typical willow planting results along Elk Creek (estimated 85% success first year).**

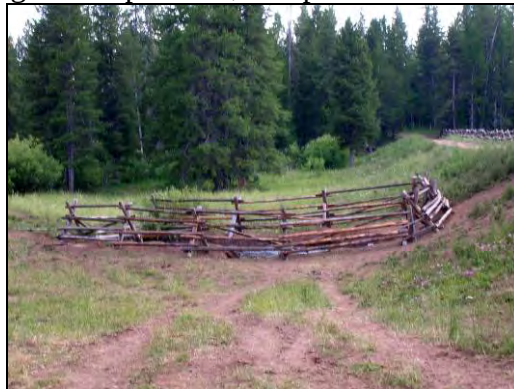
**Bootjack Pond Outlet Protection (1 acre):** The purpose of this project was to protect the outlet area from livestock. This area is typically used as a watering point for cattle. Kyle Moore, district range management specialist, completed the work.

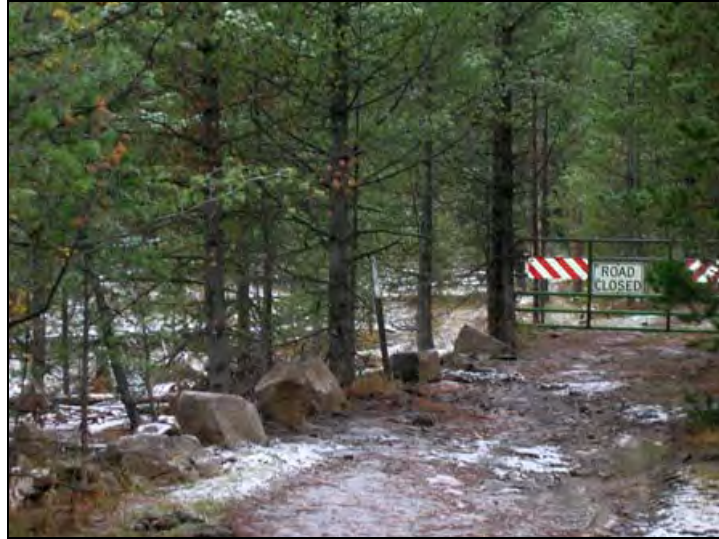
**Barrier boulders & signs placed in the Bootjack Area to stop illegal ATV use.**

**Closures of illegal roads and ATV trails (12 Acres Improved):** In 2007 the district closed numerous illegal roads and ATV trails that have impacted water quality, soil productivity and other resource values with the use of boulder and signs. Work was completed on the Continental Divide Trail near Blair Lake to close an illegal road from Keg Springs to a hilltop by placing rocks and obliterating parts of the road with a dozer. More illegal ATV access in the Bootjack area was also closed with boulders and signs as shown below in the photo protecting and improving about 7.5 acres. Additional boulder closures and obliteration work was completed in the Yale Creek area improving approximately 1.5 acres from illegal ATV trails.

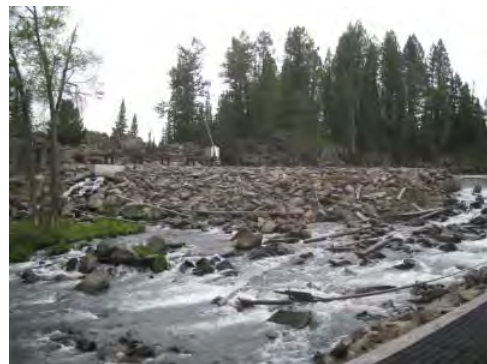
Newly constructed Fish Ladder

The resulting settlement agreement included a fish ladder and fish screens on the turbine intake system. The new ladder is designed to allow migrating adult fish to spawn in the Buffalo River and allow young trout migrating from the Henry's Fork to find more favorable over-wintering areas above the dam. The weirs in the ladder allow fish to swim through or jump over each weir. A layer of river rocks was provided for resting areas at the bottom of the fishway. The screening of the water intake to the powerhouse will exclude all but the smallest of fish. This project will benefit the Buffalo River and Henry's Fork fisheries.

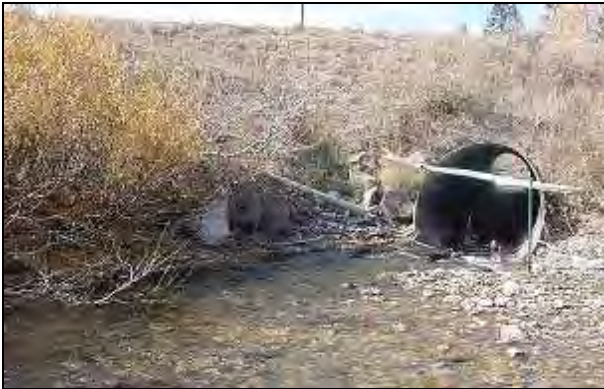
**Targhee Creek Culvert under Highway 20 before replacement was a barrier to upstream-migrating Yellowstone cutthroat trout.**

**Howard & Targhee Creek Fish Passage:** Howard and Targhee Creeks were reconnected to Henry's Lake as the Idaho Transportation Department (ITD) replaced the existing culverts that have been in place since the 1970's with full span bridges. For the last 35 years, Yellowstone cutthroat trout migrating upstream from Henry's Lake, met barriers at these highway crossings. The speed at which this project came together is a testament of how important everyone involved felt this project was. This project went from hope and desire to completion in one year, and emphasizes the importance of partnerships. The Transportation Department provided the funding and design, and the other partners (Idaho Department of Fish and Game, Greater Yellowstone Coalition, Henry's Fork Foundation, Henry's Lake Foundation, and Senator Crapo's office) provided the motivation and environmental work. The Forest provided the biological assessment, cultural resource report and clearance, and wetland delineation. Most importantly Yellowstone cutthroat trout, native to Henry's Lake, are once again able to access the largest and most important spawning tributaries to Henry's Lake.

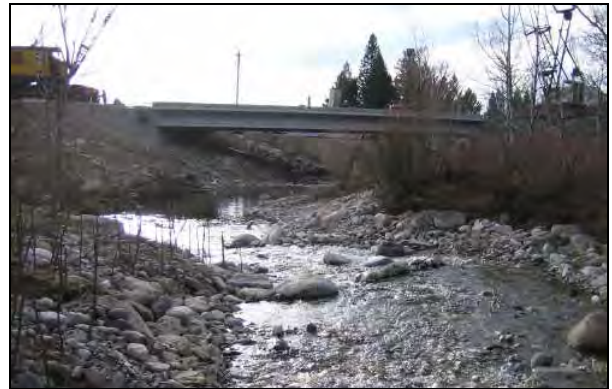
**The Targhee Creek crossing at Highway 20 after construction. The impassable culvert was replaced by a fish-friendly bridge.**

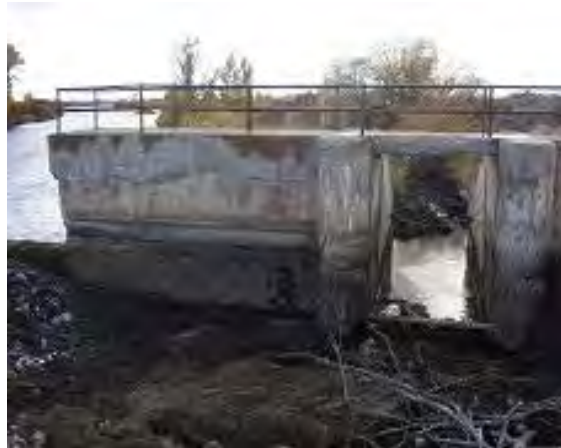
View of Old Dam

To address fish migration issues, fish screens will be put in place at the entrances to both the Crosscut and Last Chance canals and a pathway will be provided to allow downstream passage. Boat ramps will be constructed upstream and downstream of the dam and gravel parking areas will be added. Restrooms will also be built to benefit those recreational users in the area. The Conservation Groups agreed to provide all necessary funding for a fish ladder to be designed, engineered, and constructed upstream of the dam. The Project has addressed

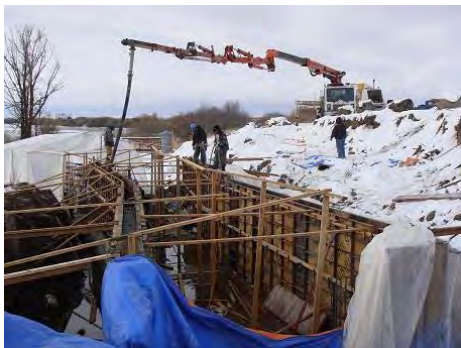
Construction of Chester Dam

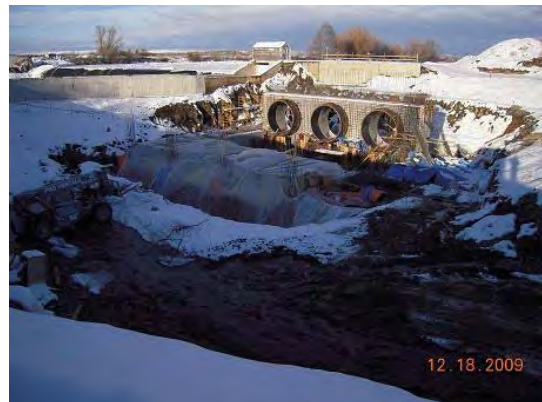
Construction of Dam
