Big Willow Creek Assessment and
Temperature Total Maximum Daily Load:
Addendum to the Lower Payette River
Subbasin Assessment and TMDL

**Department of Environmental Quality
May 2008**

**Big Willow Creek Assessment and Temperature
Total Maximum Daily Load:
Addendum to the Lower Payette River Subbasin
Assessment and TMDL**

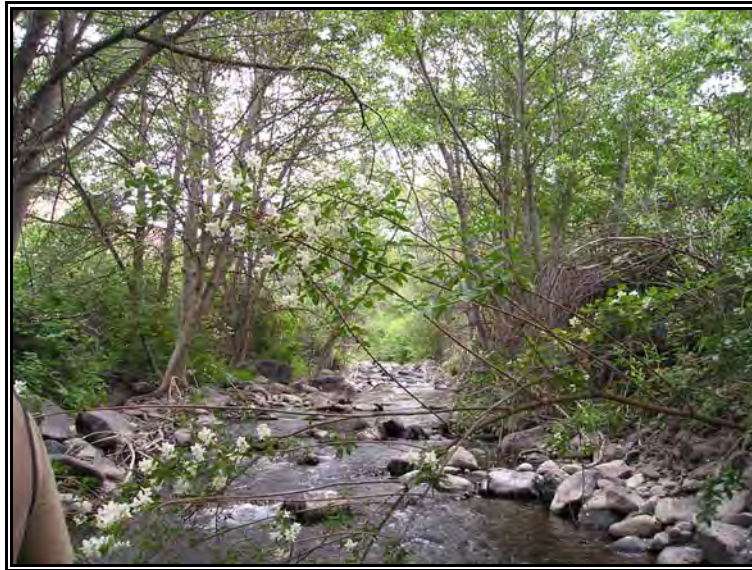
Figure 6. Big Willow Creek Upstream of French Corner. (M. Shumar, 2006)

Alders and dogwood (Figure 6 and Figure 7) dominate riparian woody vegetation. Figure 8, Figure 9, and Figure 10 (Big Willow Creek, in the lower-gradient section, downstream of French Corner), illustrate an incised system lacking mature vegetation.

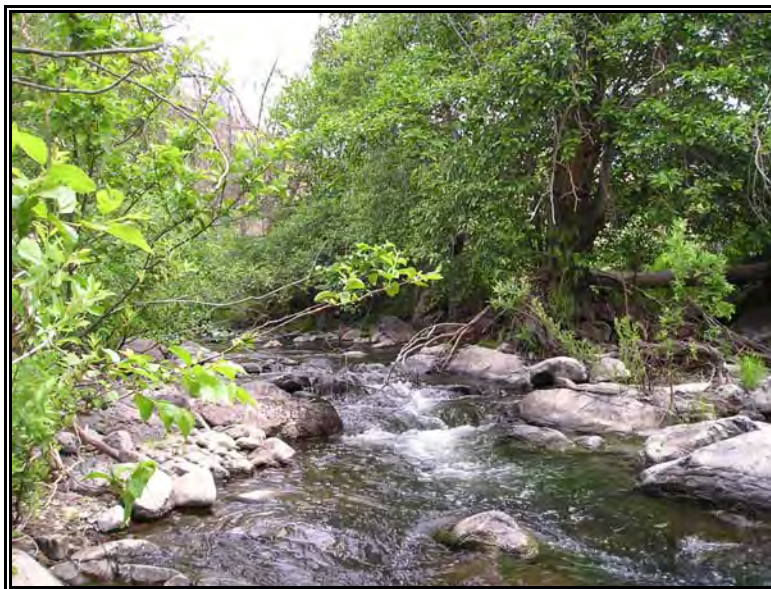
Figure 7. Big Willow Creek Upstream of French Corner. (M. Shumar, 2006)

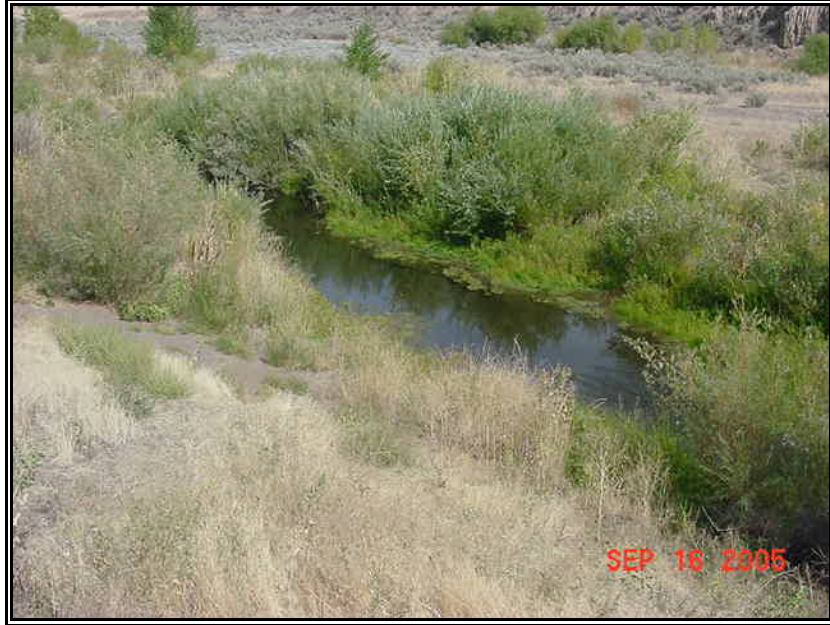
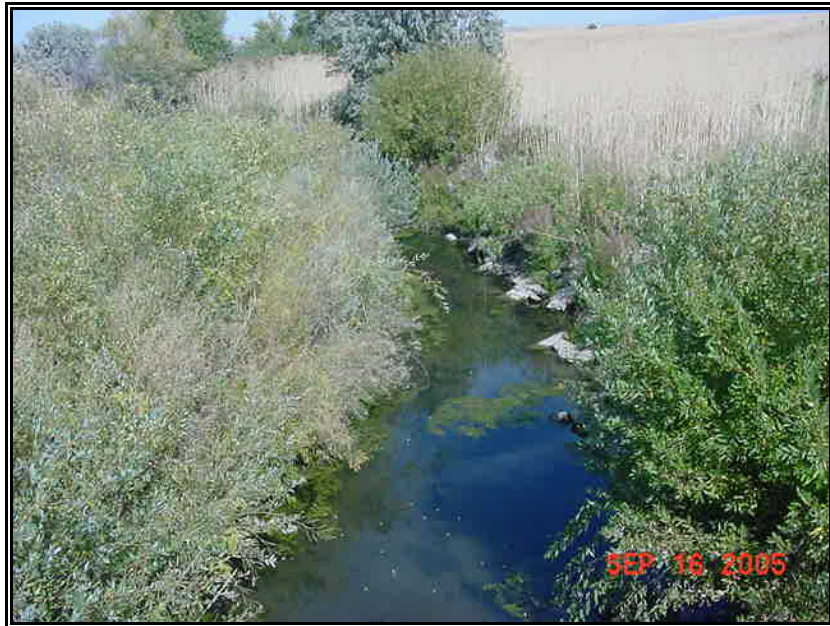
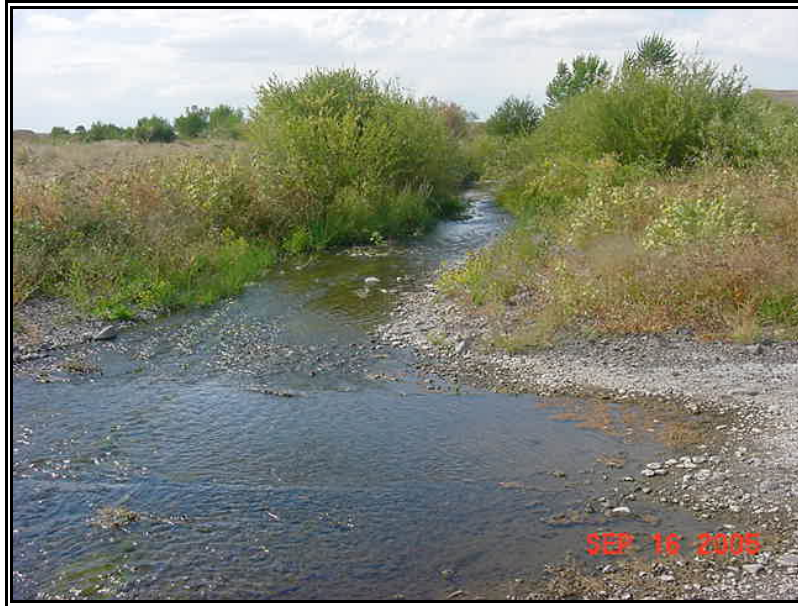
Figure 8. Big Willow Creek near Lower Road Crossing. (M. Ingham, 2005)

Figure 9. Big Willow Creek near Lower Road Crossing. (M. Ingham, 2005)

Figure 10. Big Willow Creek Four Miles Downstream of French Corner. (M. Ingham, 2005)

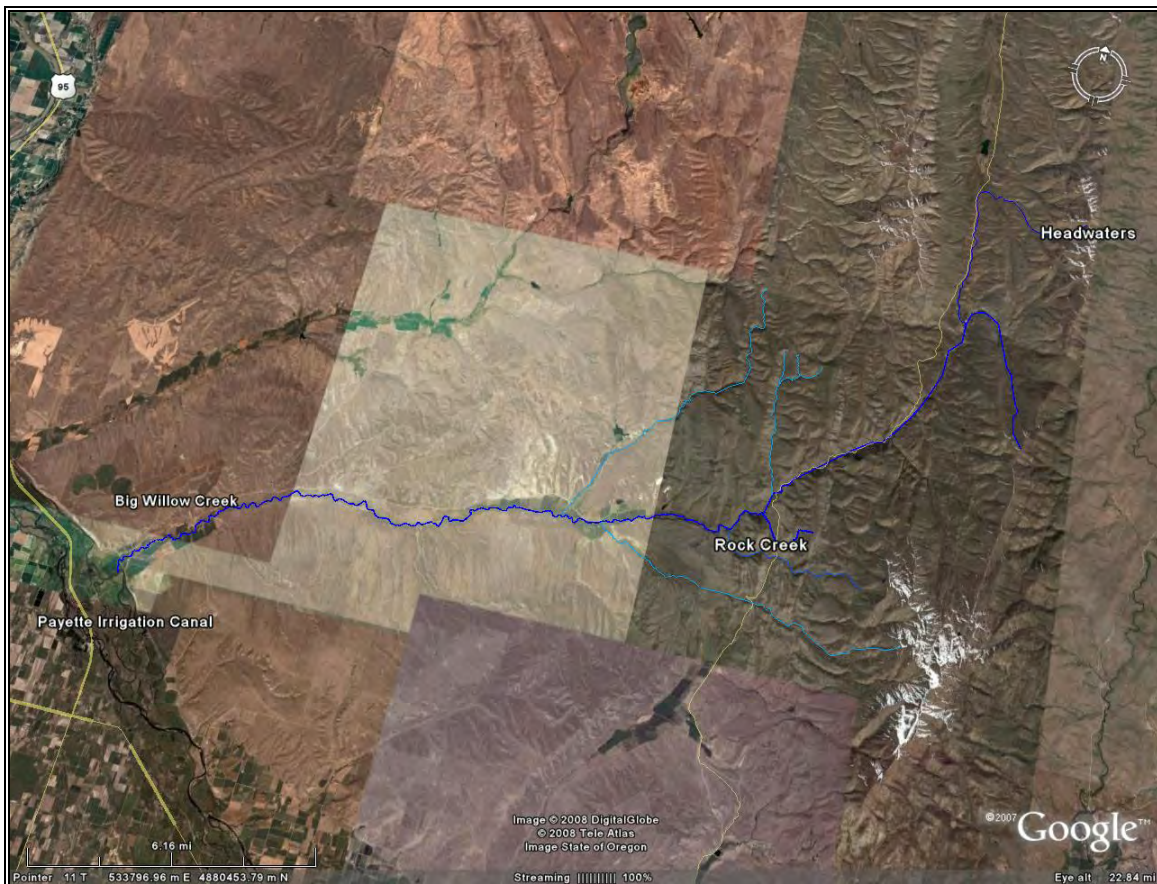
Figure 11. Main Channel of Big Willow Creek. Modified from GoogleEarth on February 15, 2008.

The hydrographic apex occurs at the confluence of a south side unnamed tributary immediately downstream of Rock Creek (Figure 11). Above the apex, 30% of the slopes have a slope angle greater than 30%; and below the apex, approximately 11% of the slopes have an angle greater than 30%.

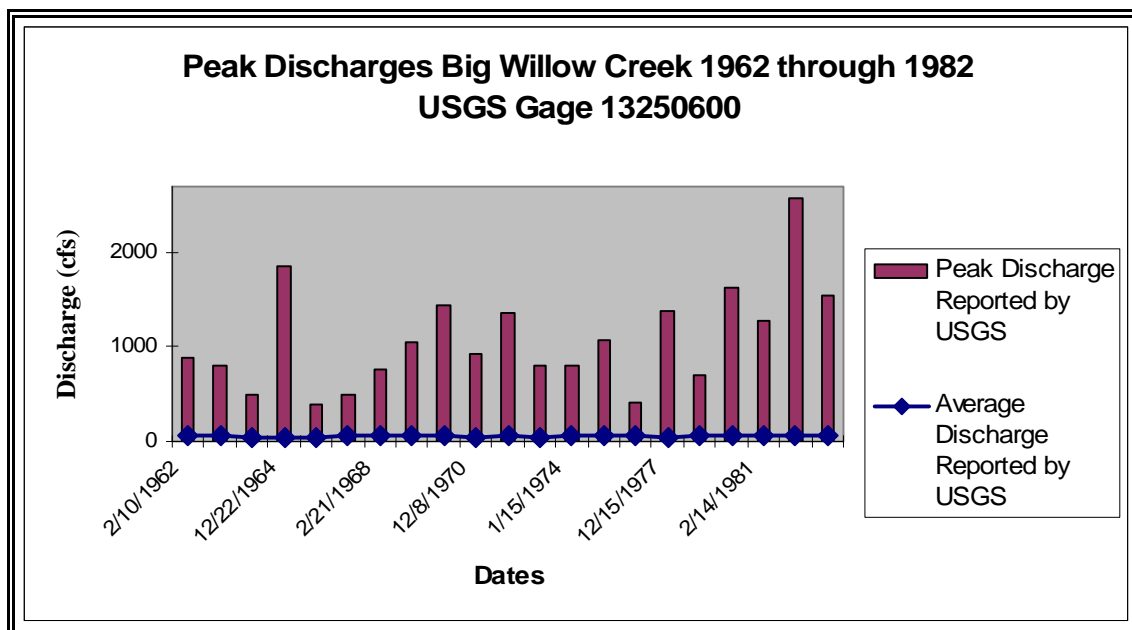
Figure 19. Average Daily and Peak Discharge Data from USGS Gauge 13250600, Big Willow Creek, October 1962 to October 1982.

The USGS operated one discharge monitoring site on Big Willow Creek (USGS 13250600). Figure 19 shows the data described by the USGS as “Period of Approved Daily-Mean Data” from 1962 through 1982. The data presented in Figure 19 and Figure 20 show the “flashy” nature of Big Willow Creek’s hydrology.

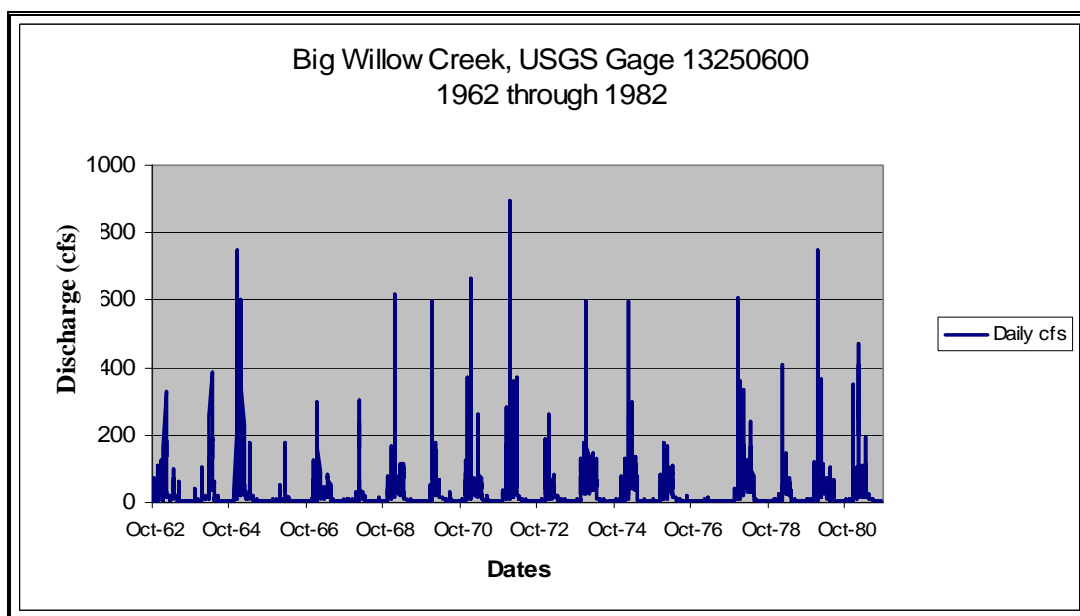
Figure 20. Daily mean Discharge, 1962 to 1982, USGS Gauge 13250600, Big Willow Creek.

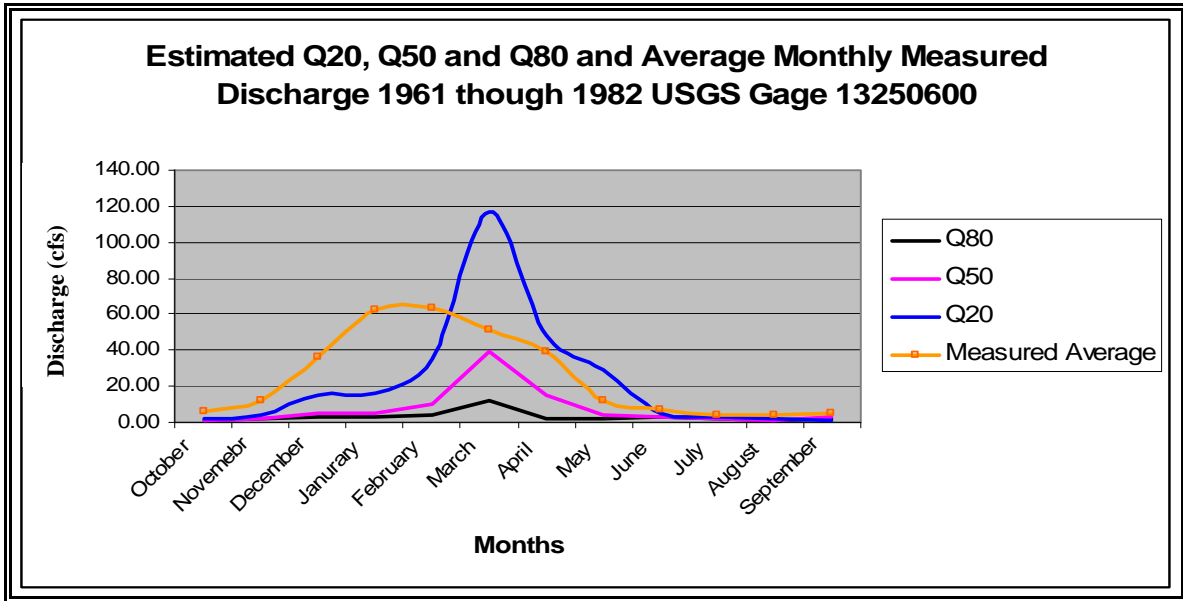
Figure 21. Estimated Q20, Q50, Q80 and Measured Average Monthly Discharge, USGS Gauge 13250600. Big Willow Creek.

Results from the estimated flow model compiled by Hortness and Berenbrock (2001) and the average monthly discharge were compared and are presented in Figure 21. Data is represented as an average of monthly measurements, and the estimated occurrence of monthly average peak flows at frequencies of 20 (Q20), 50 (Q50), or 80 (Q80) years over the period of record. It should be noted the data represent discharge associated with a little over

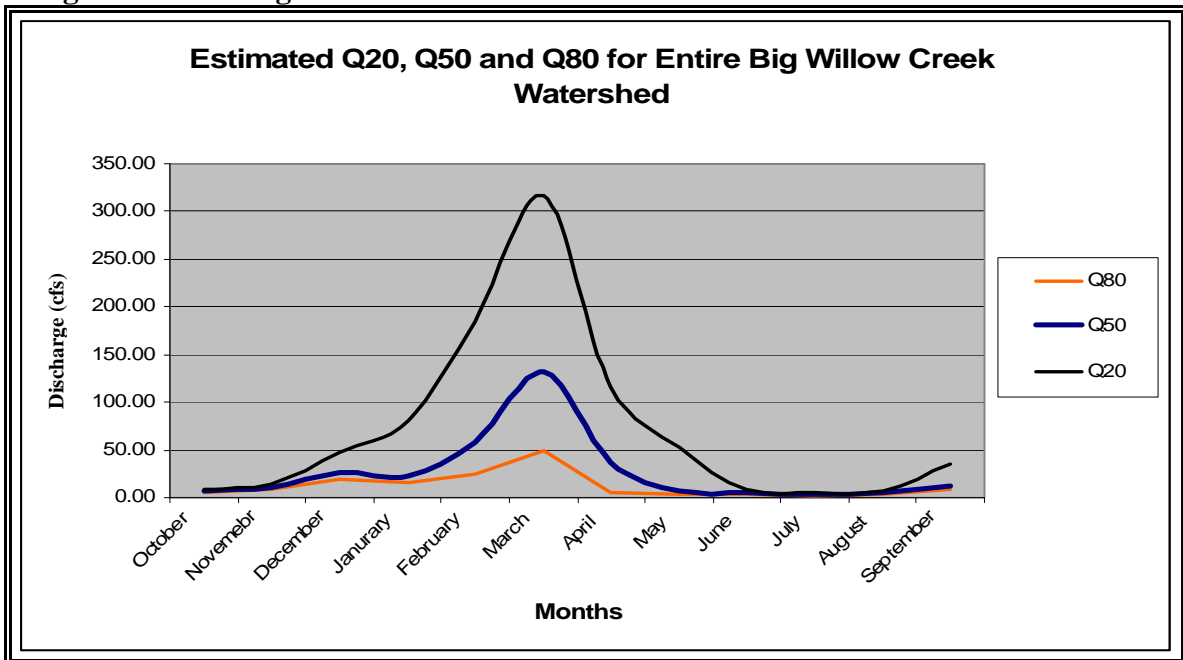
Figure 22. Estimated Q20, Q50, Q80 for Entire Big Willow Creek Watershed.

25% of the total drainage area of the watershed, or approximately 27,000 acres. Using the same model, the discharge for the entire watershed was estimated and is presented in Figure 22.

As expected, the model does not capture the extreme peak (Q100) discharges that occur in the watershed because continuous flow data must be collected for at least 25 years in order to estimate 100-year flood frequency statistics.

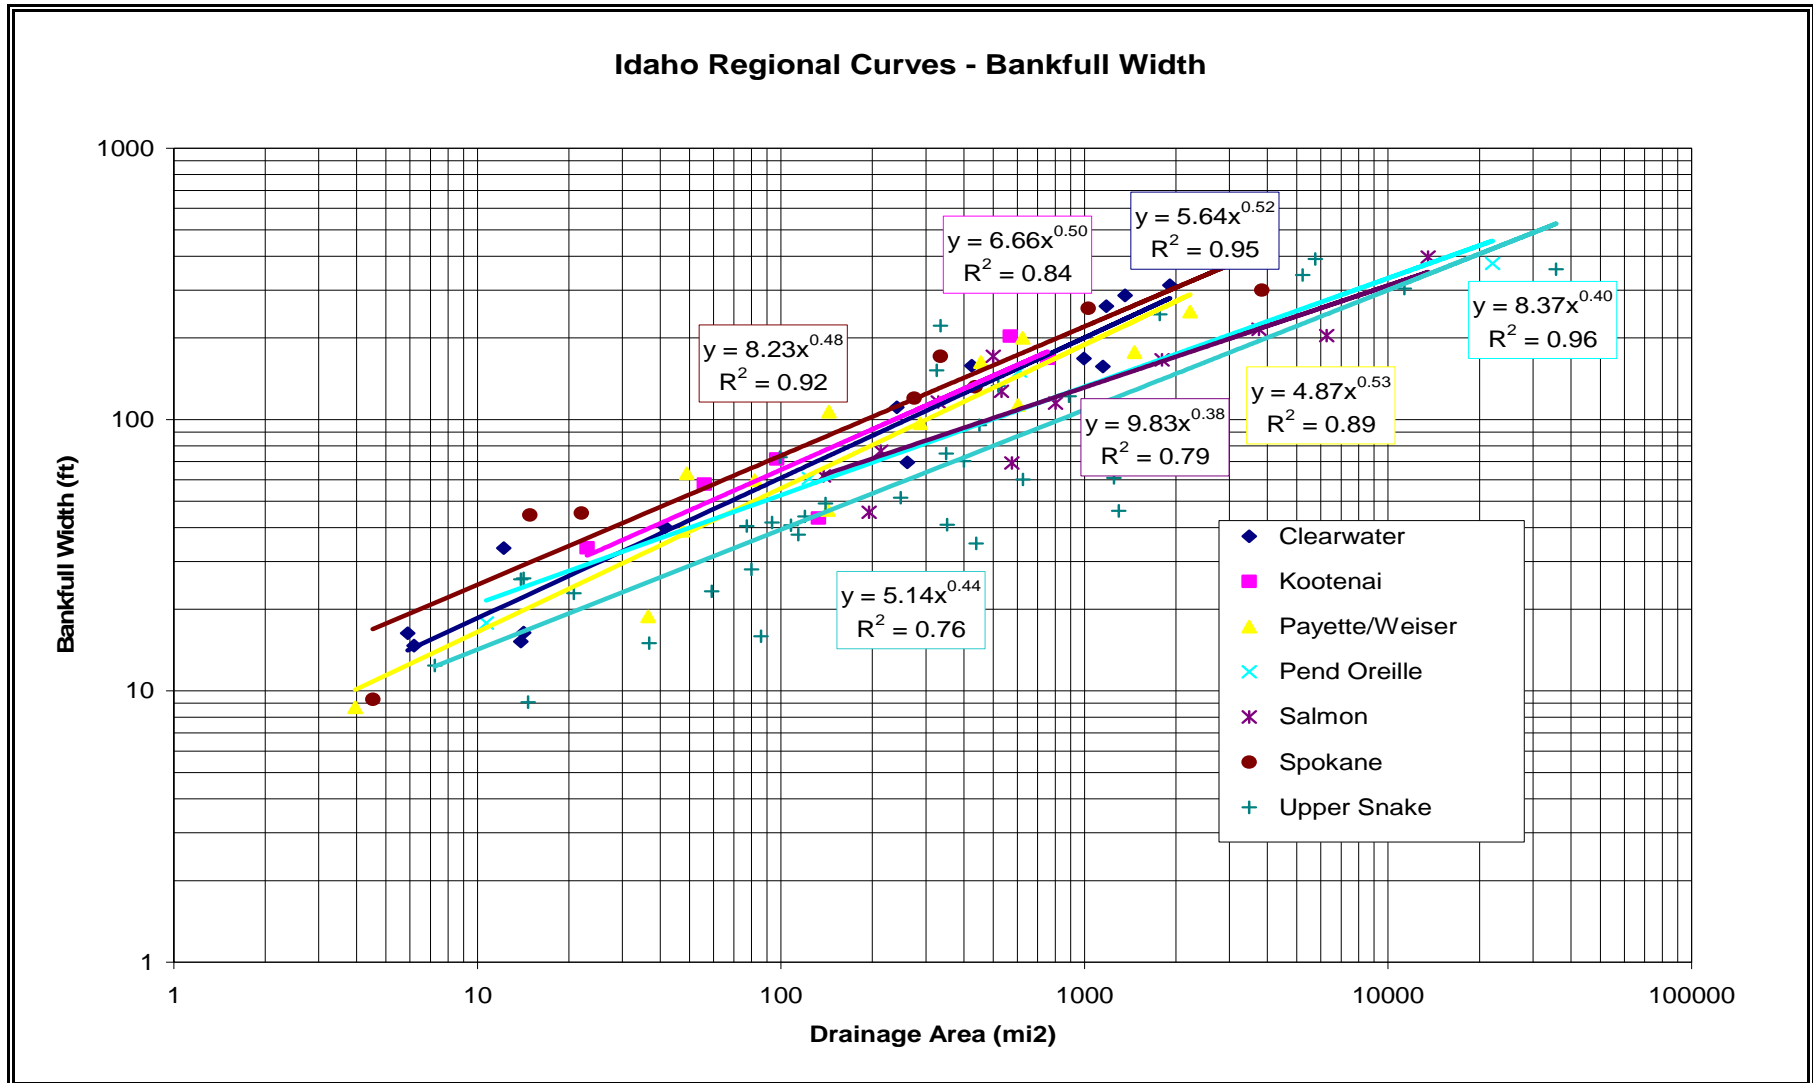
Figure 24. Bankfull width as a function of drainage area, as taken from IDL (2000).Monitoring Points
