# **Abbreviated Preliminary Assessment for Bennett Lumber Company**

**State of Idaho  
Department of Environmental Quality**

**February 2014**

Subject: Abbreviated Preliminary Assessment Report for the Bennett Lumber Site,  
Idaho County, Idaho

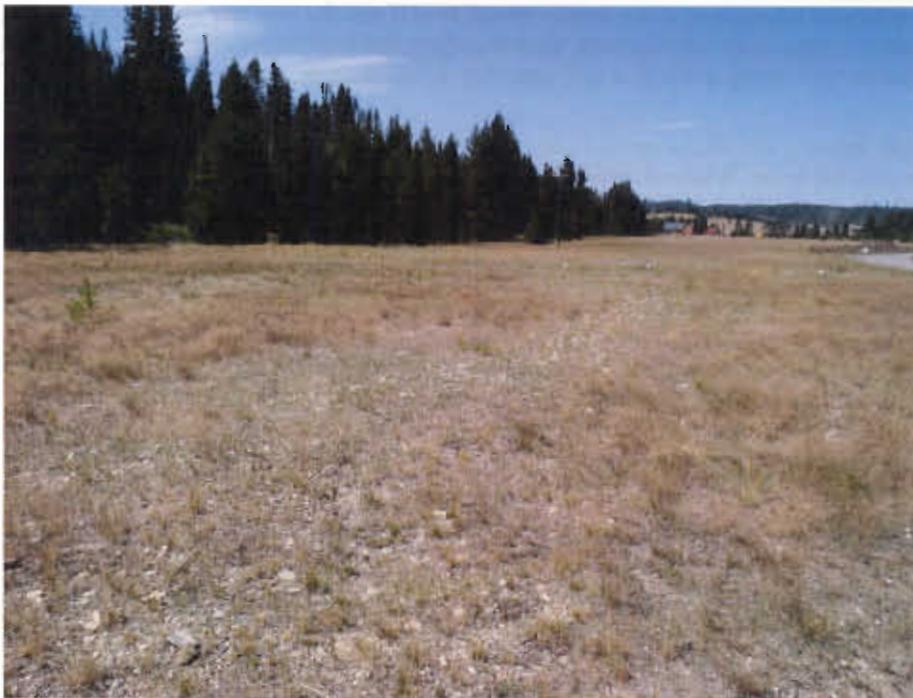
Bennett Lumber site observations and photographs were collected during the DEQ site inspection on July 25, 2013. The site was found to be well vegetated with small lodge pole pine trees and an unoccupied residence (Photos 1 and 2). All former evidence of the lumber company operations has been removed.

**Photo 1. Location of the former Bennett Lumber operations.**

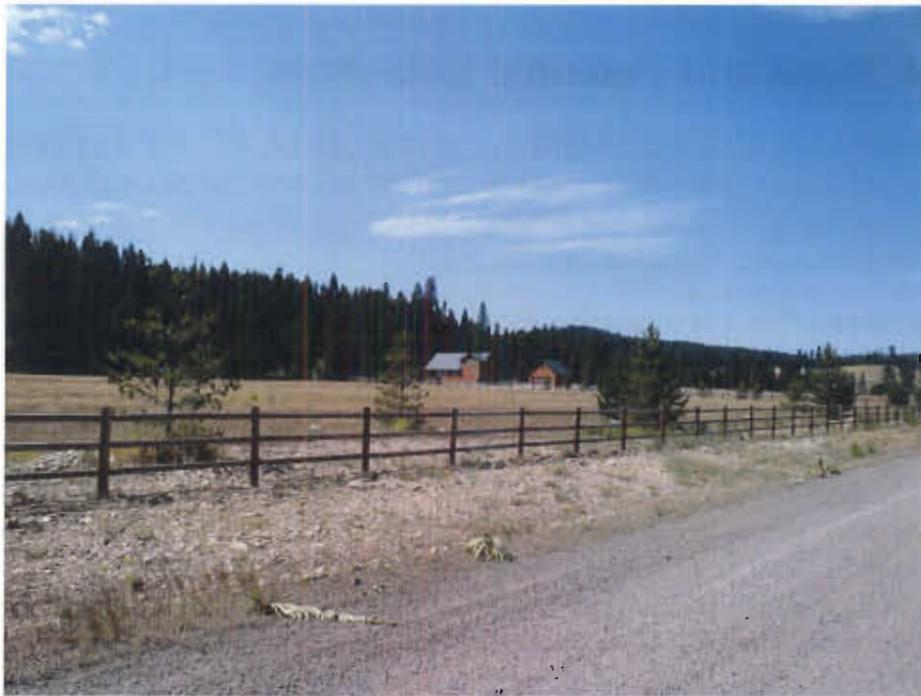
**Photo 2. Unoccupied residence on the site of the former Bennett Lumber operations.**

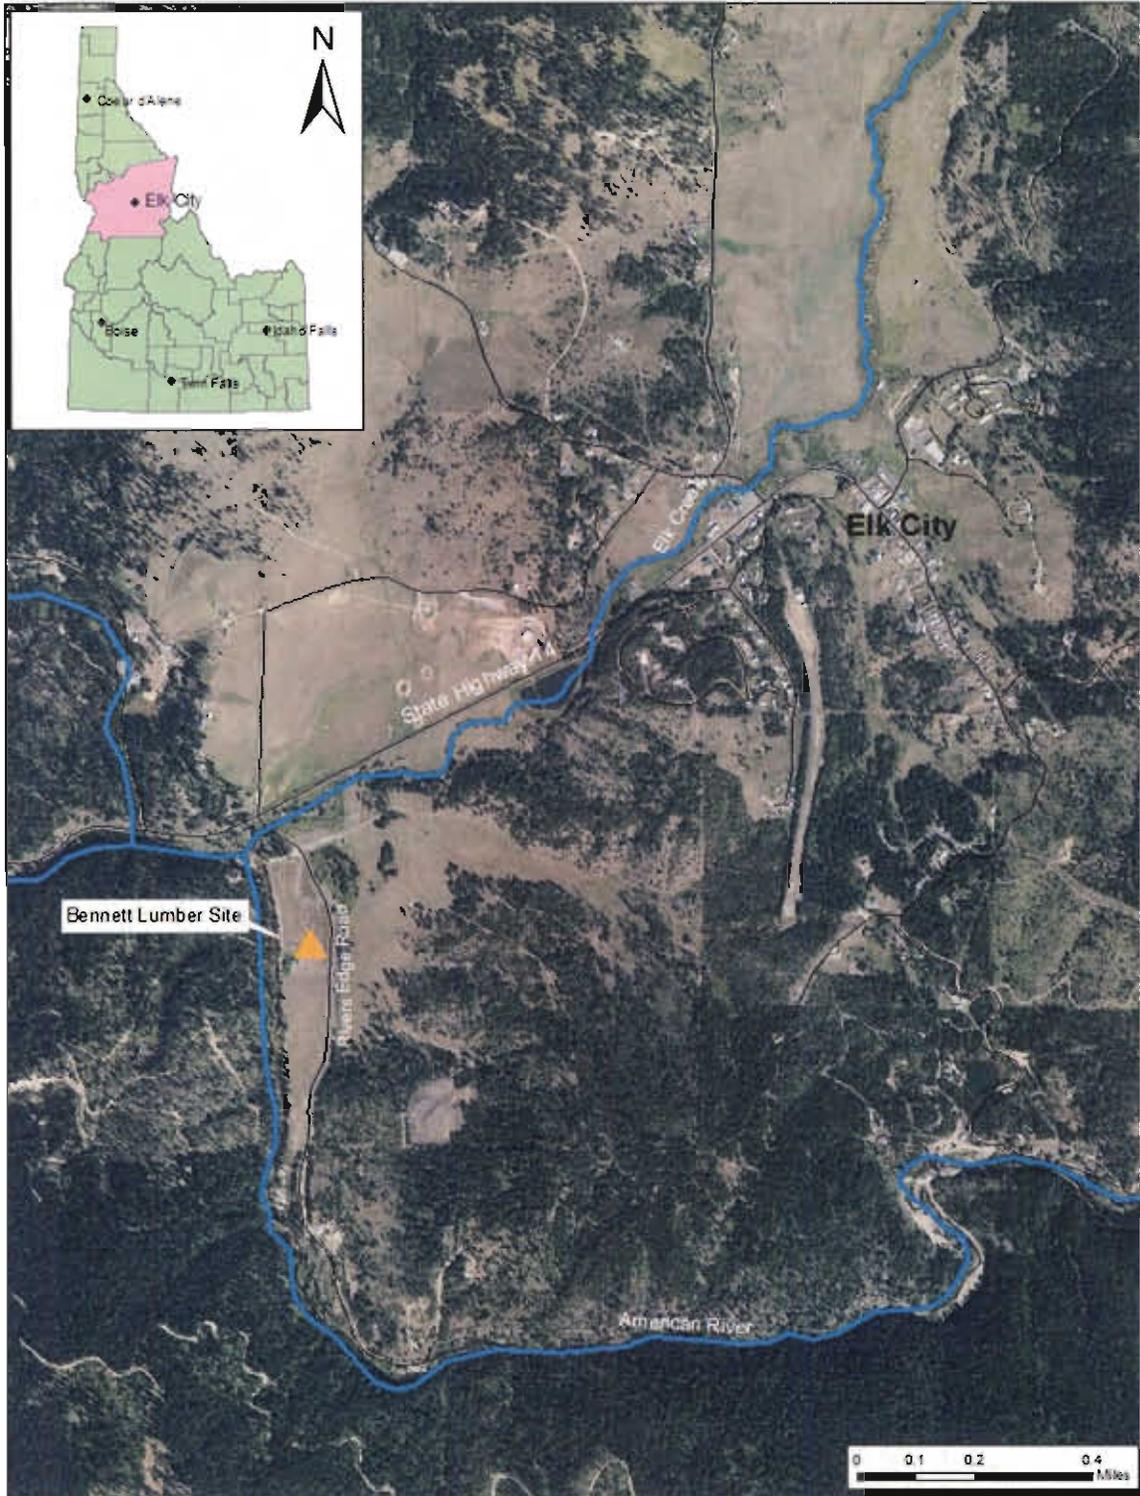
The Bennett Lumber site is located southwest of Elk City, Idaho. Figure 1 is a topographic map of the location and Figure 2 shows the aerial view of the location. Specific site location details are included in the above checklist. The generalized geology of this area is shown in Figure 3 with a description included in Section 2 of this report.

Figure 2. Aerial view of the Bennett Lumber site in Idaho County, Idaho.

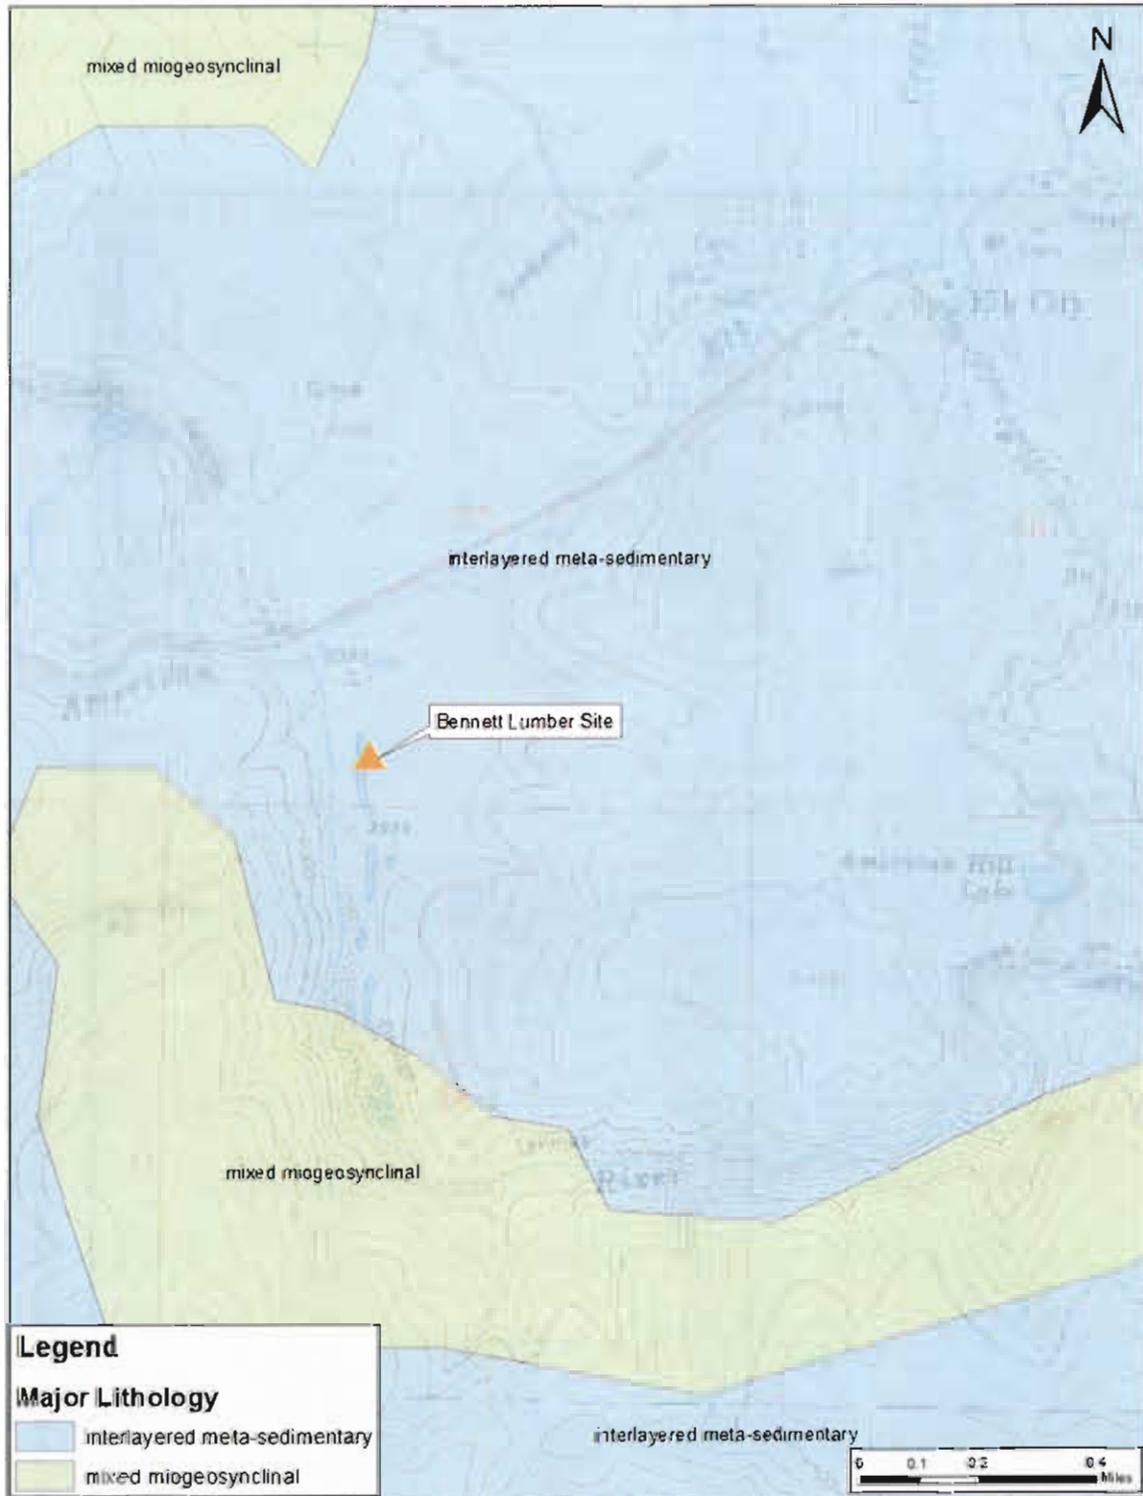
Figure 3. Map of major lithology in the vicinity of the Bennett Lumber site in Idaho County, Idaho.

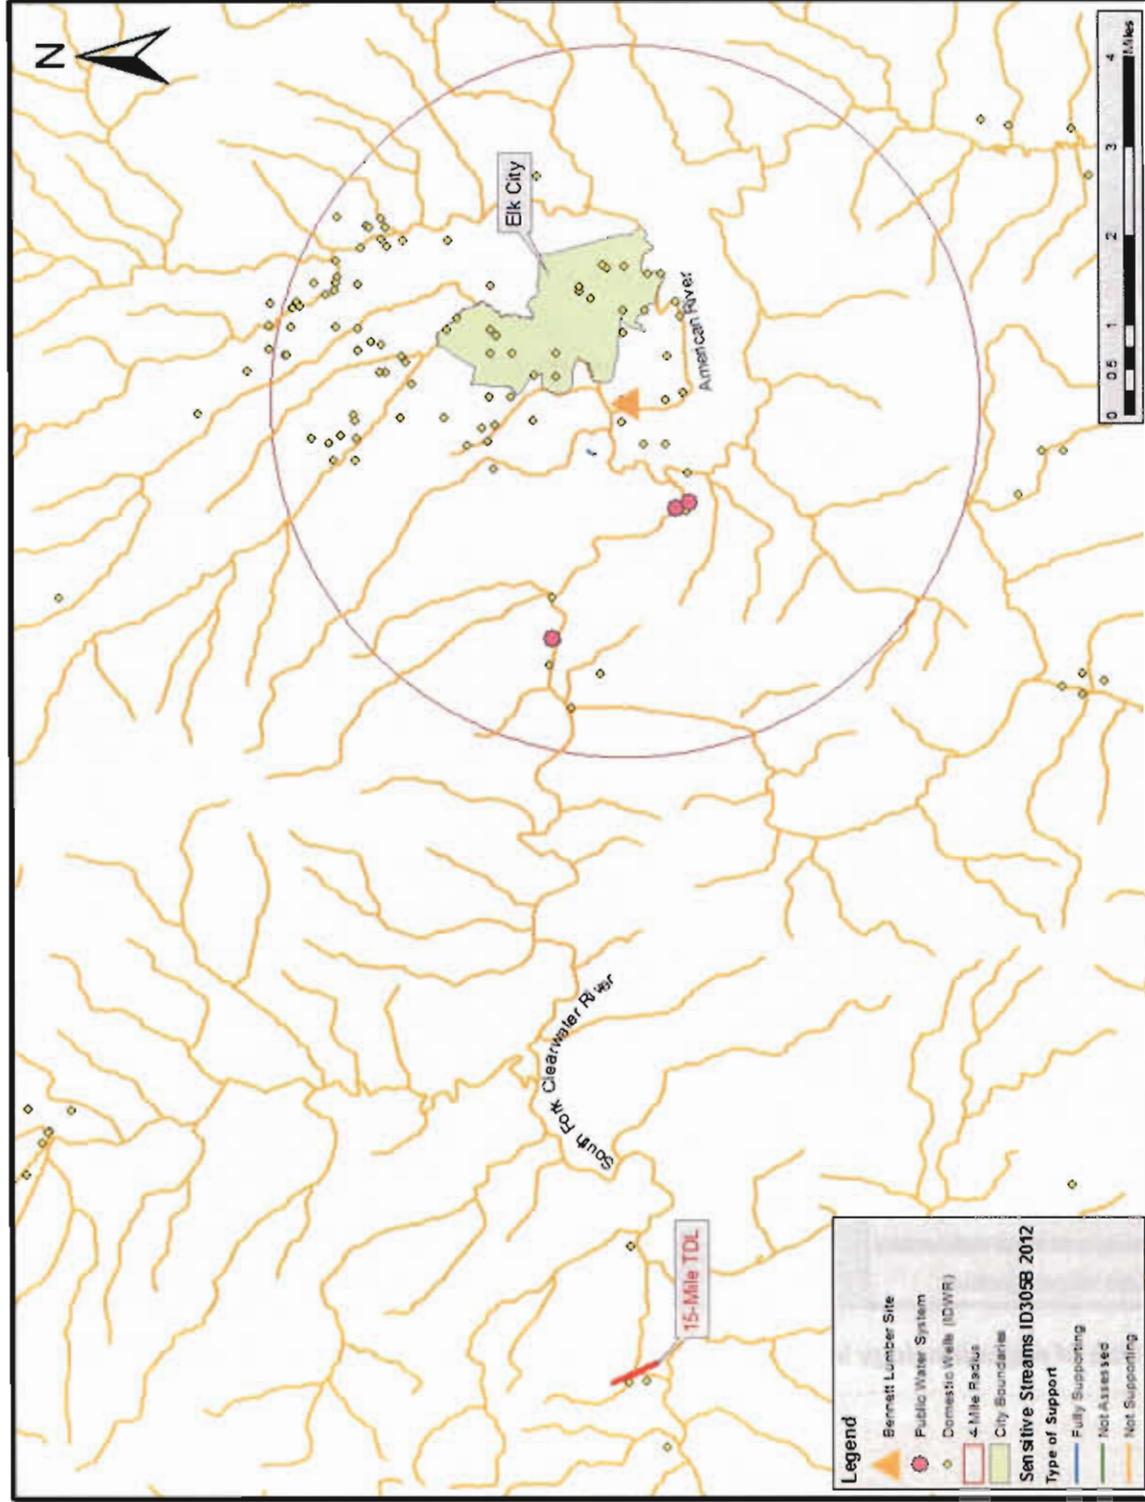
The Bennett Lumber site is located on the east bank of the American River within the South Fork Clearwater subbasin. The 15-mile target distance limit (TDL) follows the American River and ends on the South Fork of the Clearwater River (Figure 4). Potential ground water pathways include four public drinking water systems and approximately 110 domestic wells located within the 4-mile radius of the site (Figure 4). There are numerous wetlands within the 2-mile radius of the site (Figure 5).

Figure 4. Domestic well and public water system locations.

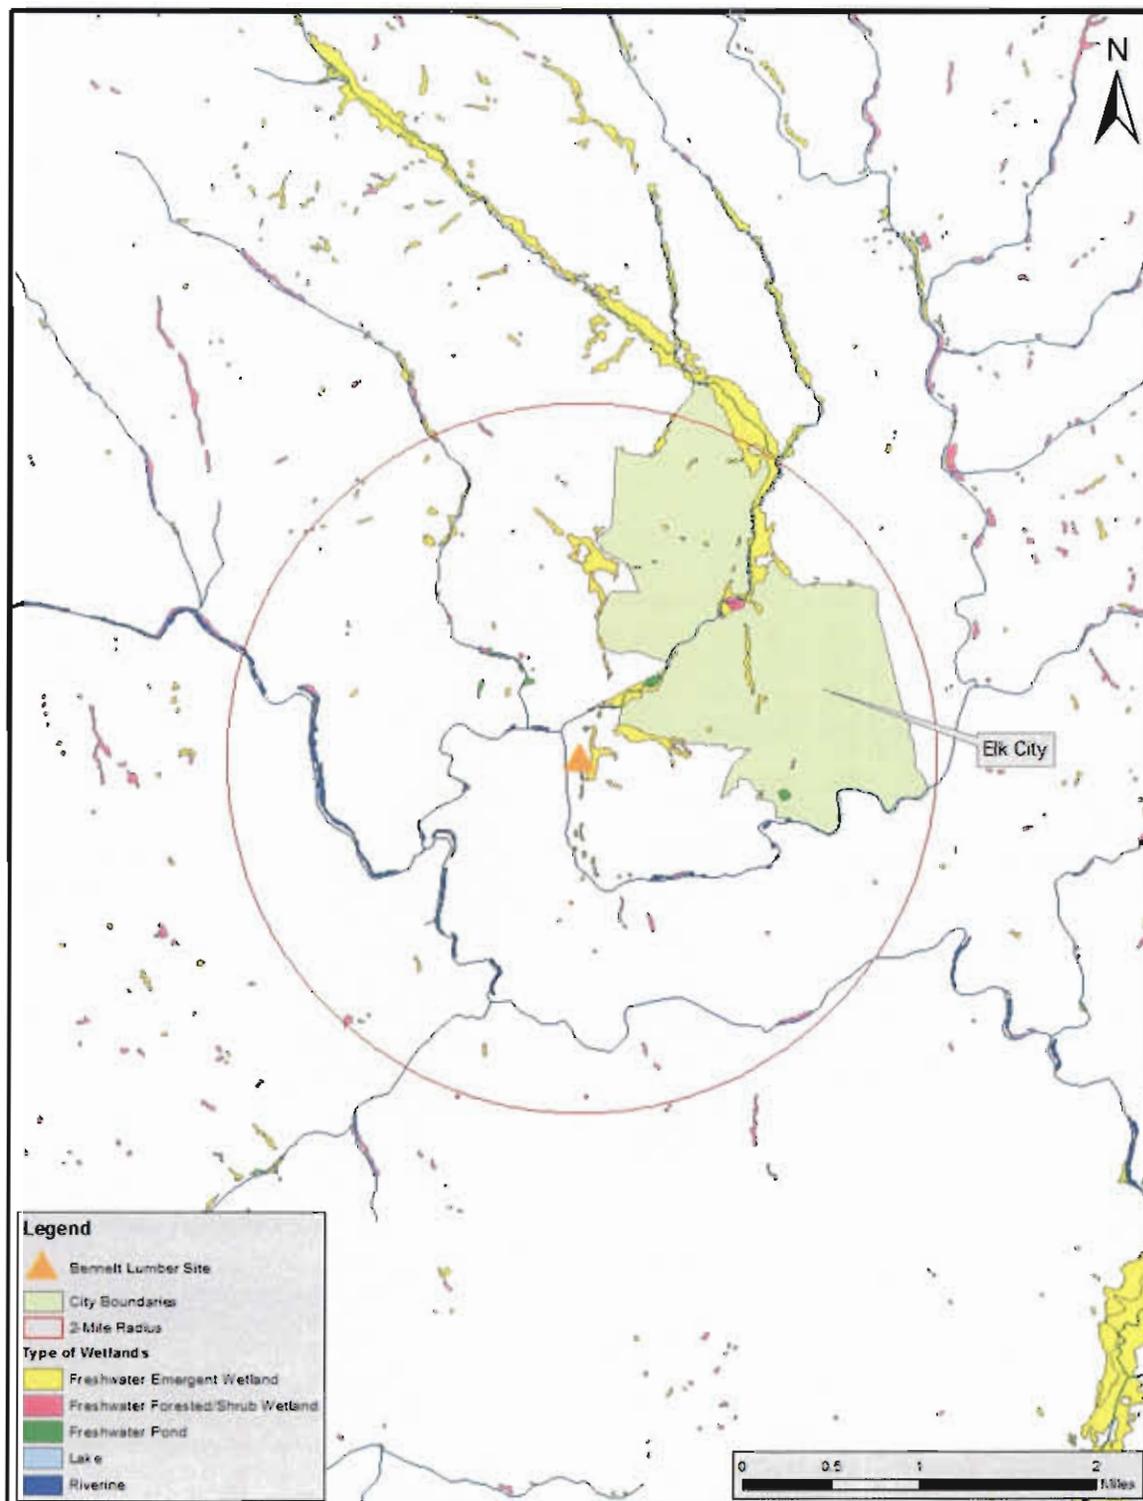
Figure 5. Wetland locations.
