LINCOLN MINE
PRELIMINARY ASSESSMENT REPORT
GEM COUNTY, IDAHO

STATE OF IDAHO
DEPARTMENT OF ENVIRONMENTAL QUALITY

October 2003

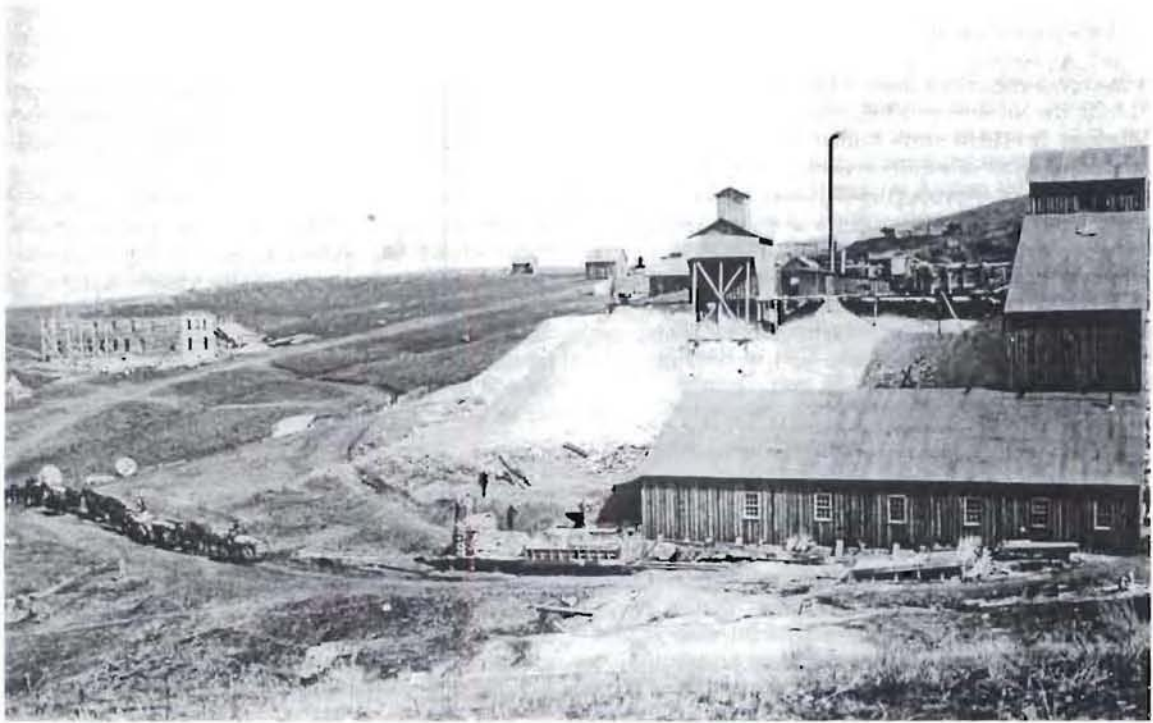
Lincoln Mine, circa 1900 (Reprinted from Wells, 1983)

A picture of the Lincoln Mine, dated 1900 (Wells, 1983), illustrates the historic operations at the Lincoln Mine. In addition to the mine framework and mill site, a loading dock (for preparing loads of ore for smelting), access roads, and other smaller structures were present.

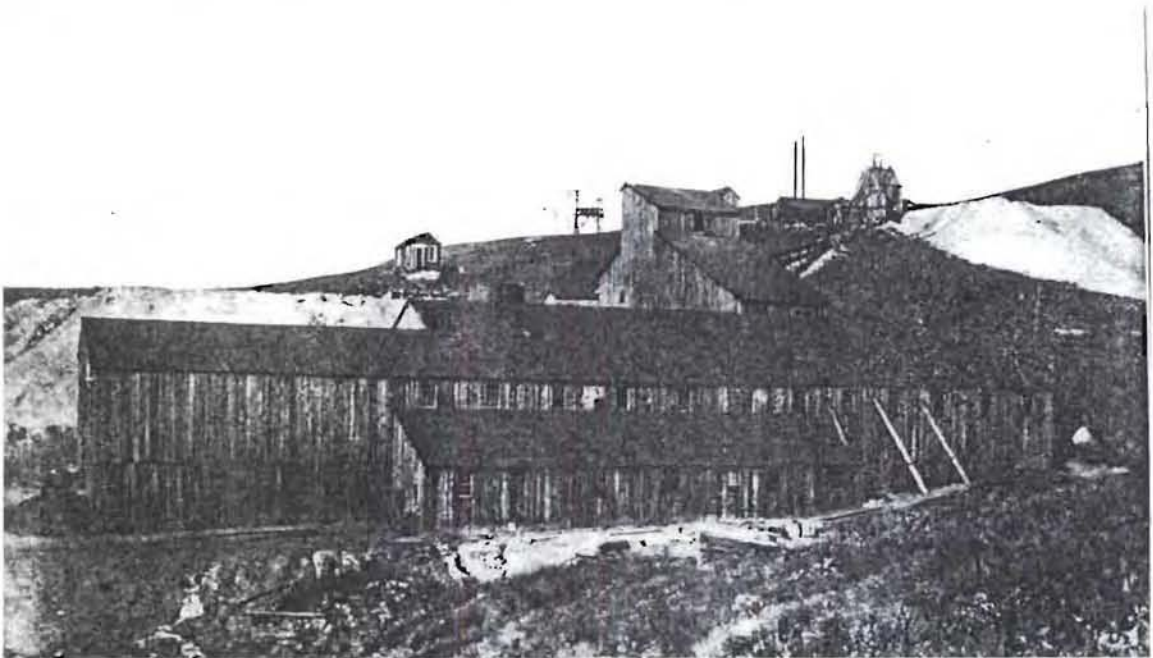
Lincoln Mine, circa 1907 (Reprinted from Bell, 1907)

Another historic photo (below) of the Lincoln Mine from 1907 (Bell, 1907) shows the expanded mill site and waste dumps.

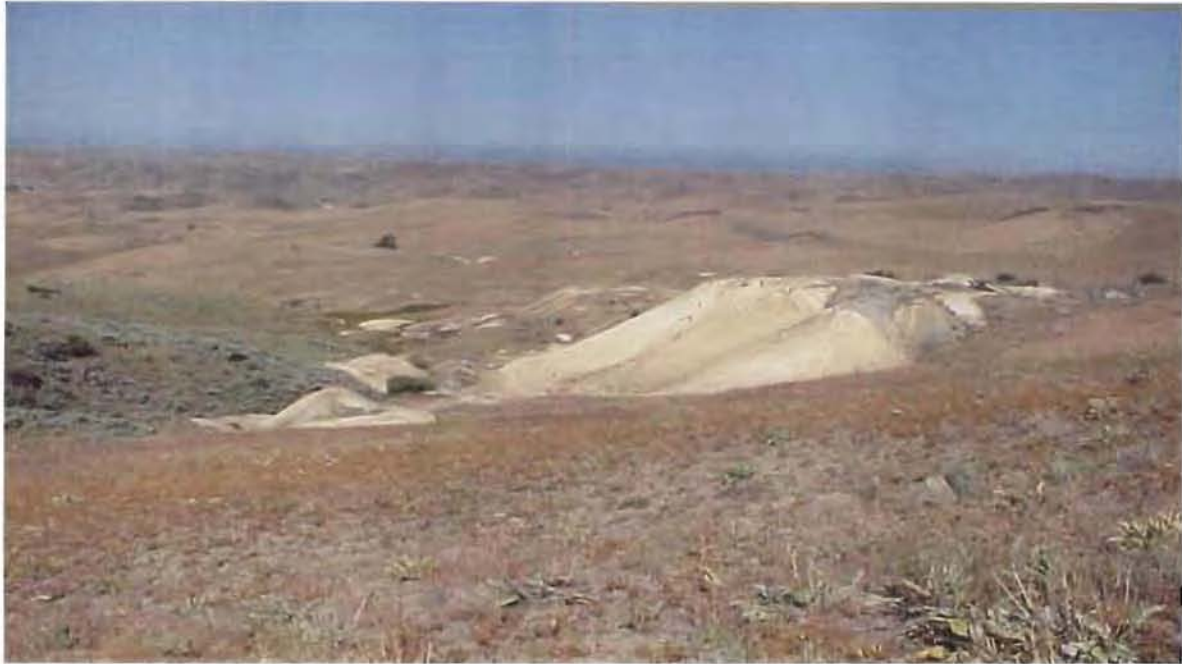
Photo No. 1. Looking downhill and west towards the Lincoln Mine. The small and large waste rock piles dominate the landscape.

Several large waste rock piles are currently present at the Lincoln Mine site. The large waste rock piles, near the former shaft, and the tailings piles, near the former mill, are shown in Photos Nos. 1, 3, 7, 8, and 9. The mill site and foundations of smaller associated structures flank the large waste rock pile. A smaller waste rock pile exists up the draw approximately 200 feet to the east, where more mining activity occurred. The waste rock piles appear stable, and plants have begun growing at their bases and tops. Some mass wasting has occurred, and runoff from the large waste rock pile appears to have collected in a shallow depression. No runoff water was observed during the site visit. Soil Sample No. 1 was collected at the base of the large waste rock pile (refer to Figure 2-2, Site Map and Sampling Locations).

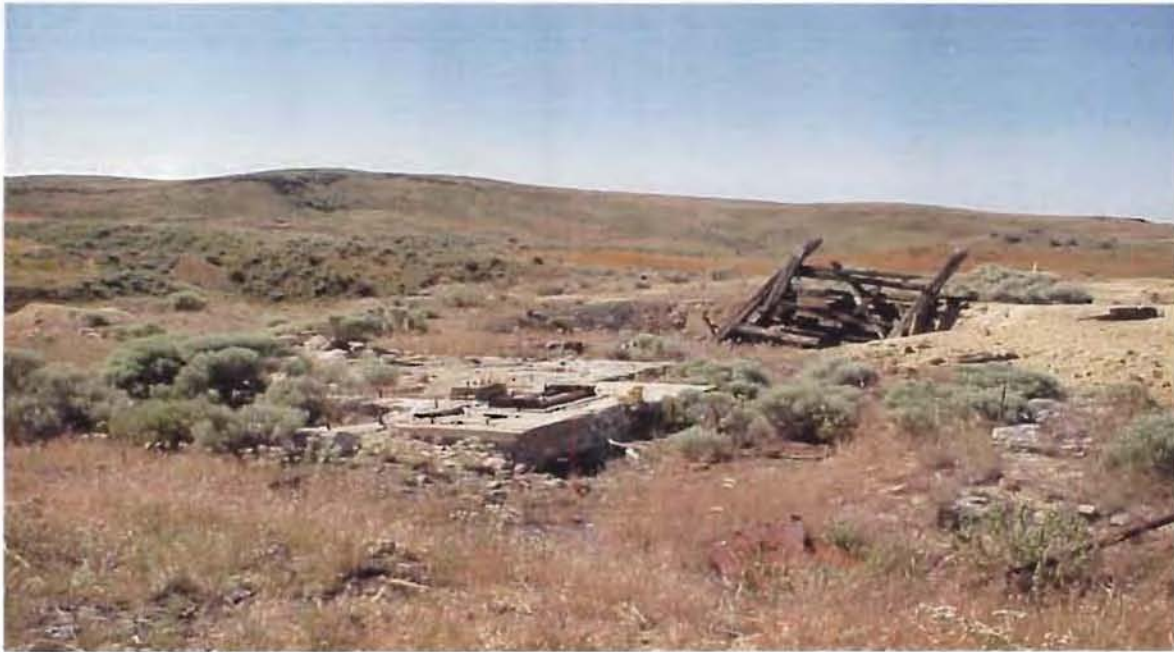
Photo No. 2. Looking south across the top of the large waste rock pile. All buildings and structures were either burned or toppled. The collapsed shaft is visible to the right of the middle of the picture.

All of the adits appear to be caved in and abandoned, and only the burned remnants of the former buildings are visible (refer to site photographs in Appendix A). The unburned frameworks have toppled. Scrap metal and other inflammable materials (most likely associated with ore flotation processes) are strewn about. Three small buckets containing a hard, chalky white substance were observed near the concrete foundation next to the mine shaft. Concrete foundations of the mill remain (refer to Photo Nos. 2, 6, 7, 8, and 9). Segments of a water pipe network (for steam-driven power tools) protrude from the ground near some of the foundations. An empty, rusted 55-gallon metal drum was observed near the former mill foundation (see Photo No. 7).

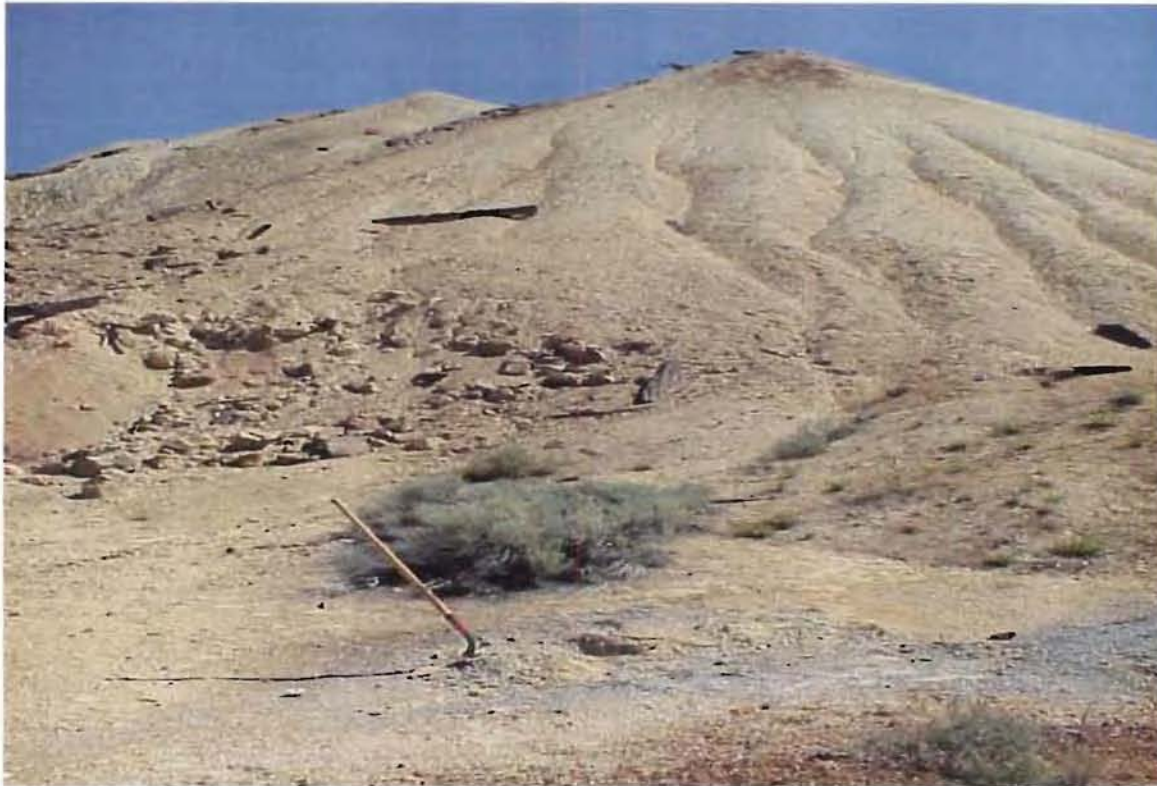
Photo No. 3. View looking north from base of largest waste rock pile. Note shovel in foreground marking the location of Soil Sample No. 1.

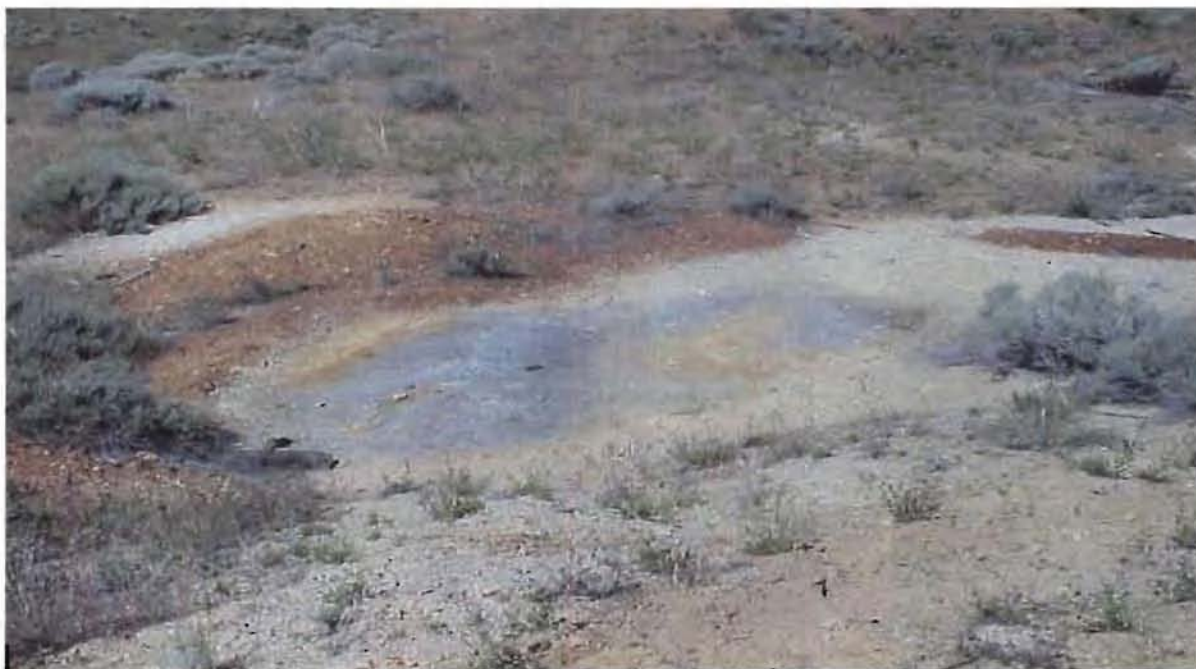
Photo No. 4. Location of Soil Sample No. 1. View looking south from base of waste rock pile. A shed mule deer antler was found 20 feet to the left.

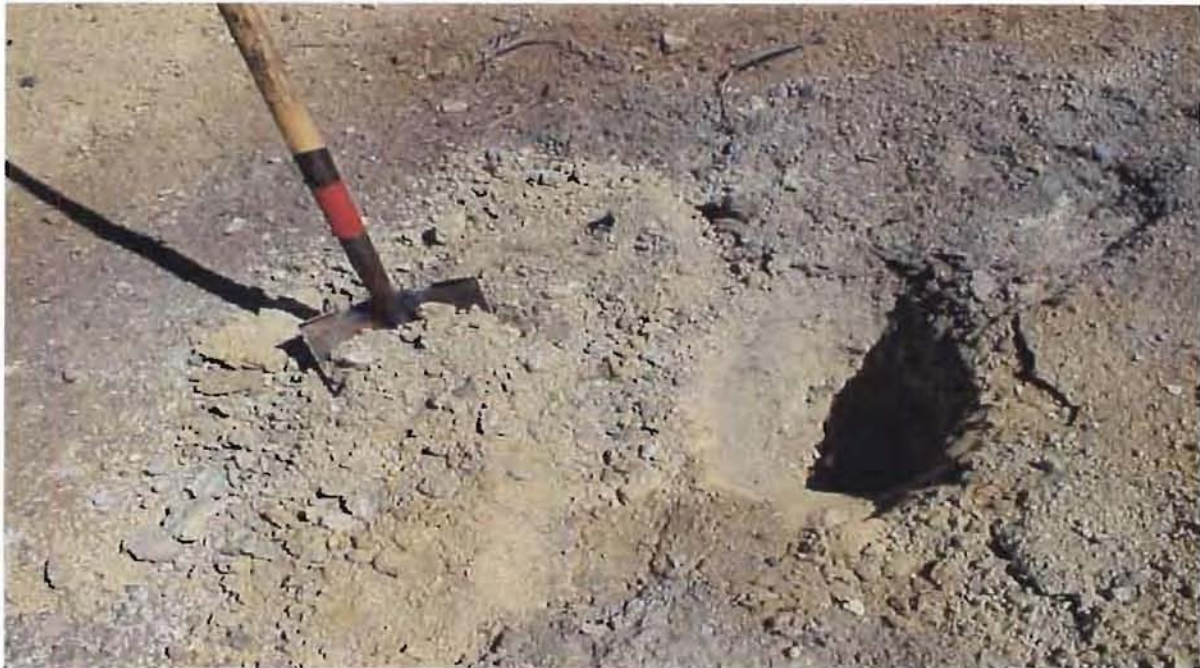
Photo No. 5. Close up of Soil Sample No. 1 location. Note discoloration of soil.

DEQ collected two soil samples from the tailings pile areas of the mine. Sample analysis of the stained soil indicated elevated levels of arsenic and lead (Appendix B).

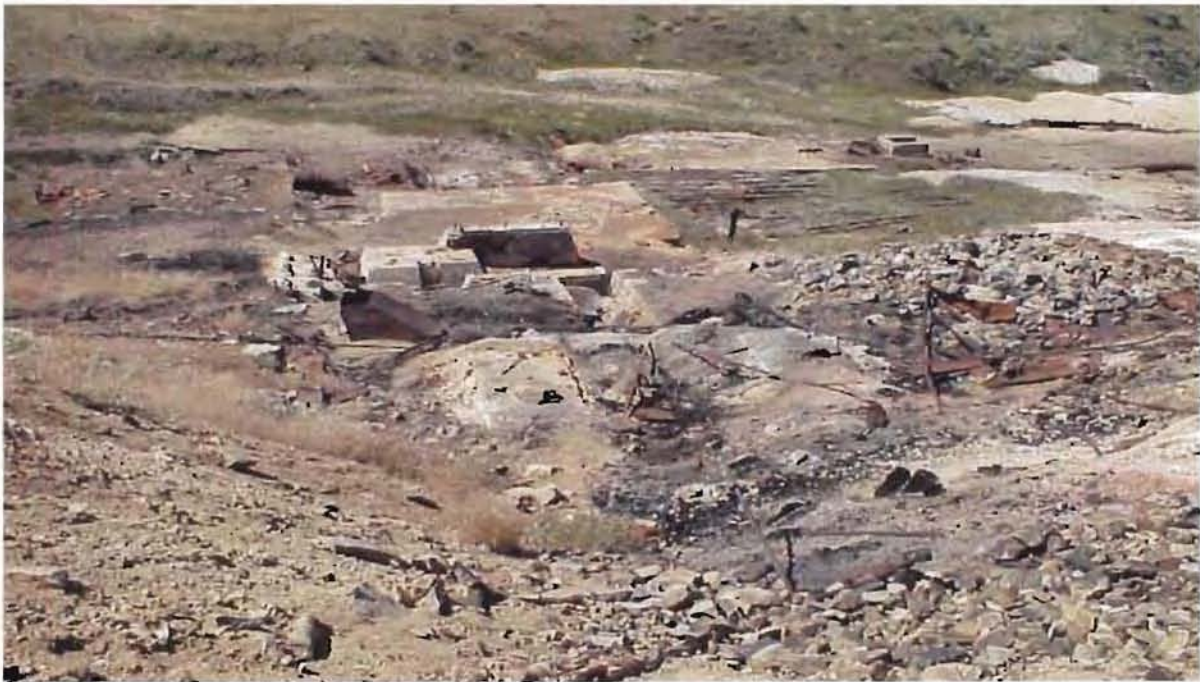
Photo No. 6. Looking south and down on the foundation of the former mill. Soil Sample No. 2 taken just downhill of mill foundation.

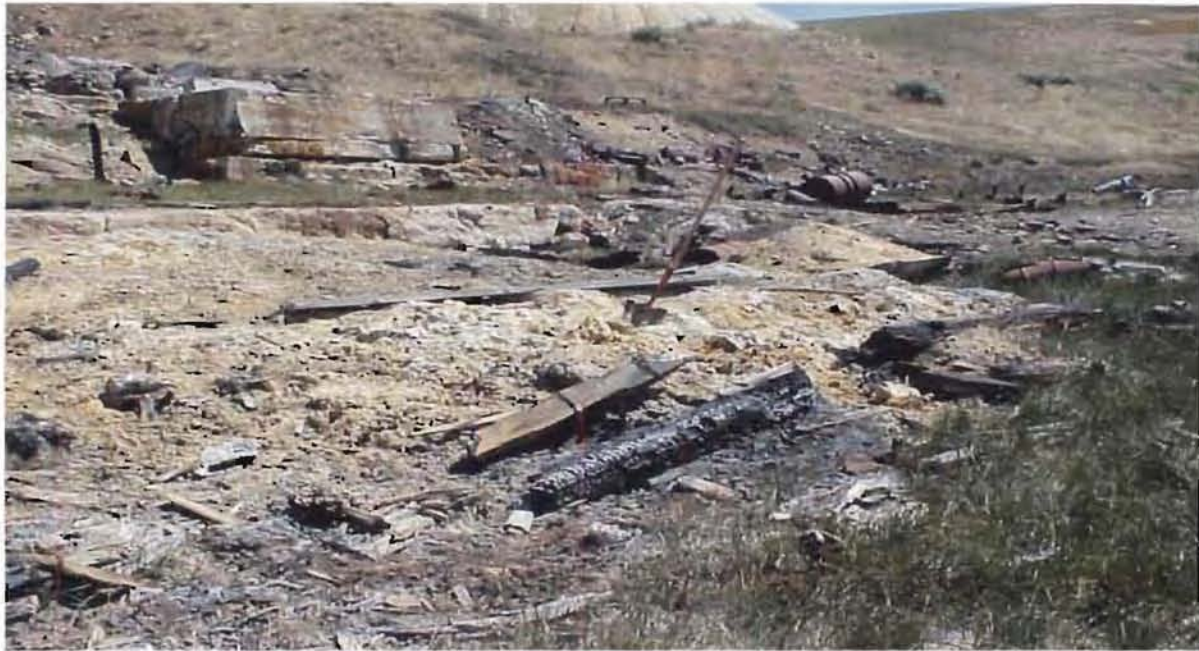
Photo No. 7. Close up of mill foundation and site of Soil Sample No. 2. Note shovel in the middle of the picture marking the location of Soil Sample No. 2.

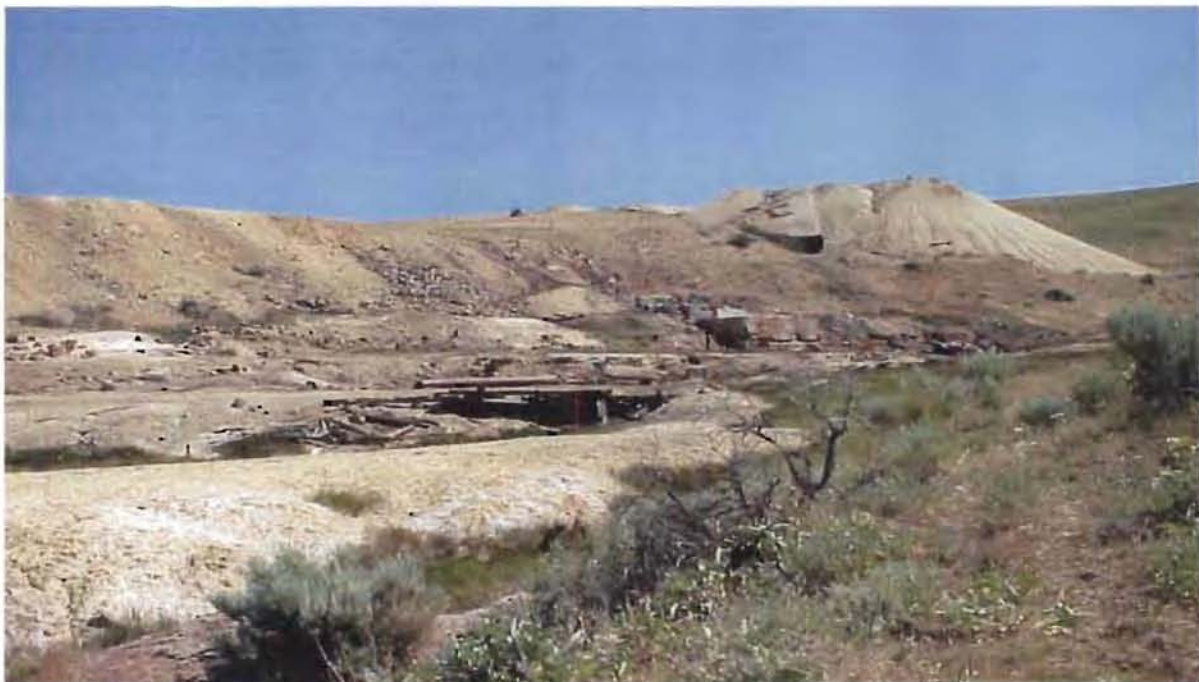
Photo No. 8. View looking northeast toward the former mill foundations and tailing piles.

Downslope of the former mill site is a fine-grained tailings pile that has been encrusted to a depth of approximately 0.5 inches (Photo Nos. 8 and 9). The whitish to yellowish clayey material had a strong sulfur-like odor. Soil Sample No. 2 was collected at this tailings pile.

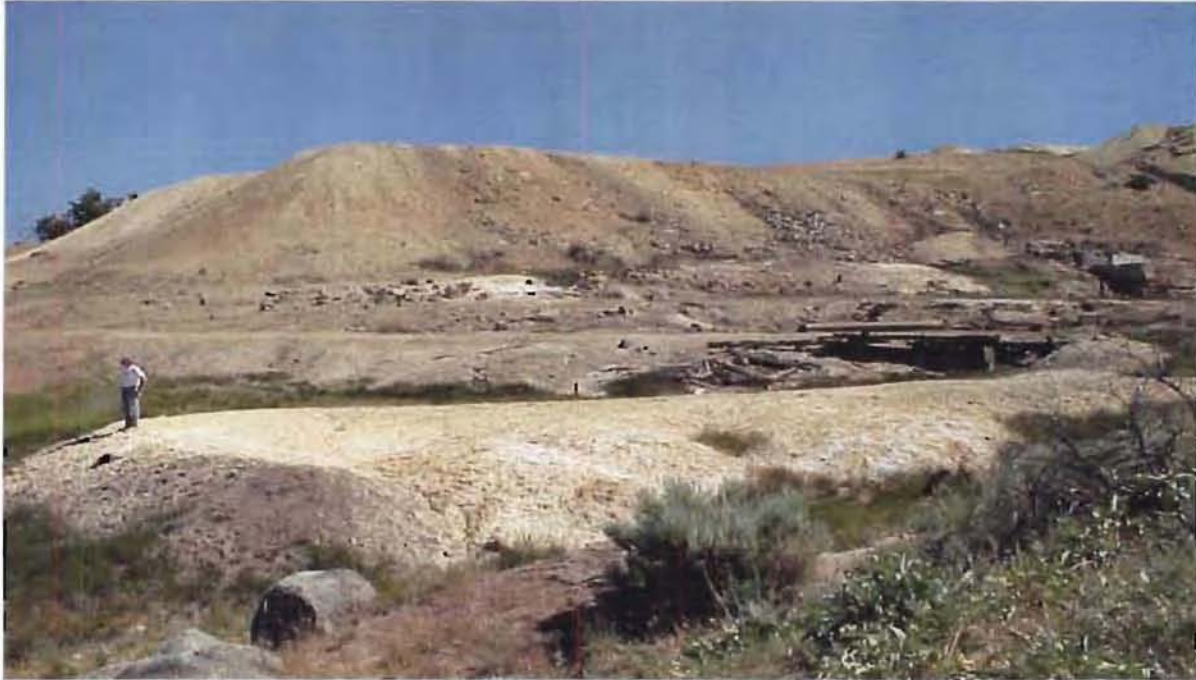
Photo No. 9. View looking north from draw of mill foundation and waste rock piles. A spring and wetland are present in front of the DEQ representative.

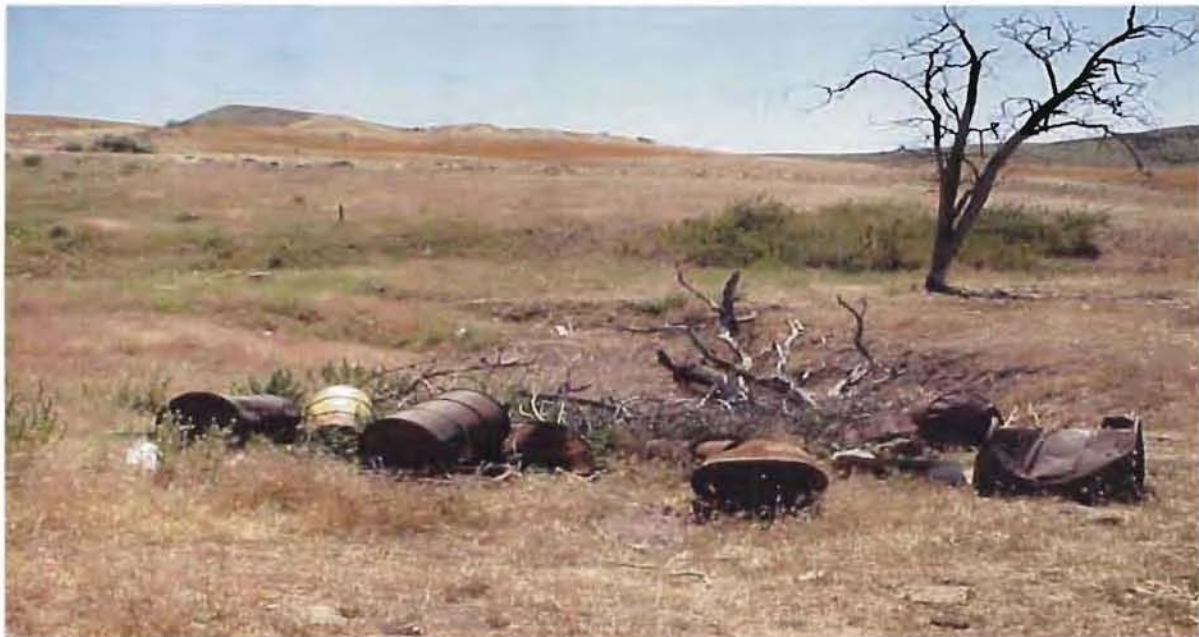
Photo No. 10. Old dump site containing miscellaneous debris, located approximately 200 yards north of (above) the Lincoln Mine. All of the 55-gallon drums were empty.

A small pile of waste debris is located approximately 200 yards north of the mill. Glass and metallic objects (typewriter, vacuum), as well as several empty 55-gallon drums were observed (refer to Photo Nos. 10 and 11). One of the 55-gallon drums had a wood preservative label indicating that it previously contained pentachlorophenol.

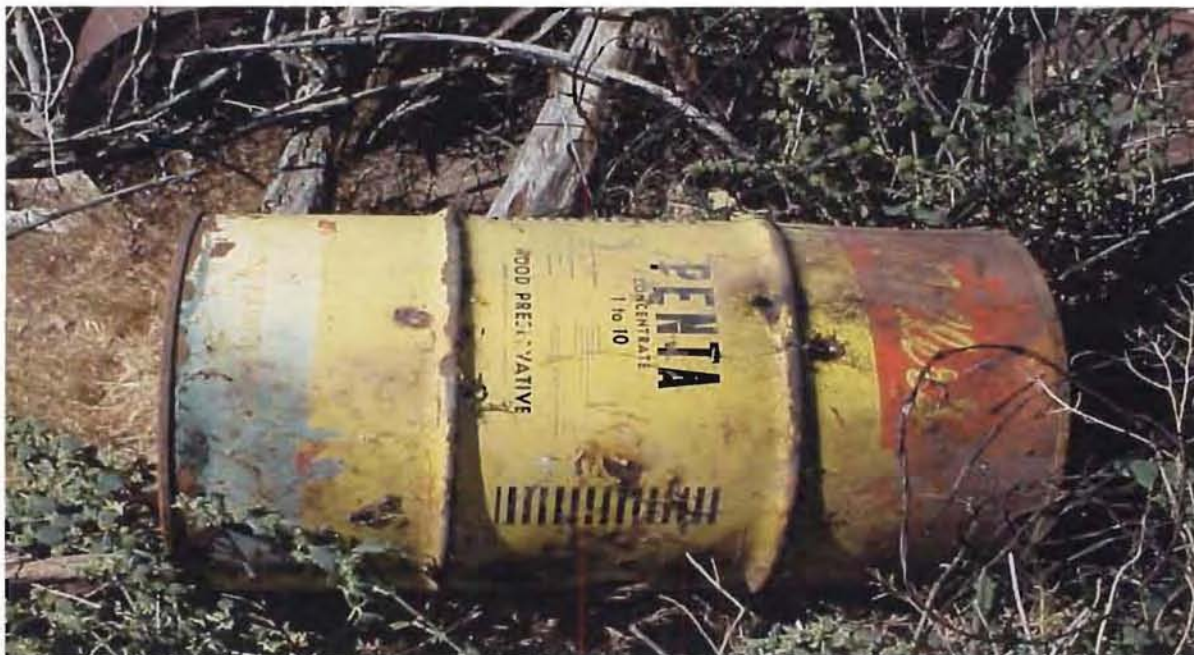
Photo No. 11. Close up of empty wood preservative (pentachlorophenol) barrel found in the dump site.

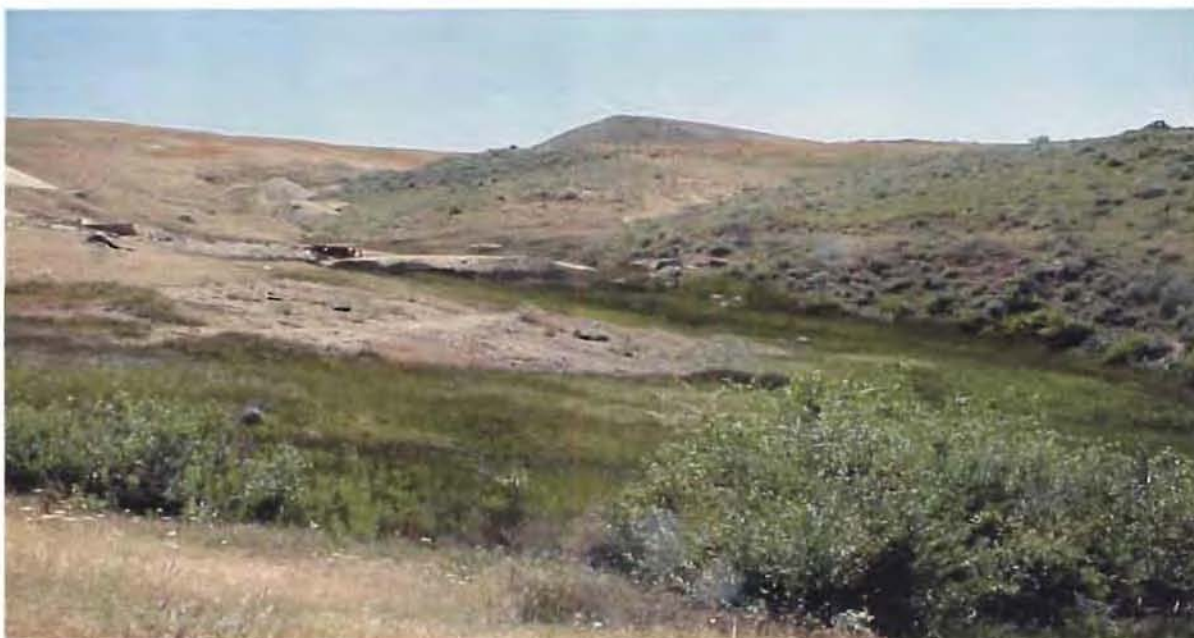
Photo No. 12. Spring and wetland that exist below (southwest) the Lincoln Mine (looking northeast).

Ground water flow in the country-rock is expected to be limited to the preferential pathways of faults and brecciated zones of the country rock. The overlying fractured basalt and sedimentary deposits are more than likely quite permeable. Some ground water becomes surface water through the spring located approximately 80 yards below the mine's most downstream structure (former loading dock). A granitic outcrop exists in the draw creating a spring and wetland area above it. (Photo Nos. 12 and 13).

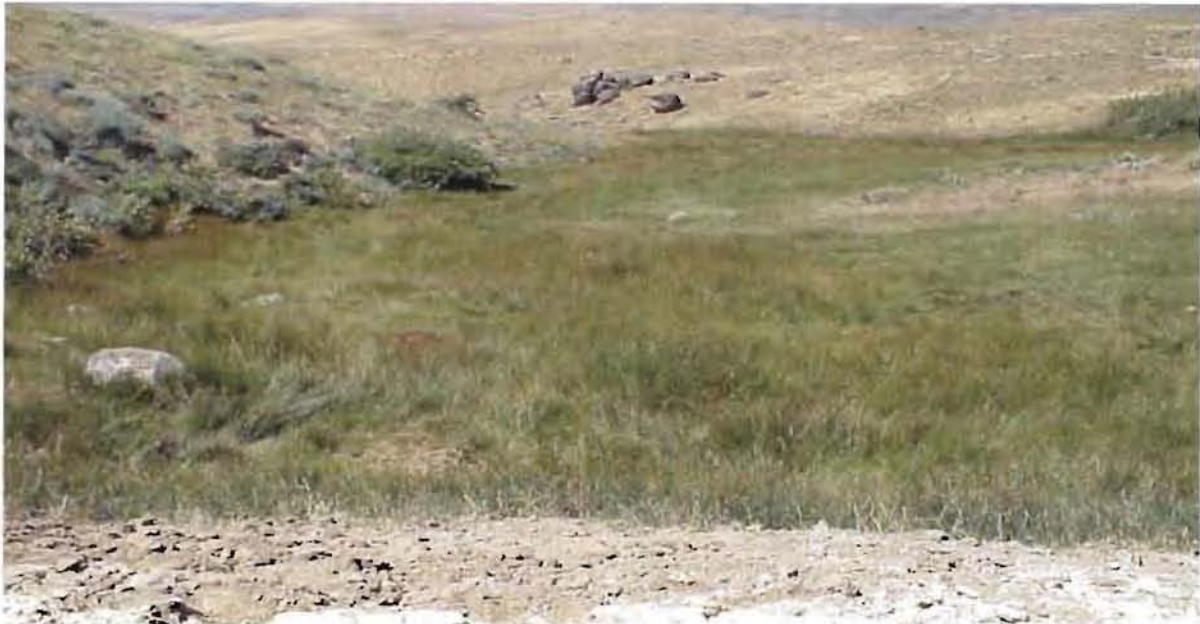
Photo No.13. Spring and wetland. Looking down the draw (towards the southwest).

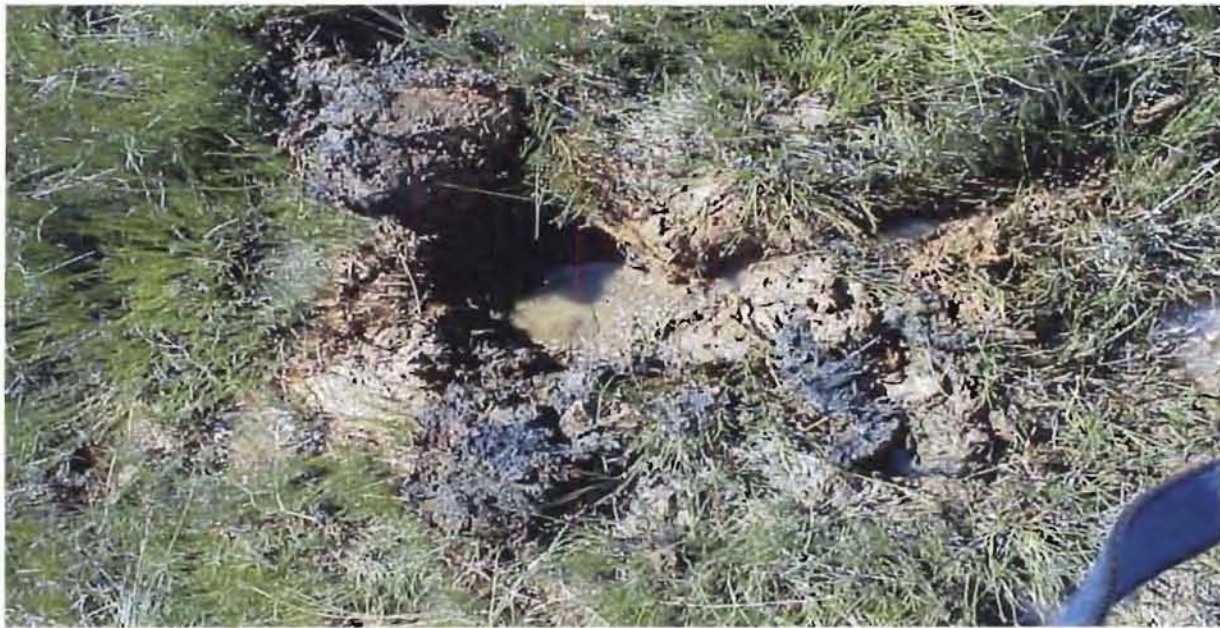
Photo No.14. Close up of wetland soils and vegetation at location of water sample (L3).

During DEQ's July 2003 visit, a small spring was observed downstream of the mine within the tributary drainage. The spring created a wetland area below it approximately 80 yards long and 0.5 acres in total size. Analytical results for the Surface Water Sample L3 collected in the wetland indicate elevated levels of arsenic, cadmium, lead, mercury, and zinc (Appendix B).
