LIVINGSTON MILL SITE INSPECTION REPORT

Sawtooth National Forest, Idaho

January 17, 2003

***MSE* Millennium Science & Engineering, Inc.**

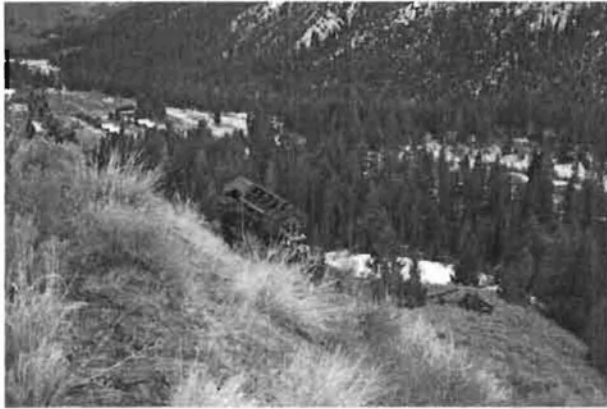
Figure 2. Mill 2, Tailings Area 5 and Jim Creek.

Jim Creek flows eastward down from the mine adits, and passes below Tailings Area 5 and the older mill (Mill 2) in a narrow canyon (Figure 2). These tailings are relatively coarse grained, and date from the earlier, less efficient stage of production. The tailings appear to have been formerly contained within a dike that is now breached. Some erosion due to surface flow through the dam breach is visible (Figure 3), and the eroded tailings form a wide shelf below the dam. Water was observed flowing out from beneath the tailings shelf below the dam, and flowing into Jim Creek. Unnamed tributaries enter Jim Creek about 250 feet upstream and downstream of Tailings Area 5. These tributaries may be dry during the summer months.

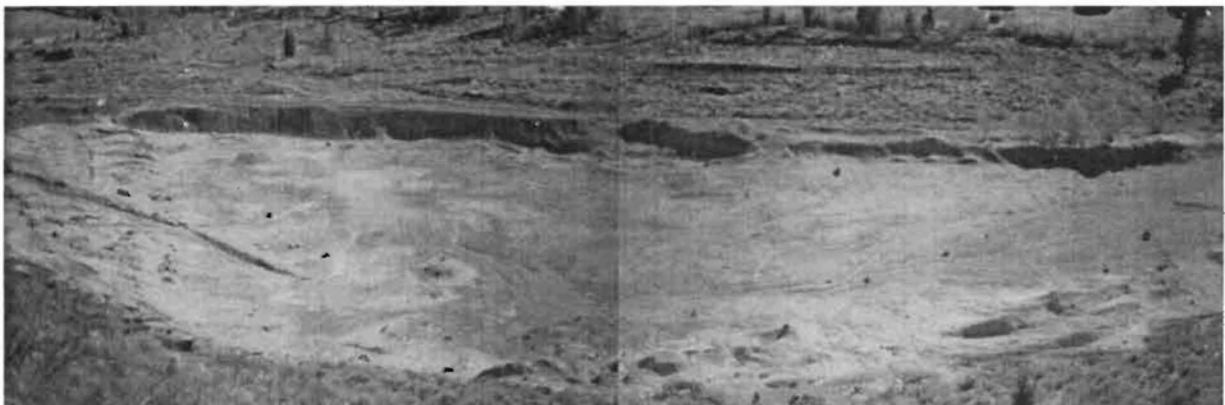
Figure 4. Tailings Area 4.

As the canyon widens near the confluence with Big Boulder Creek, Jim Creek passes about 200 feet below Tailings Area 4 (Figure 4). A set of cabins lies about 100 feet south of Jim Creek, in the relatively flat area between Jim Creek and Big Boulder Creek. Tailings Area 4 forms a large bowl on the northern slope of the valley, with a containment dike along the east and southeast. Most of the tailings have been removed, probably for processing at Mill 1. The central depression has variable topography and shows signs of trail riding by off-road vehicles and erosion by both wind and water. The tailings are relatively isolated from streams, but some runoff can flow in from the slope directly above. There is a “saddle” in the dike along the south, but its elevation is too high to pass water, except in extreme events. The tailings appeared dry on each visit, suggesting that water that collects in the bowl evaporates or exits via subsurface flow. An intermittent drainage flows about 50 feet west of the west end of these tailings, and a drainage ditch runs along the east edge, just west of Railroad Ridge Road. The outflow from this ditch crosses the road south of Tailings Area 4, and then works its way toward Jim Creek via a complex set of man-made channels and beaver ponds. Several features of Tailings Area 4 make it a likely candidate for a tailings repository: its location on a bench, its relative isolation from surface water, its ability to accommodate a large volume of material and its location adjacent to an existing road.

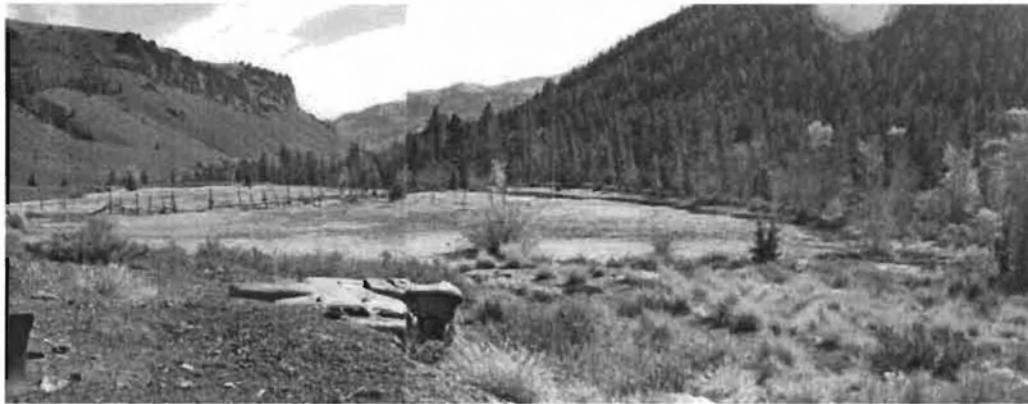
Figure 5. Tailings Areas 3 (foreground) and 2.

Tailings Area 3 (Figure 5) is located south of Mill 1. It is bounded on the east by a low tailings dam and fence line, on the north by an unpaved road, and on the south by a berm that separates it from the former channel of Jim Creek. A channel running inside the berm along much of the south side of the tailings area can be seen in the photograph. This channel may have been intended to facilitate tailings transfer from Area 3 to Area 2. It is fed by a conveyance running through the berm from the former Jim Creek channel, but it did not contain standing or running water during 2001–2002 field observations. The low tailings dam has been breached, and shows definite evidence of erosion. There is also evidence of ponding and surface water erosion on the surface of the tailings area.

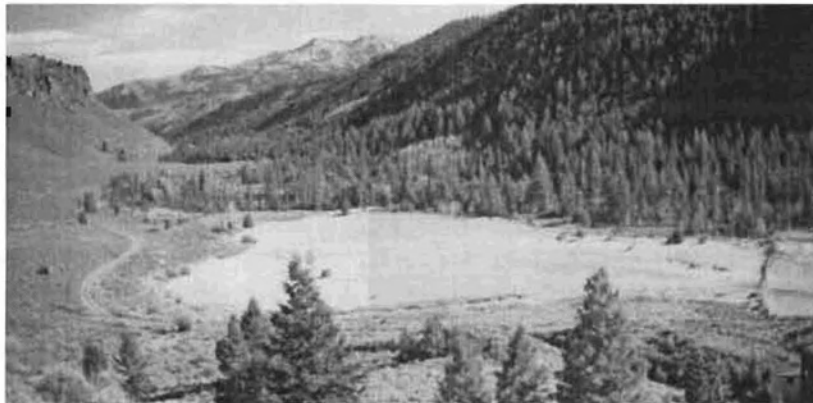
Figure 6. Tailings Area 2.

Tailings Area 2 covers a large area east of the fence line and breached dam. It is bounded on the north by the unpaved road and on the south and east by a berm. The former Jim Creek channel lies to the south. A low ridge runs roughly east–west across the area, topped by deciduous trees and large boulders (Figure 6). This suggests that the underlying topography is higher along this ridge than on either side of it. For purposes of discussion, we have designated the zone north of this ridge as Area 2A, and the zone to the south as Area 2B.

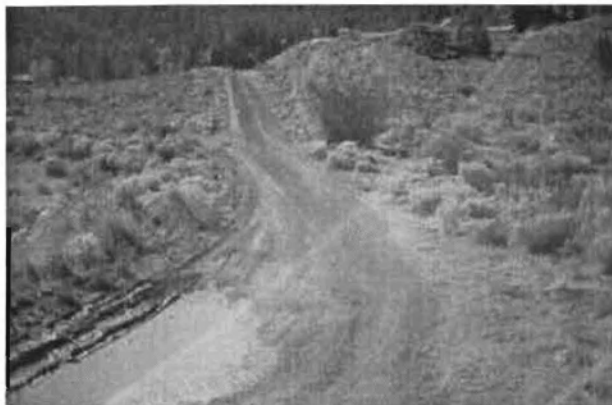
M1 Creek crosses the unpaved road and enters Tailings Area 2A (Figure 7). Eastward from this point, the northern tailings boundary is marked by a series of willow bushes and a few small pine trees. Since the tailings themselves are barren (except along the ridge) and the vegetated zone along the north edge is characterized by willows and grasses, this suggests the presence of water along the northern boundary of Area 2A. Careful examination of the tailings topography indicated that the topographic low is not along the boundary, but somewhat south of it. A temporary piezometer constructed of 2-inch polyvinyl chloride well screen was installed near one of the willow bushes (Figure 8). Although the piezometer was screened down to the soil contact, no groundwater was observed. This may be due to seasonal conditions.

Figure 7. “M1 Creek” crossing road towards Tailings Area 2A (at willow).

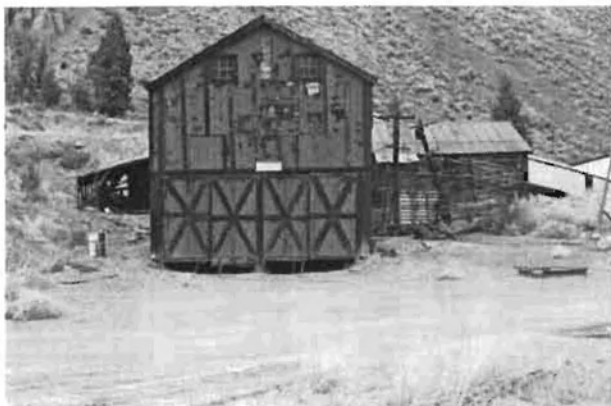
Four process residuals samples (M001 through M004) were collected from around Mill 1 on October 11 (Figure 11). These samples were collected from near the ground surface, where visual evidence of discoloration was observed. Several drums were observed in the vicinity of Mill 1. One sample of a white granular solid (M005) was collected from one drum, and one sample of a yellowish granular solid (M006) from another drum was collected for analysis (Figure 12). No samples were collected from inside the building or at Mill 2 at this time because of access restrictions.

Figure 11. Process residuals samples M001–M004 (flagged) and transformer sample M007 at Mill 1.

No PCBs were detected in the sample from the east transformer (M007). Small chromatographic peaks were observed in the PCB elution range, but these peaks were below the 1.0 mg/kg Method Detection Level, and the characteristic Arochlor patterns were not present.

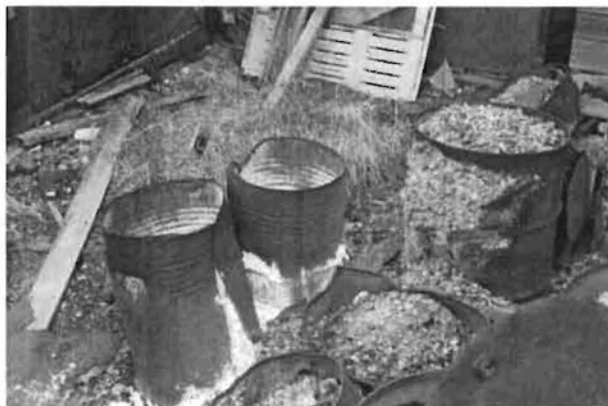
Figure 12. Drum samples M005–M006 at Mill 1.

The white powdery sample collected from a drum outside Mill 1 (M005) contained lower concentrations of metals than in the other process residuals or tailings samples. However, it was found to be 29.2% calcium by weight, suggesting that it is primarily some form of lime. Both quicklime and hydrated lime are used in the flotation process for zinc-, copper- and lead-bearing ores. Lime is also used in the cyanide leaching process of silver and gold ores, both for control of pH and as a cyanide recovery aid (National Lime Association, undated). The white-gray powder found inside Mill 1 (M009) is probably also a form of lime, as indicated by the high calcium content and slightly alkaline pH value.

Samples M005 and M009 also contained cyanide ion, in concentrations of 1.85 mg/kg and 63.5 mg/kg, respectively. There is no Toxicity Characteristic concentration for cyanide (40 CFR 261.24). However, this waste could be classified as a D003 Reactive Hazardous Waste if, "when exposed to pH conditions between 2 and 12.5, [it] can generate toxic gases, vapors or fumes in a quantity sufficient to present a danger to human health or the environment" (40 CFR 261.23(a)(5)). EPA has withdrawn its analytical method for determining the reactivity of cyanide and sulfide wastes, but the regulatory definitions remains in effect. This complicates the assessment of whether cyanide-containing wastes are hazardous wastes under RCRA. Since the EPA guidance level for reactive cyanide is 250 mg/kg (as HCN; SW-846 §7.3.3.1), and the Treatment Standard for Hazardous Waste D003 is 590 mg/kg total cyanide or 30 mg/kg cyanide amenable to chlorination (40 CFR 268.40), the drum contents represented by M005 would not be classified as a RCRA hazardous waste on the basis on their cyanide content. However, the total cyanide concentration in M009 is 63.5 mg/kg and the zinc concentration is nearly 6%. Since zinc cyanides are highly amenable to chlorination (EPA 2000), the amenable cyanide concentration is expected to exceed the 30 mg/kg treatment standard. It would be prudent to handle this material as a RCRA hazardous waste.

Some waste materials were found at Mill 1, including electrical equipment, a few unlabelled drums and a box containing blue crystals. One sample taken from a large transformer showed it to be free of detectable PCBs. Small concentrations of cyanide salts were found in two drums. General knowledge of cyanide salts suggests that the cyanide concentration in one drum is above the Treatment Standard for D003 wastes. Prudence indicates that this drum be handled as a RCRA hazardous waste. A limited amount of other reagents should be disposed of if Mill 2 is closed.

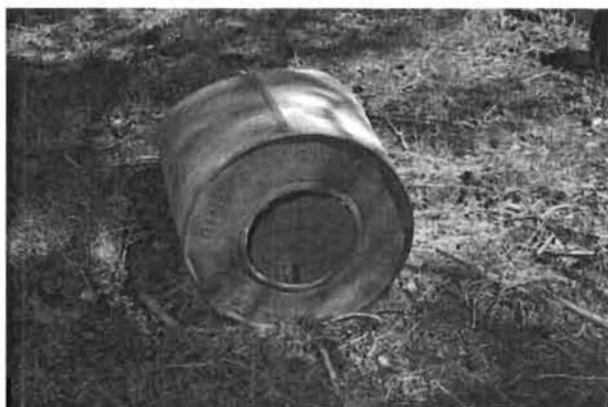
Figure 14. Empty cyanide can south of Tailings Area 2.

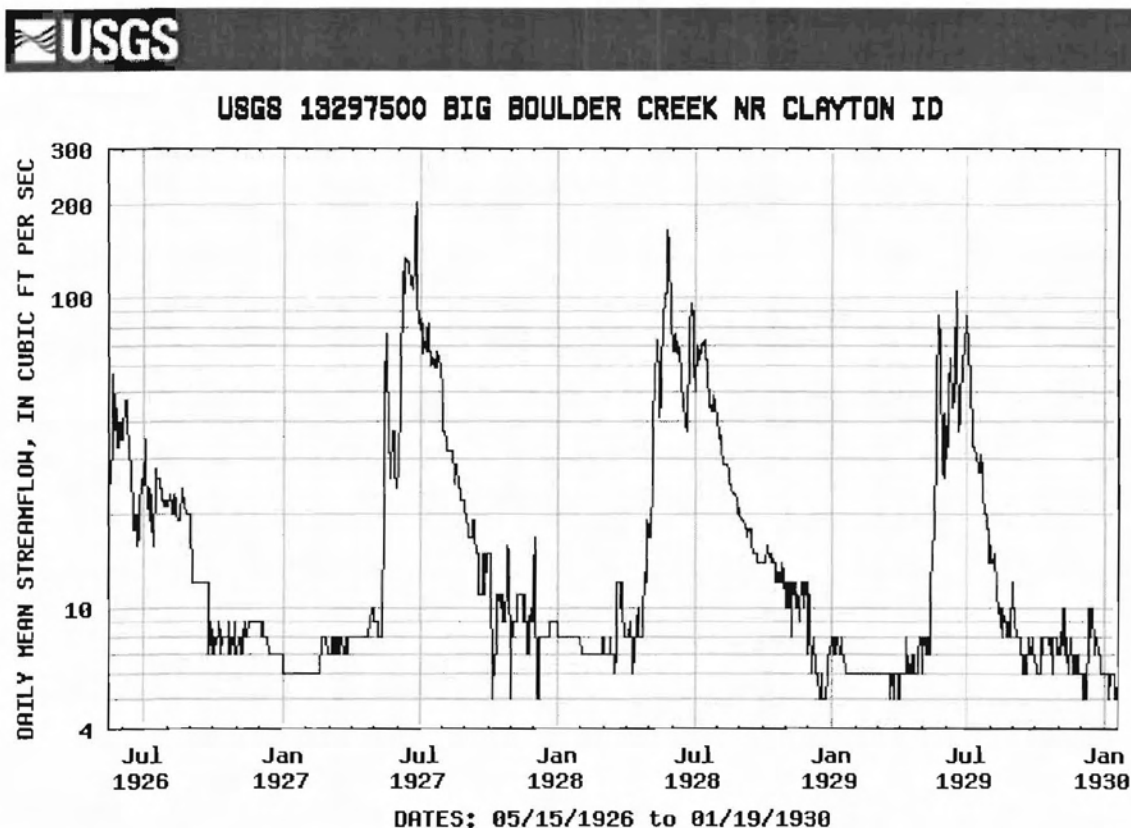
Figure 15. Historical USGS Flow Data for Big Boulder Creek, 1926–30.

Available historical flow data were limited to a four–year period in the 1920s (USGS 2002). These data are presented in Figure 15. It can be seen that the October 2001 flows measured in lower Big Boulder Creek were similar to the minimum seasonal flows observed at the USGS gauge. The annual maximum flows were 67 cfs, 206 cfs, 184 cfs and 115 cfs in May 1926, June 1927, May 1928 and June 1929, respectively. These are 13 to 41 times the minimum flow of 5 cfs. Since the 1927 flow corresponded to a gauge height of 2.04 ft, it appears likely that bank overflows at the project site will occur.

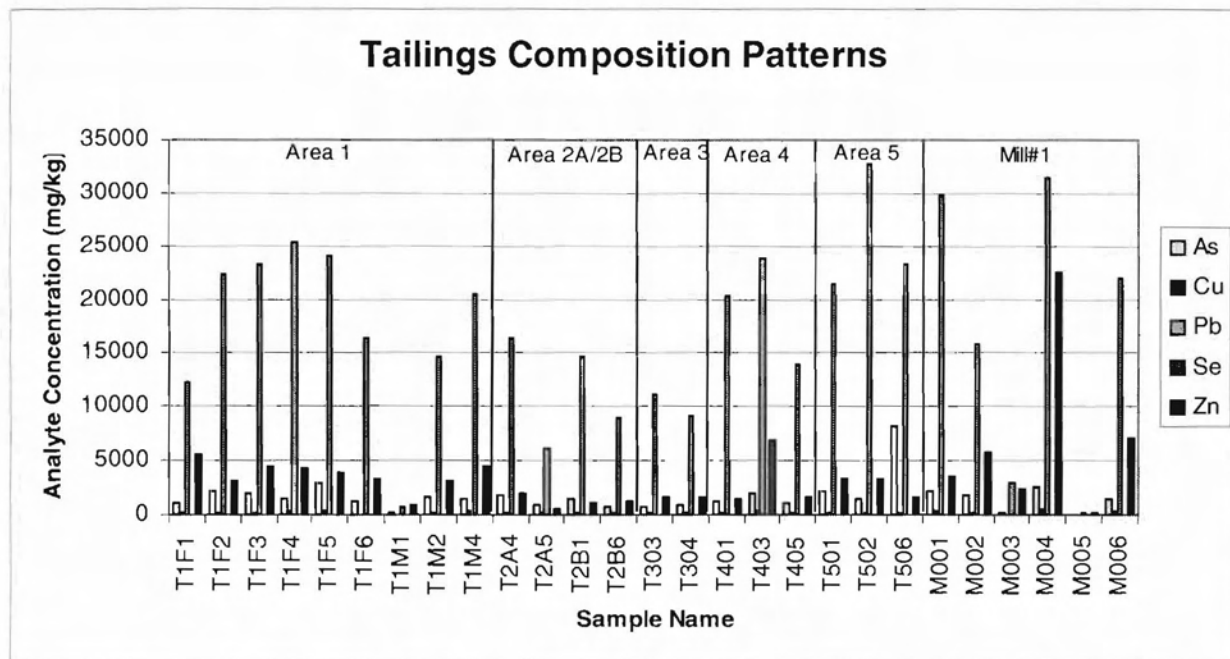
Figure 16. Chemical composition of tailings and process residuals.

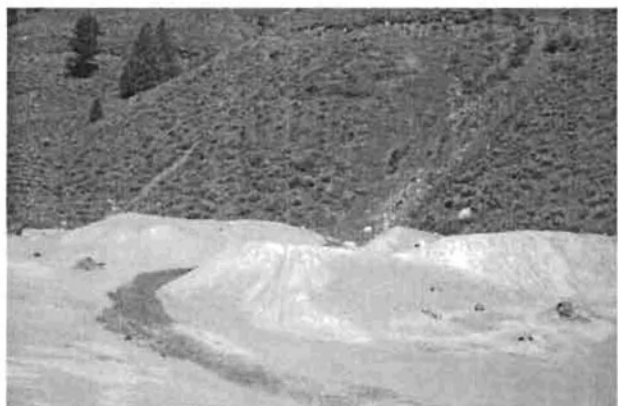
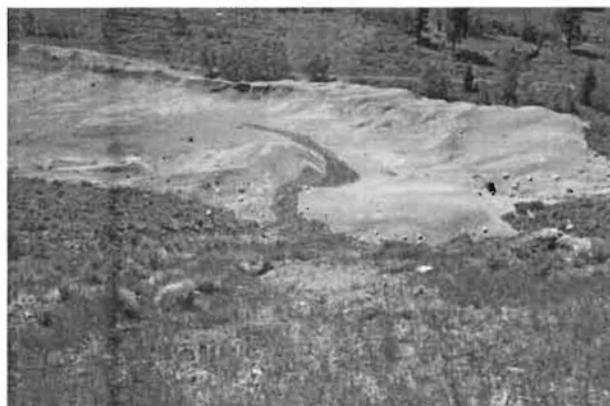
The extreme variation in topography at the surface of and underlying the Tailings Areas makes accurate volume estimates difficult. This is particularly true in Area 4. The effect is somewhat mitigated in Areas 2 and 3 by the use of the augering technique, but the wide variation in measured thickness over an area that looks fairly flat on the surface demonstrates the variation in underlying topography. The volume estimates presented here are not suitable for detailed engineering design, but should be usable in evaluating gross removal action alternatives. Accurate topographic surveys (not available at the time of this study), combined with limited field mapping and estimation of tailings depth would provide a basis for better volumetric estimation.

Figure 17. Landslide into Tailings Area 4.

Figure 18. Landslide into Tailings Area 4.
