Subject: Site Assessment of the Poorman Mine, French Creek-Florence Mining District,  
Idaho County, Idaho

## ABBREVIATED PRELIMINARY ASSESSMENT

**Site Name:** Poorman Mine

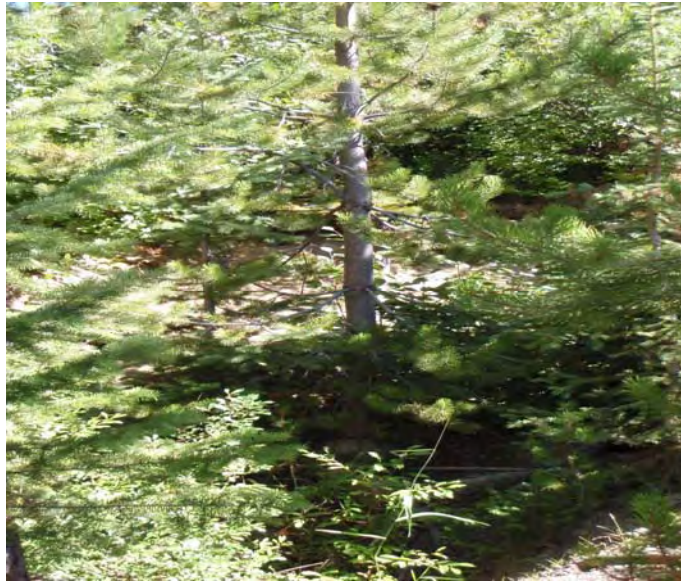
**Photo 1.** Collapsed Adit 1.  
Latitude 45.47808°N, Longitude -116.06123°W

No mineralization was present at Collapsed Adit 1. It was well vegetated with brush and trees. No water was flowing from the adit.

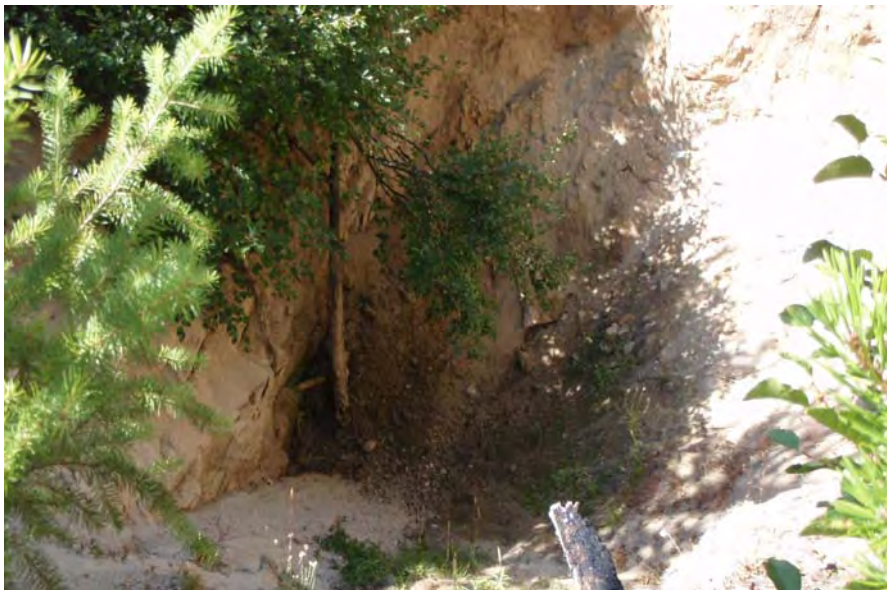
**Photo 2.** Partially Collapsed Shaft 1.  
Latitude 45.47805°N, Longitude -116.06139°W

The hole remaining at the partially collapsed Shaft 1 was approximately 20 yards deep and 15 yards wide. It is a physical hazard due to its depth and steep sides. The shaft was dry.

The Poorman Mine is not located near any occupied dwellings, towns, or inhabitants. No hazardous materials were evident during the site visit. The partially collapsed shaft is a physical/safety hazard and should be buried.

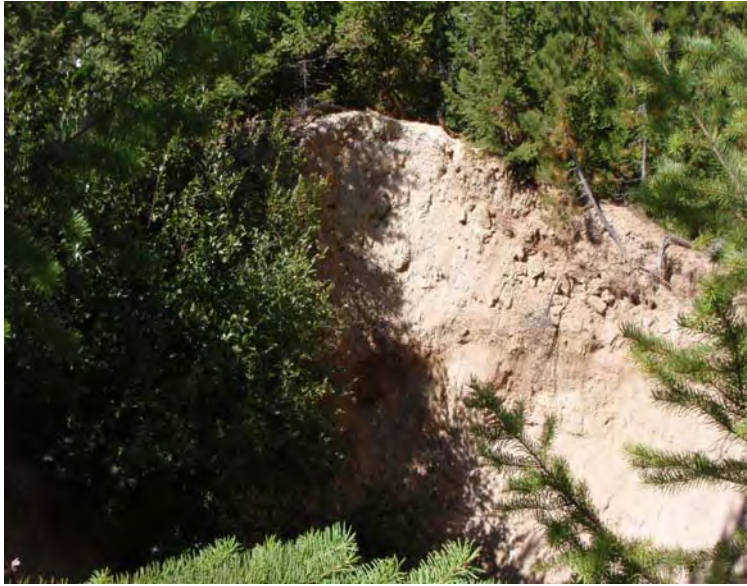
**Photo 3.** Collapsed Shaft 1 (steep banks, deep and dangerous).

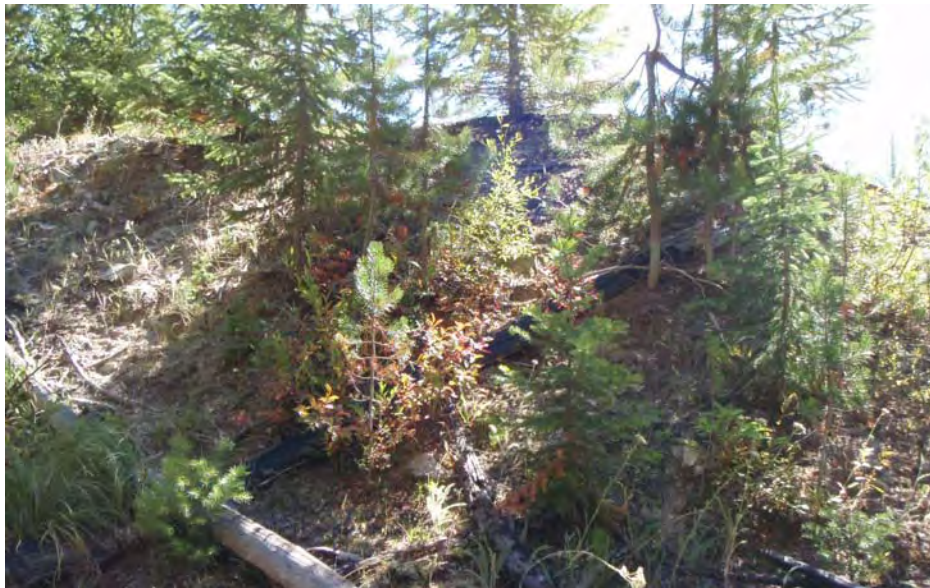
**Photo 4.** Waste dump from Shaft 1.

The waste dump from Shaft 1 consisted of country rock and native materials. No mineralization was observed. The waste dump was approximately 20 yards by 6 yards by 7 yards in size and was well vegetated and stable.

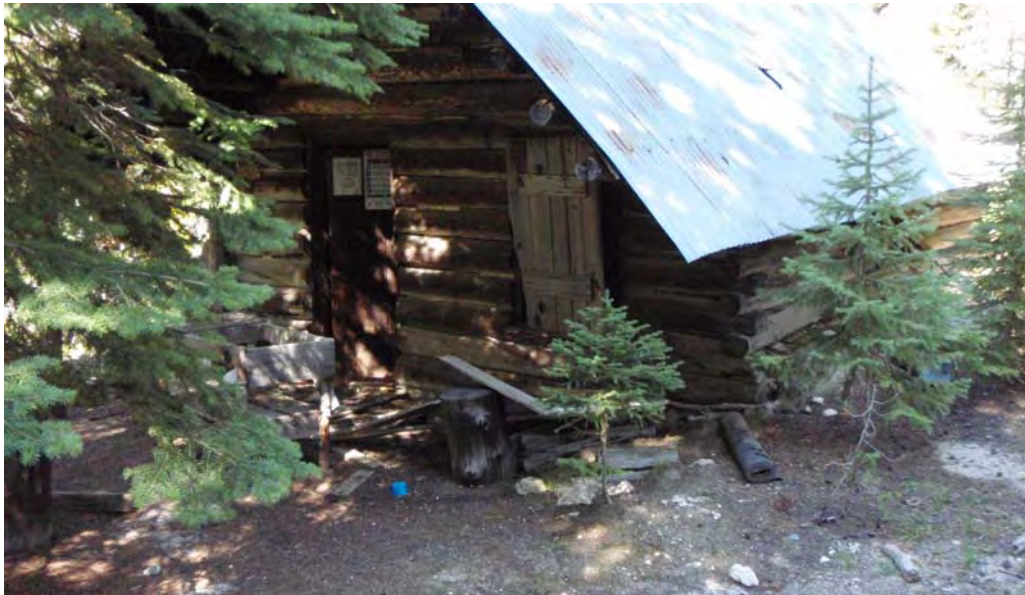
**Photo 5.** Cabin on north side of Shaft 1.  
Latitude 45.47805°N, Longitude -116.06209°W

Approximately 40 yards from the north side of Shaft 1 is a cabin. The cabin is 8 yards long by 7 yards wide and is full of pack rat trash and debris.

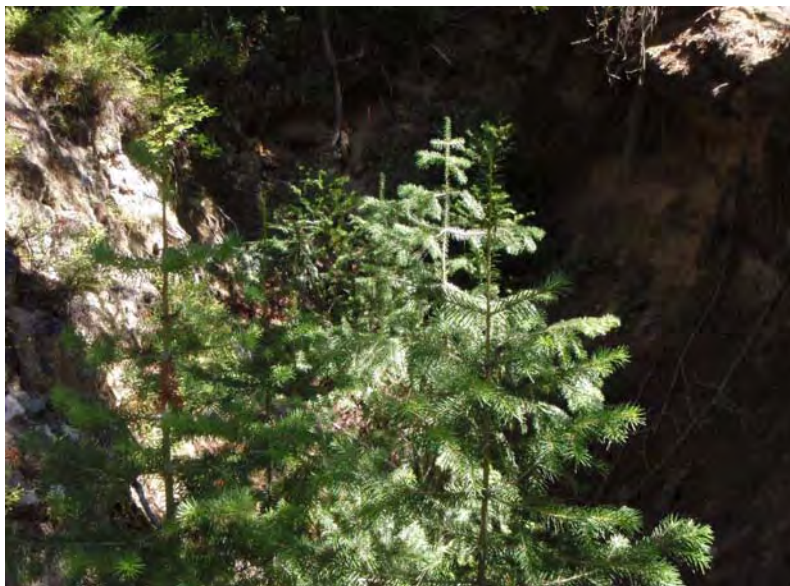
**Photo 6.** Poorman Mine Adit 2.  
Latitude 45.47827°N, Longitude -116.06204°W

Directly behind the cabin was Adit 2. The adit was dry with no flowing water. It has a small waste dump which is well vegetated and has been flattened out. DEQ was unable to estimate the size. It consisted of country rock and native materials. No mineralization was present.

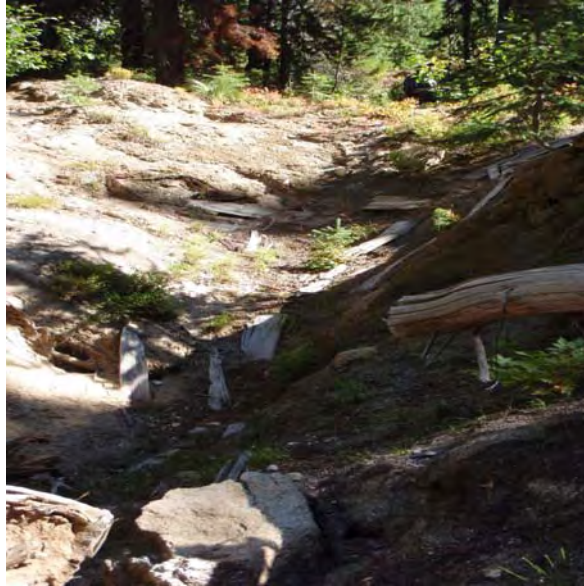
**Photo 7.** Collapsed Adit 3.  
Latitude 45.47824°N, Longitude -116.06204°W

Poorman Mine collapsed Adit 3 is 25 yards east of the back of the cabin. The adit was dry with no flowing water.

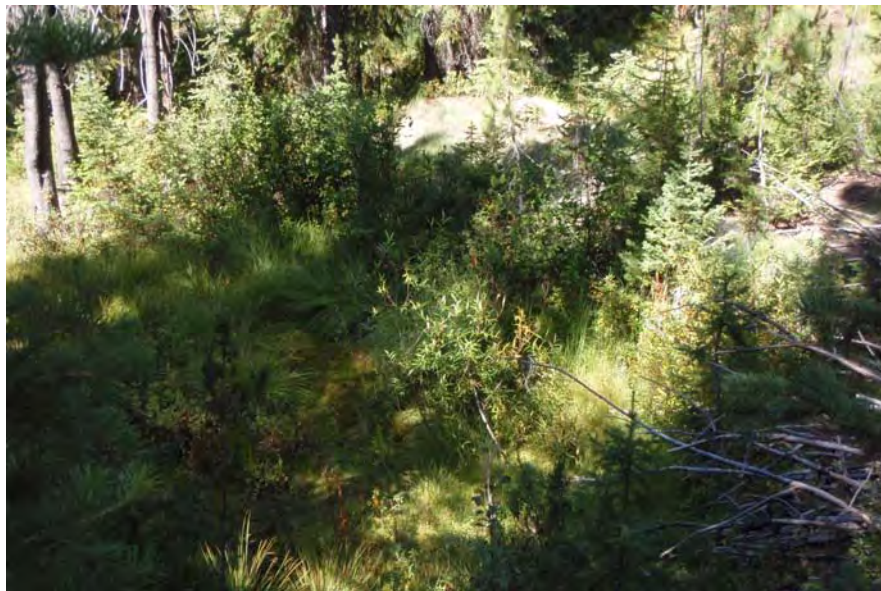
**Photo 8.** Waste dump from Adit 3.

The Adit 3 waste dump is spread out into a boggy area and is well vegetated and the plants did not appear stressed. Waste material is country rock and native material. No mineralization was evident.
