Queen Bess Mine

Preliminary Assessment Report

Blaine County
State of Idaho

Idaho Department of Environmental Quality

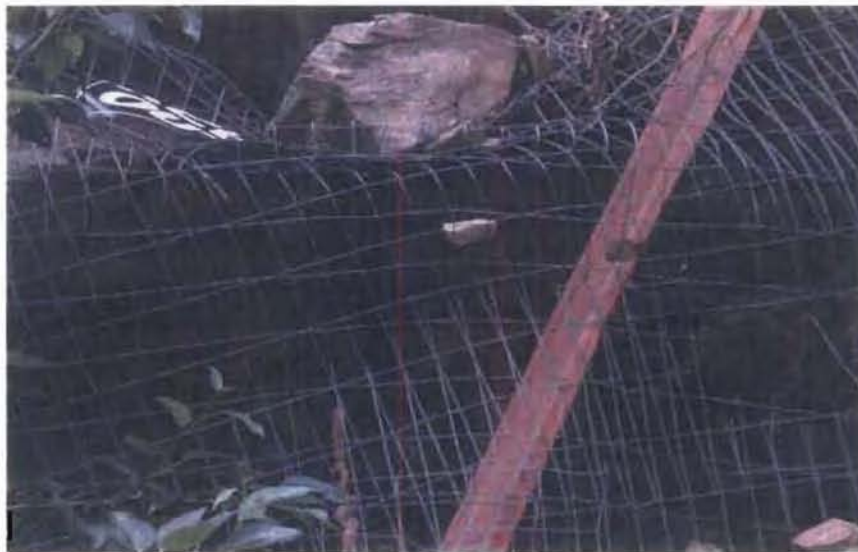
Close-up view fence barrier at inclined shaft; fallen rocks obscure danger signage

The Queen Bess claim has at least one adit and one inclined shaft. The inclined shaft is open to an unknown depth, a portion of which appears flooded. The adjacent adit is partially open as well. Both of these workings warrant closure to minimize safety hazards. If constructions of homes or other buildings do occur above mine workings, unstable ground conditions or subsidence may be experienced.

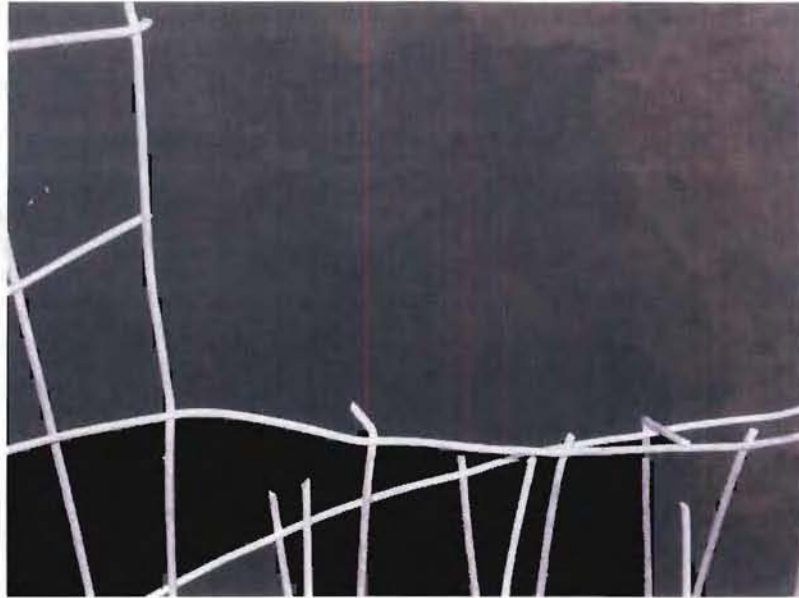
Interior close-up view of inclined shaft; water (lower left in shadows)

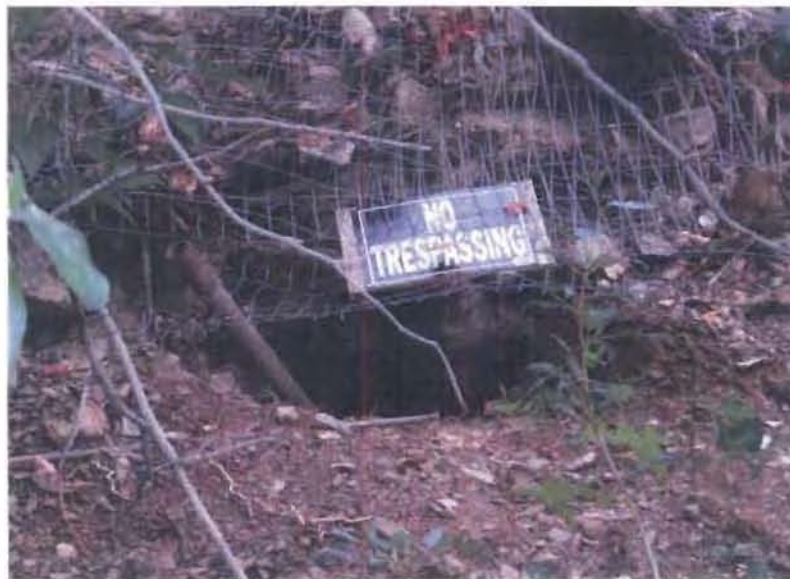
Collapsed portal of adit, open at outcrop face; air circulation pipe & warning sign

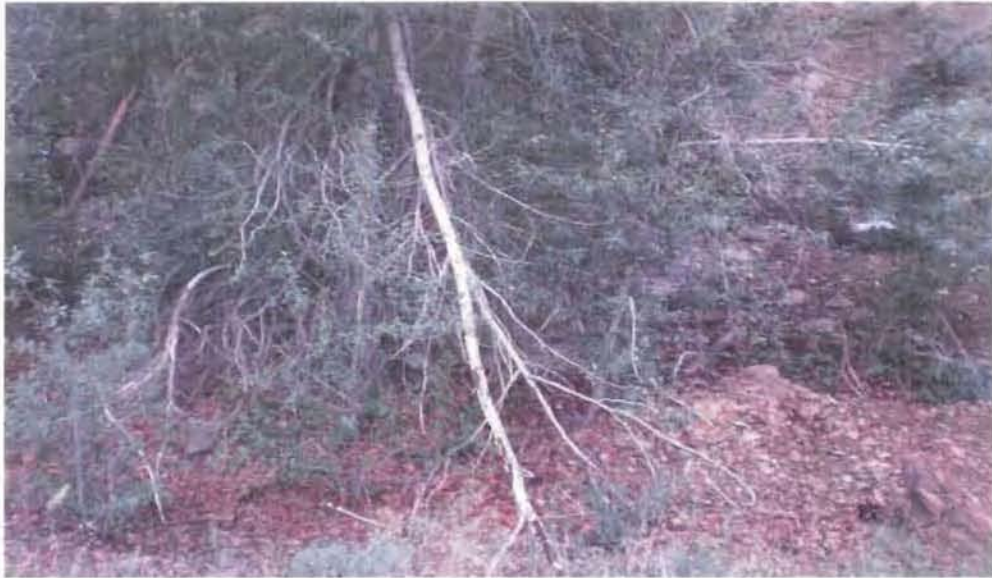
Panoramic view of inclined shaft (upper left) and adit (upper right) below "No Trespassing" sign; both partially hidden in the brush
