ABBREVIATED PRELIMINARY ASSESSMENT CHECKLIST

Site Name: Hatton Patented Claim

Photos and Site Conditions for Patented Claims in Gilmore

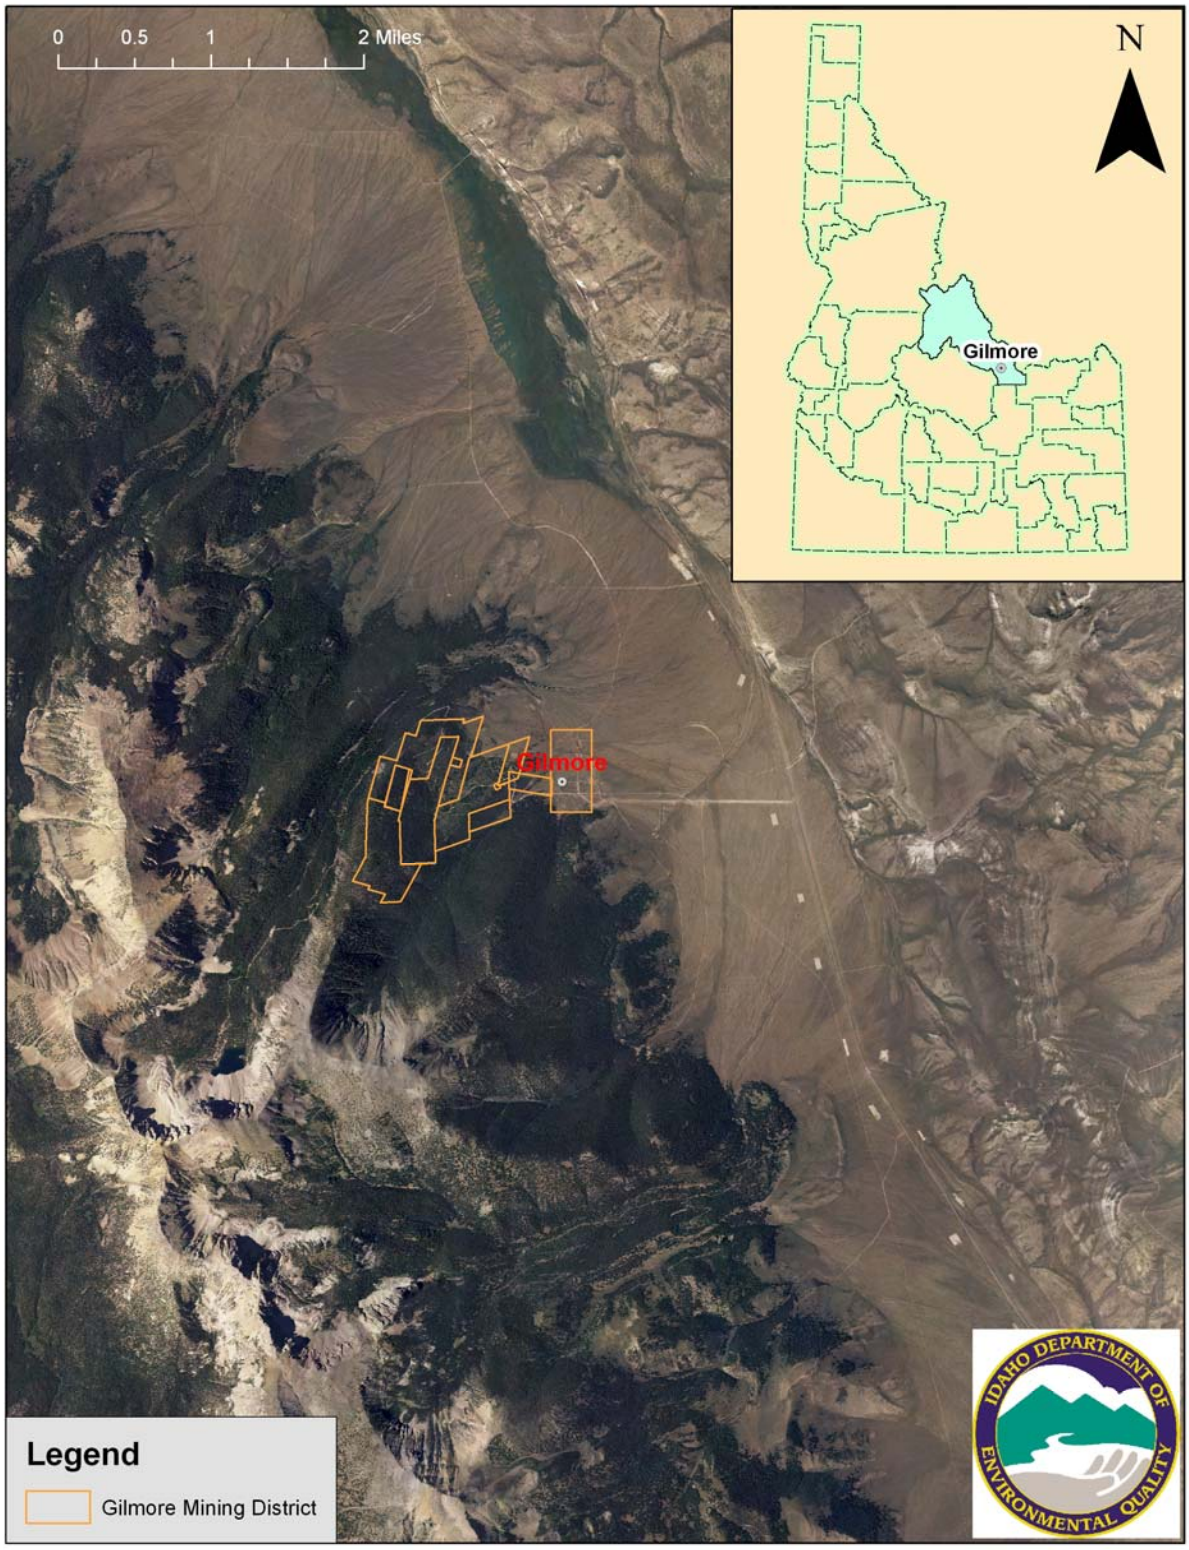
Figure 1. Location of the Gilmore Mining District with Lemhi County 2010 Parcel Data overlay. (Map source: Lemhi County NAIP 2004)

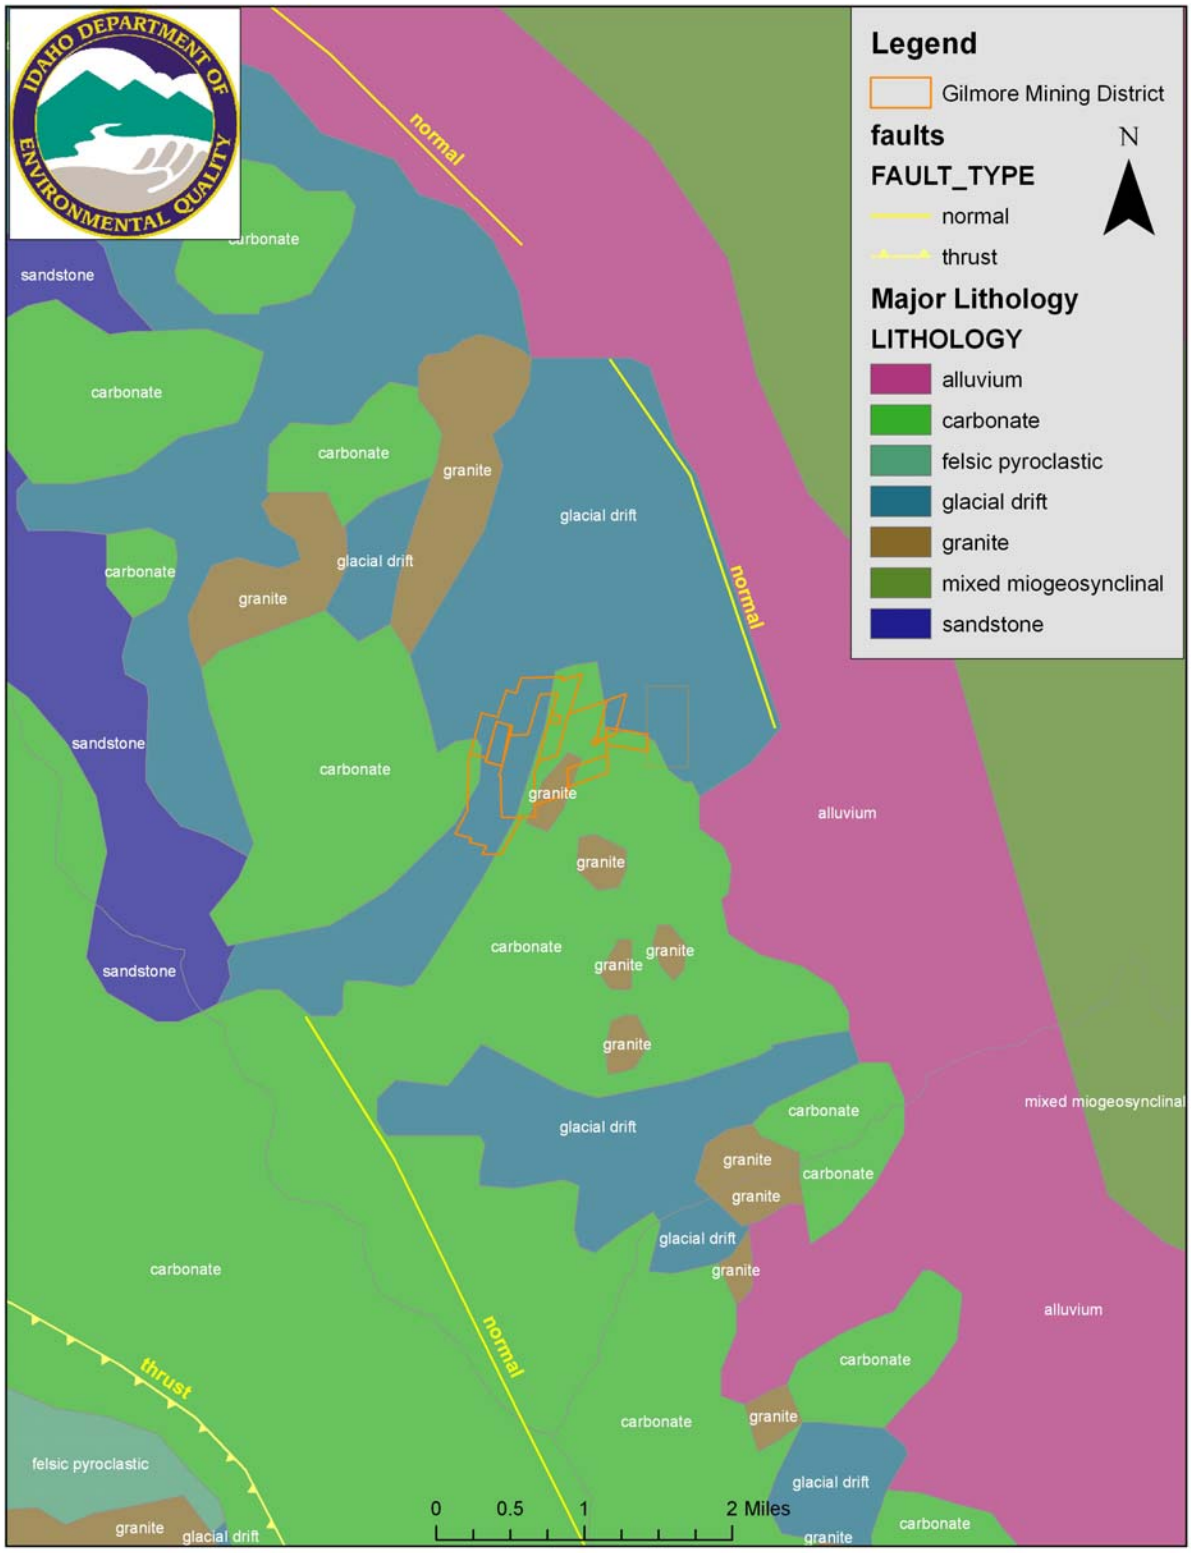
Figure 2. Lithology of the Gilmore Mining District. (Map source: Idaho DEQ ArcSDE 9.2 Geodatabase)

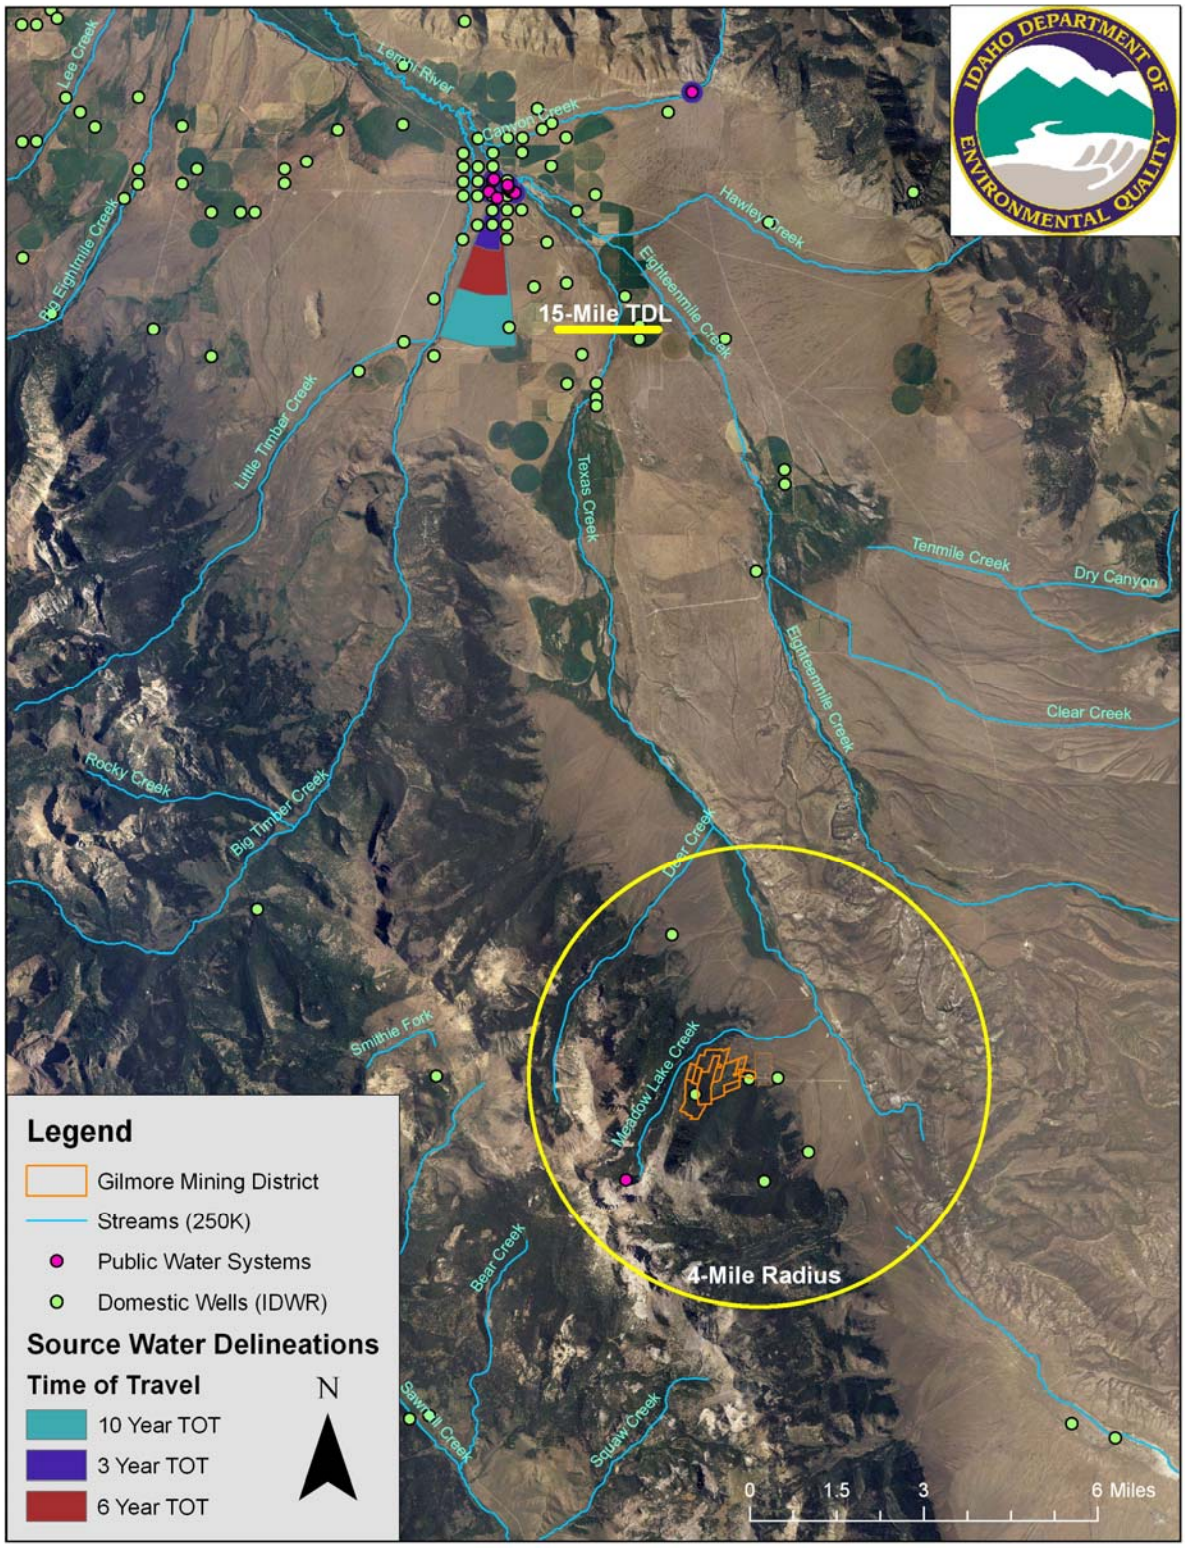
Figure 3. Drinking water well locations and source water delineations. 15-Mile Target Distance Limit (TDL). (Map source: Lemhi County NAIP 2004)

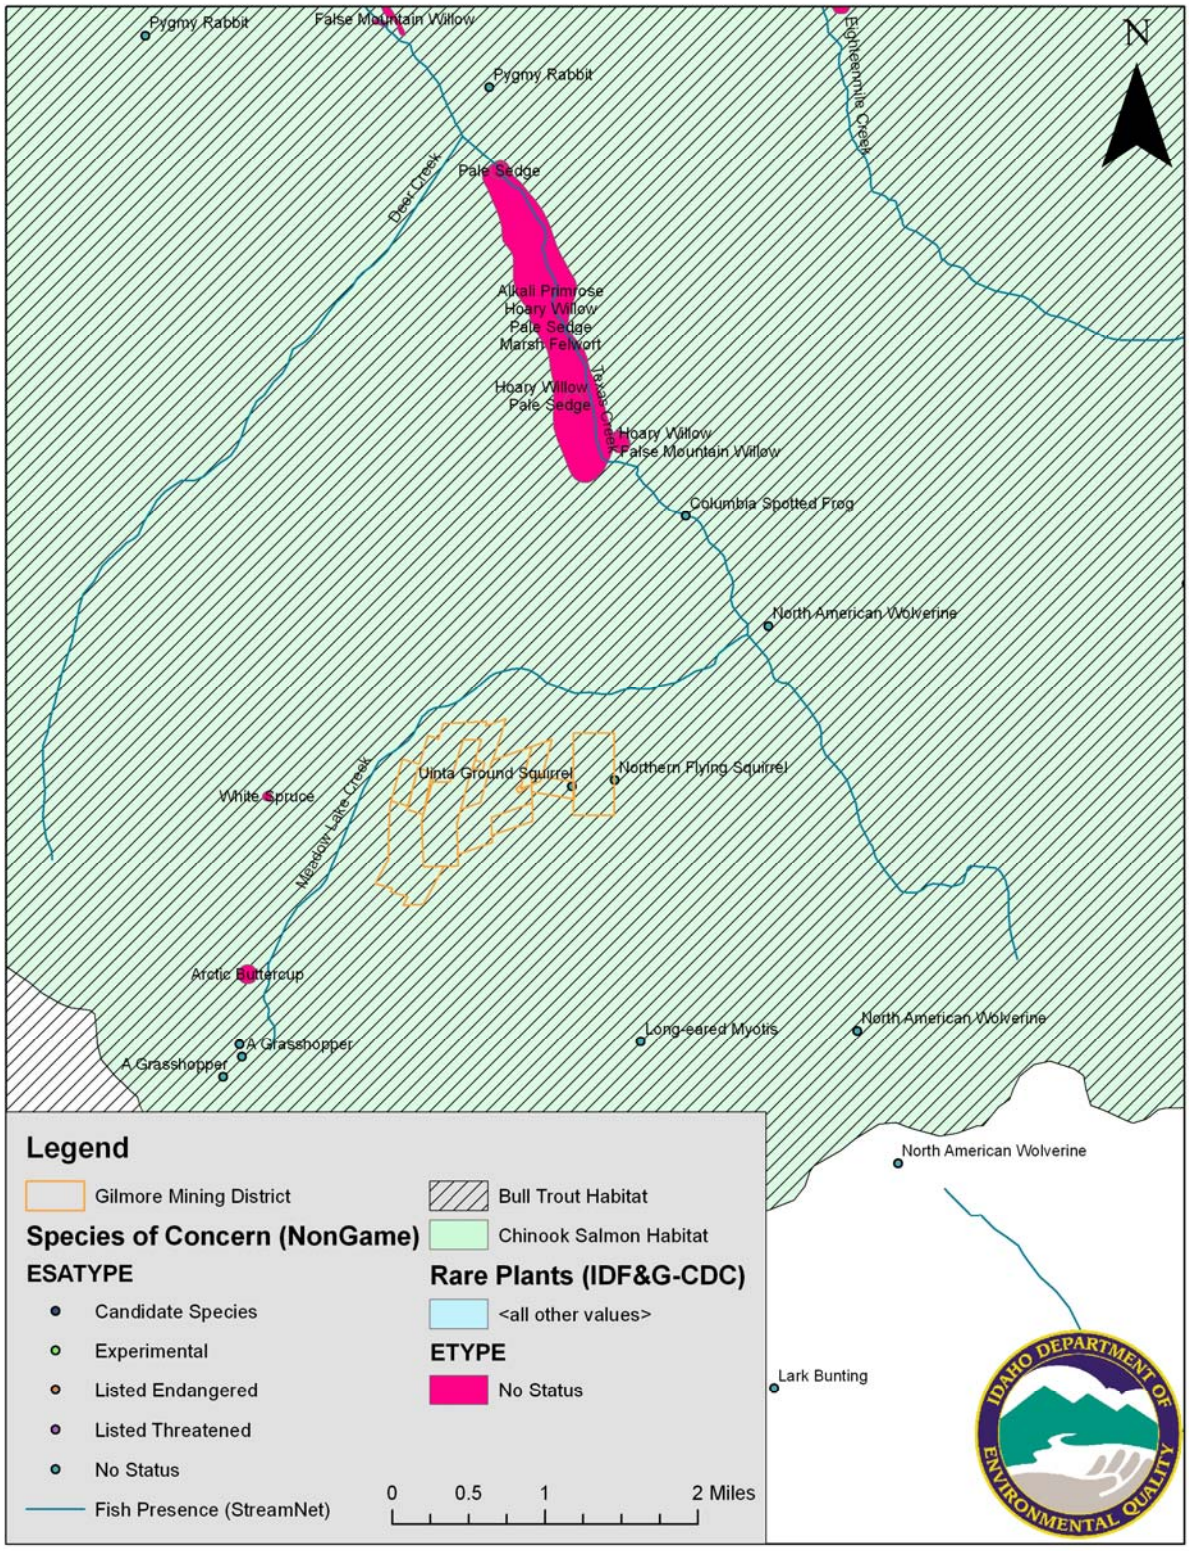
Figure 4. Sensitive species near the Gilmore Mining District. (Map source: Idaho DEQ ArcSDE 9.2 Geodatabase)
