# Triumph Mine Tailings Piles Site

## Fifth Five-Year Review

Blaine County, Idaho

January 2025

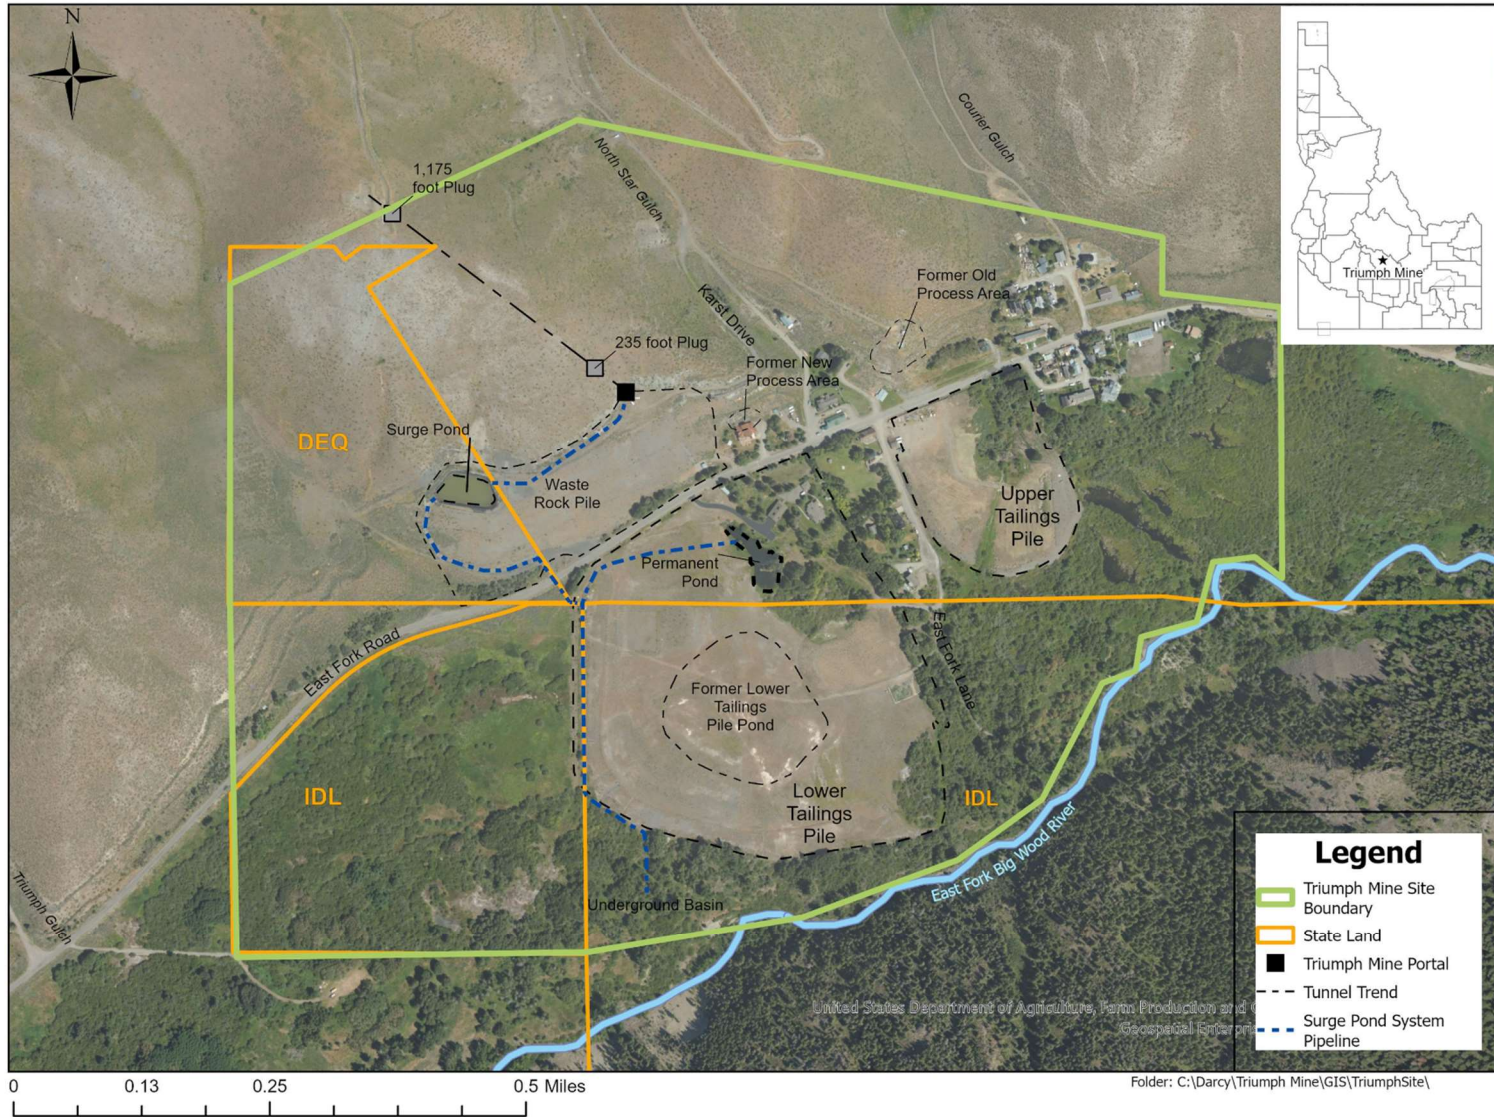
Figure 2. Map of Triumph Mine site including areas of previous contamination in relation to current conditions.

Figure 2 provides a map of site features:

- General trend of the mine tunnel, with locations of plugs at 1,175 feet and 235 feet from the portal
- Mine portal where discharge is measured at an average 6 to 7 gallons per minute (gpm)
- Blue lines showing an underground piping system conveying mine water from the portal to the surge pond; from the surge pond downhill and under East Fork Road; channeling groundwater from the permanent pond around the lower tailings pile to meet the pipeline from the surge pond, then channeling the combined discharge to an underground basin about 500 feet from the river
- Remediated areas including the former process areas, waste rock pile, and the upper and lower tailings piles
- Former ponded area on the lower tailings pile and the existing permanent pond to the northeast of the lower tailings pile
- State-owned property boundaries for DEQ and IDL
